Subject: 2019 Annual Site Inspection and Monitoring Report for Uranium Mill Tailings
Radiation Control Act Title II Disposal Sites

Enclosed are six copies of the *2019 Annual Inspection and Monitoring Report for Uranium Mill Tailings Radiation Control Act Title II Disposal Sites*. The report covers the annual inspections of the six Title II disposal sites managed by the U.S. Department of Energy Office of Legacy Management.

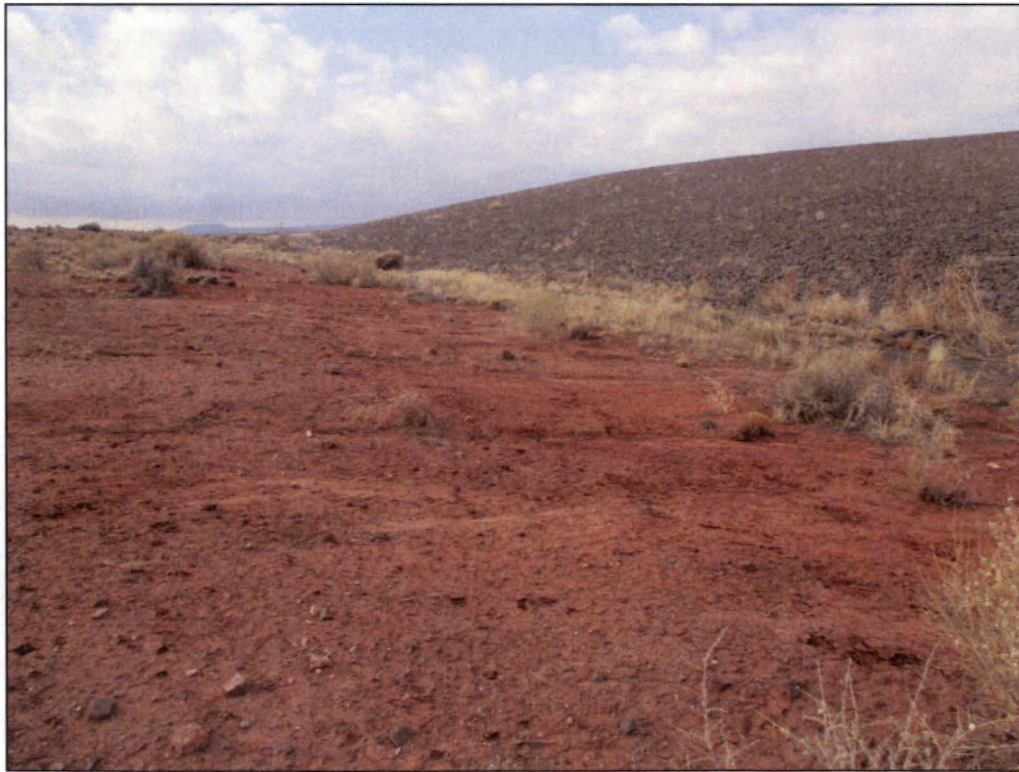
PL-10. Rills at the Base of the Main Tailings Disposal Cell East Side Slope

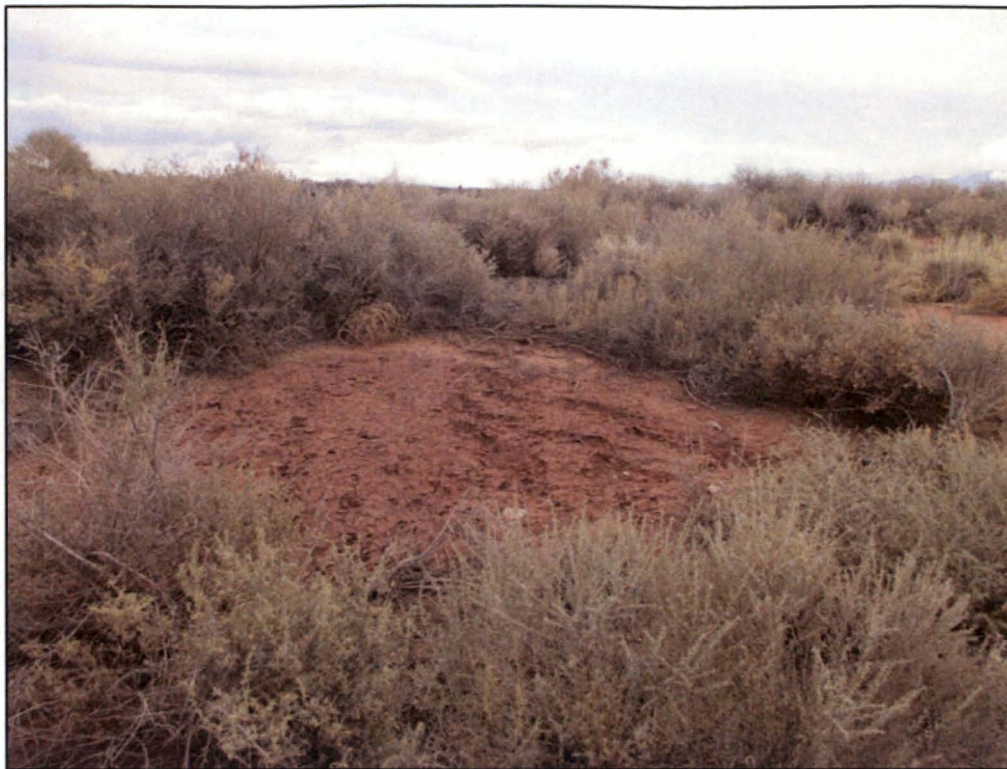
PL-13. Area of Depression Repaired in the Asbestos Disposal Area

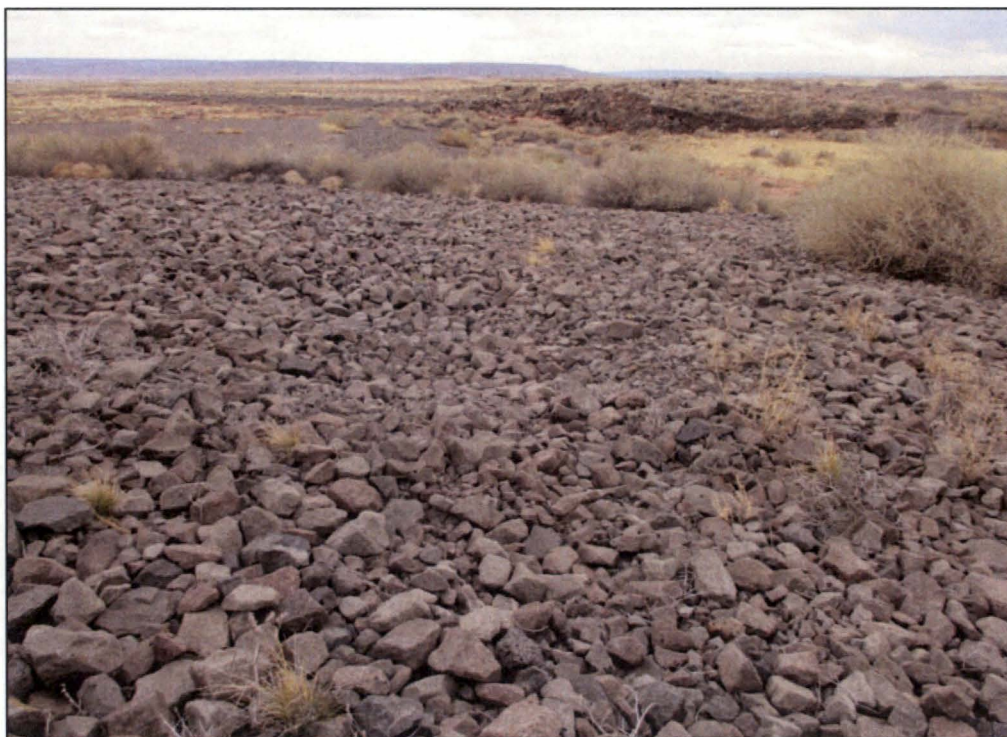
PL-14. Minor Depression on the Asbestos Disposal Area North Side Slope

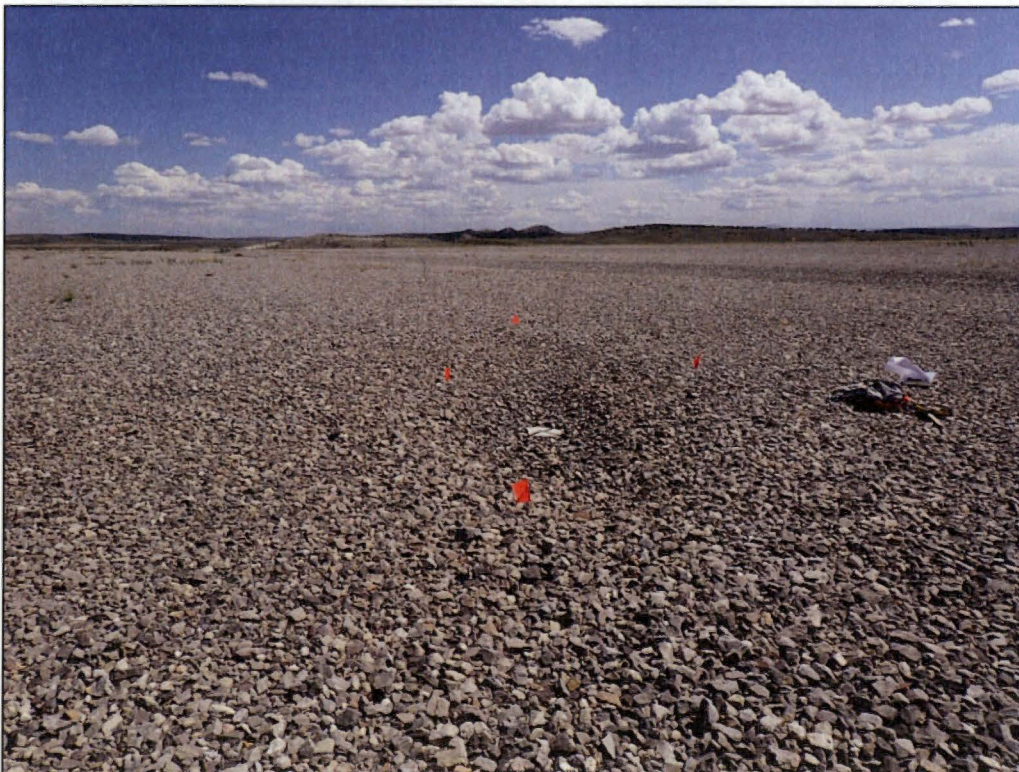
PL-6. Depression Feature on Top of Disposal Cell

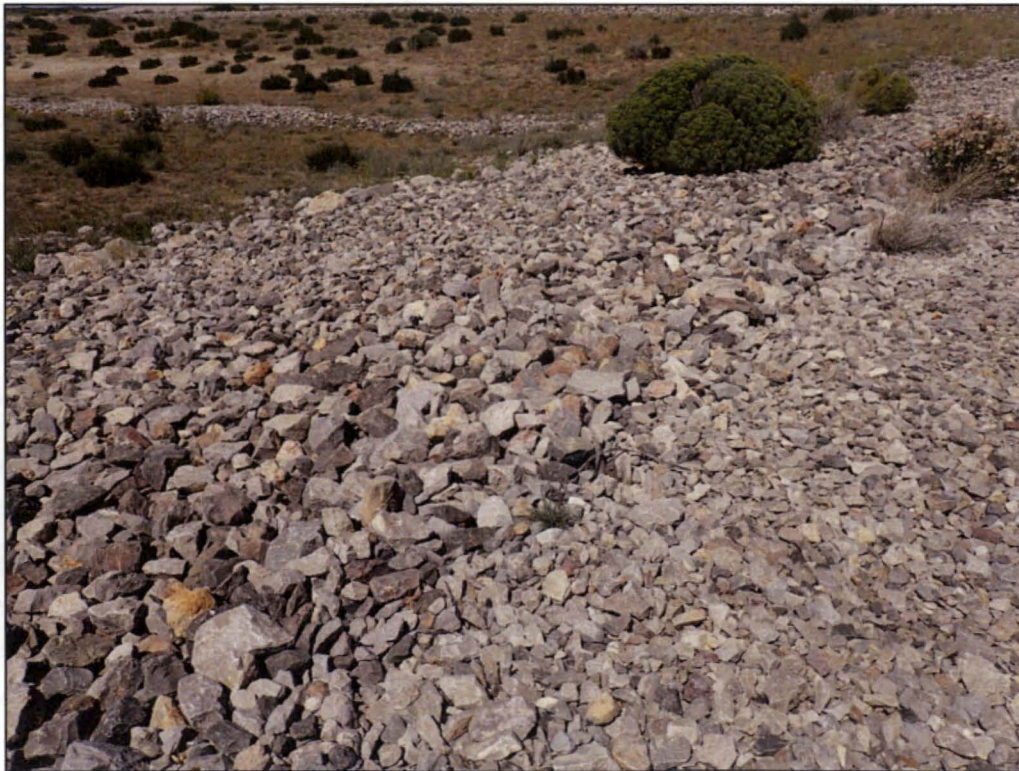
PL-12. Ancillary Cell West Side Slope with Small Depression on Cell Top Slope in Foreground

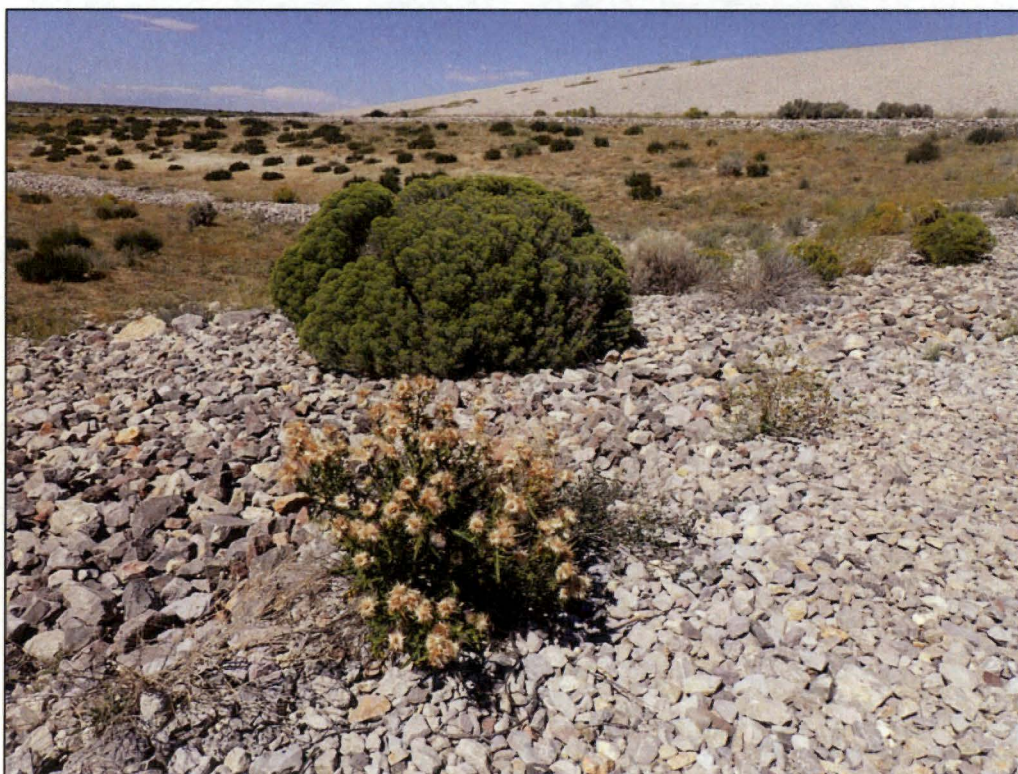
PL-14. Noxious Weed and Rubber Rabbitbrush on Ancillary Cell

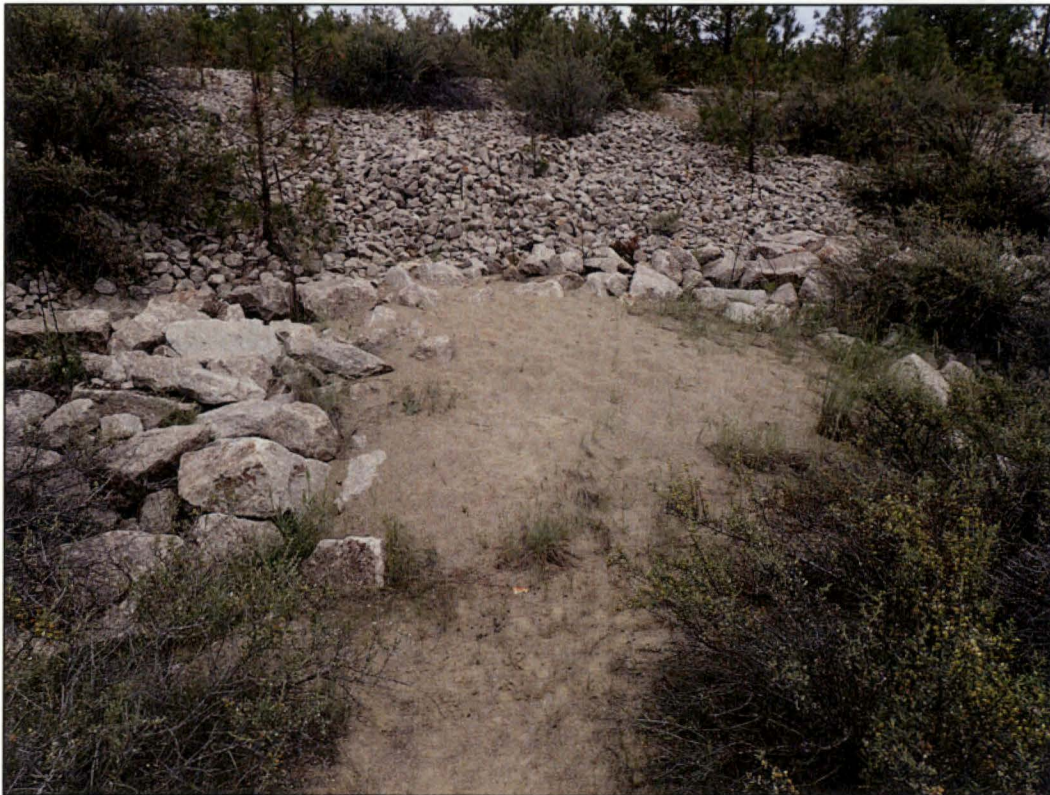
PL-8. Sand Deposit at Toe of Containment Dam Outslope

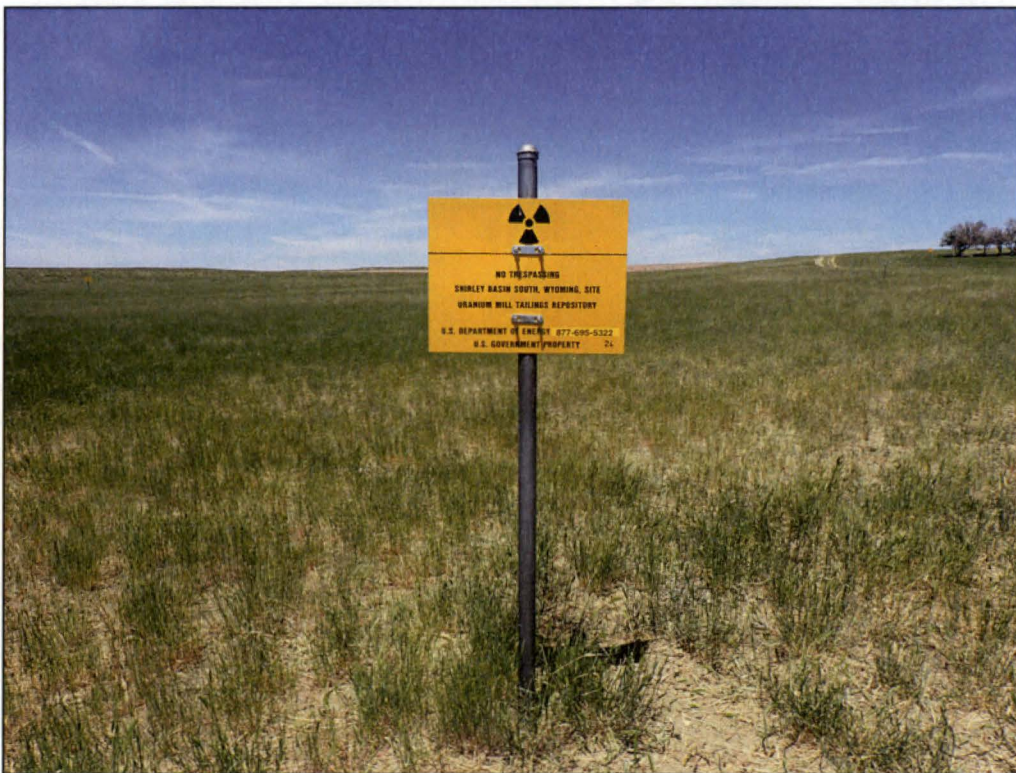
PL-2. Perimeter Sign P26 (Entrance Sign, Replaced)

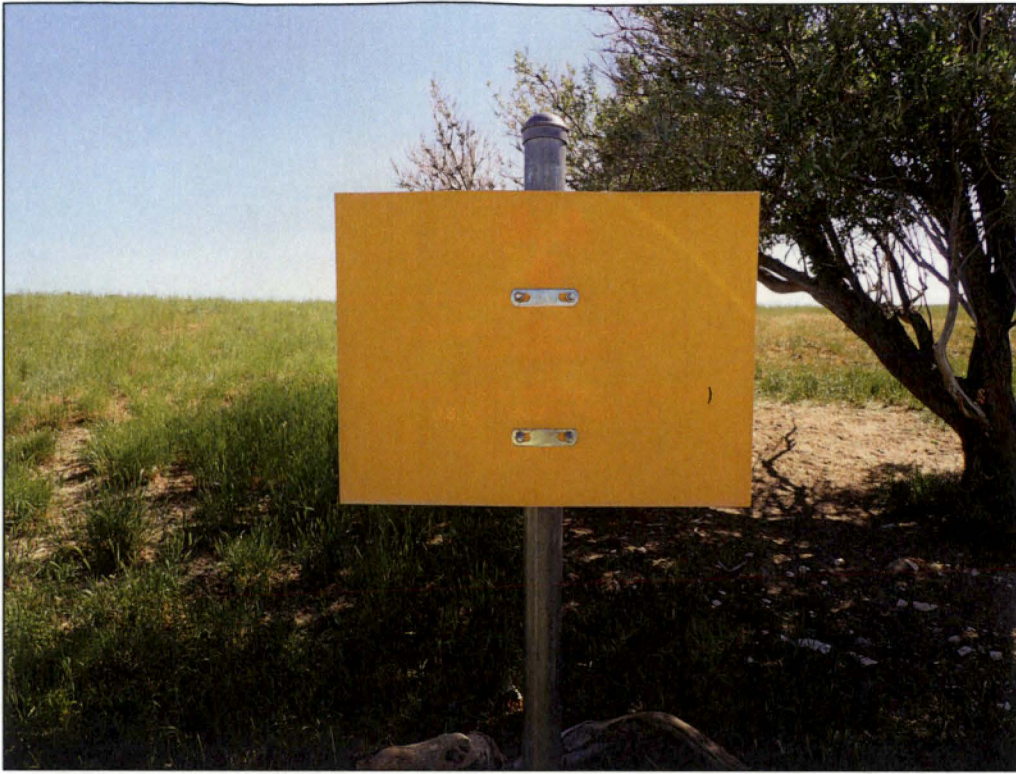
PL-3. Perimeter Sign P3 (Illegible, Replaced)
