SUBJECT: DAIRYLAND POWER COOPERATIVE
LA CROSSE BOILING WATER REACTOR (LACBWR)
PROVISIONAL OPERATING LICENSE NO. DPR-45
RESPONSE TO QUESTIONS RELATIVE TO VOIDS
UNDER TURBINE BUILDING MAT

ENCLOSURE 1

1. Description of Geometry of Voids Under Turbine Building:

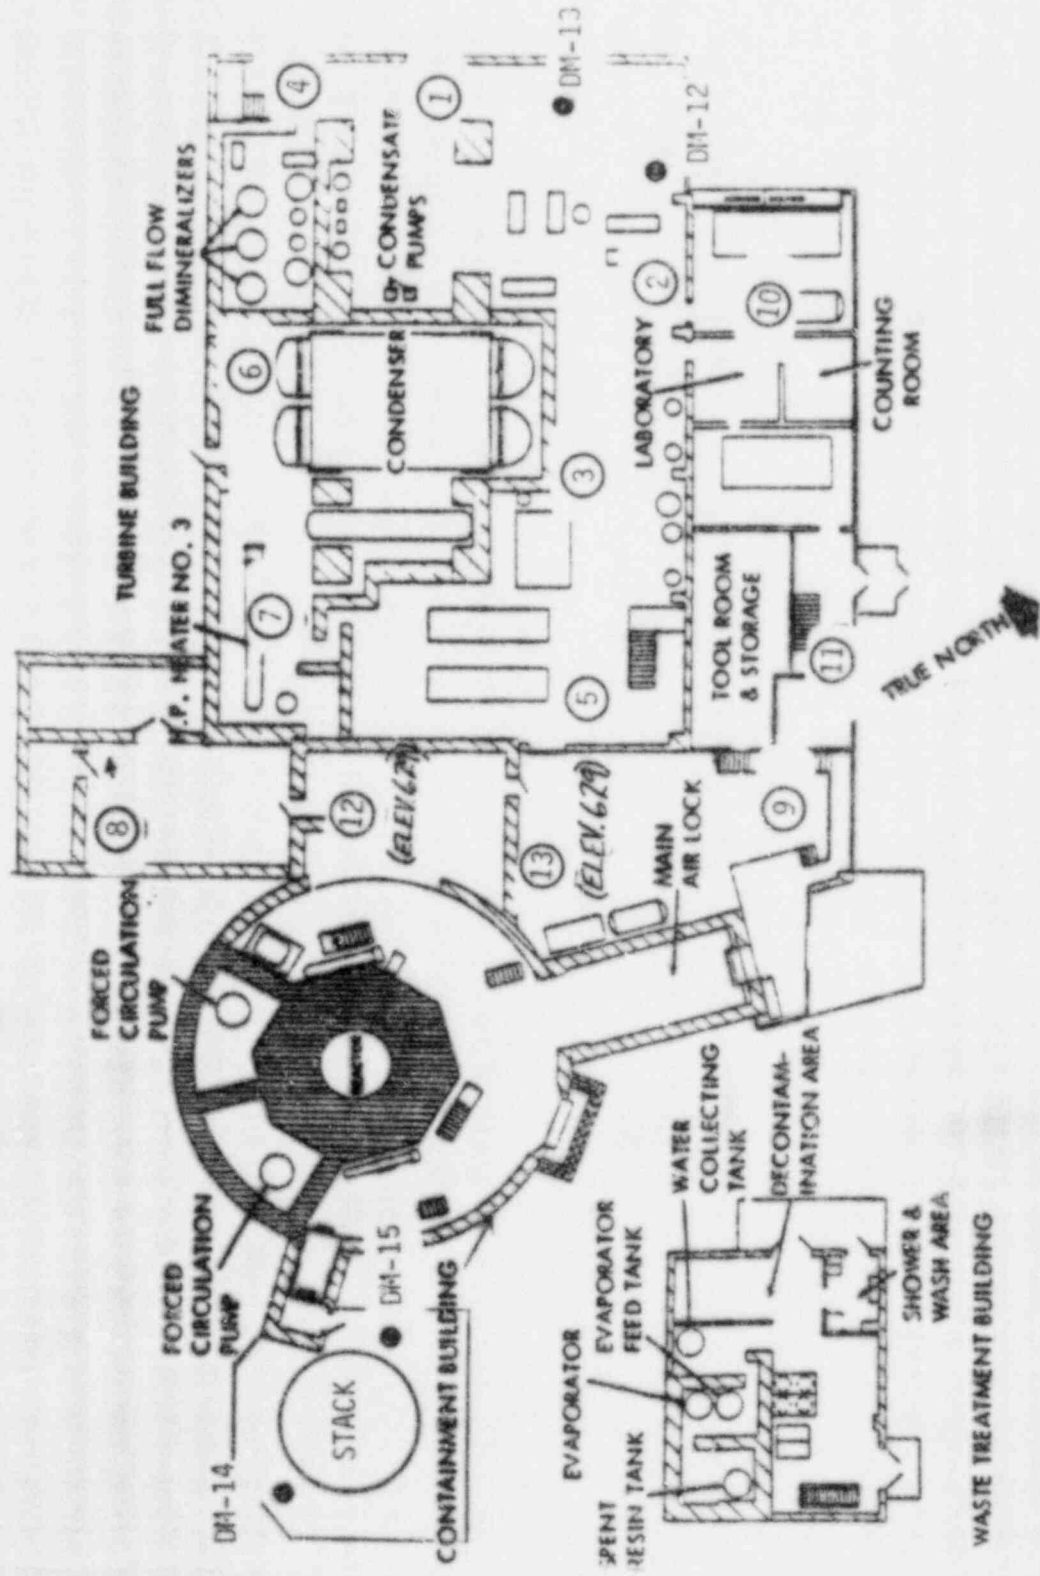
BORING LOCATIONS

During the recent test boring program within the developed area of the LACBWR plant site, two borings, DM-12 and DM-13, indicated the existence of minor voids in the vicinity of the borings. The other two borings, namely DM-14 and DM-15, drilled on either side of the stack did not indicate any such voids under its pile cap. The discovery of two minor voids raised the question whether voids exist beneath the turbine floor in other areas. In order to study the lateral and vertical extent of the voids, an exploratory drilling program was undertaken. DPC personnel drilled a total of 13 holes through the concrete floor using a light portable core drill. The locations of these bore holes 1 through 13 along with the recent soil borings DM-12, 13, 14 and 15 are shown in Plate 1.

Table 1 shows details such as the diameter of the holes, depth of concrete cored, and the approximate measured depth of voids below the concrete floor. It can be seen that the void depth ranges between 0 to 10 inches. The data also indicates that the voids exist only within the turbine building area. Lateral definition of voids could not be obtained due to varying floor thicknesses and the existence of the concrete beams under the floor.

We believe that by grouting the voids under the turbine building floor, any potential problems under seismic conditions will be solved. We are currently studying the most effective procedures that can be used to accomplish the above goal of filling all the voids under the turbine building floor with a suitable grout. We will submit the details of our proposed grouting plan in the near future.
