MIDLAND NUCLEAR PLANT
UNIT NO 1, DOCKET NO 50-329
UNIT NO 2, DOCKET NO 50-330
HELBA RESTRAINT DESIGN
FILE: 0.4.9.41 UFI: 73*10*01 SERIAL: 8830

QUALITY ASSURANCE PROGRAM
MANAGEMENT CORRECTIVE ACTION REPORT
MCAR-1

SUBJECT: MCAR 40 (issued 8/21/80)
High-Energy Line Break Analysis (HELBA),
Pipe Whip Restraint Designs

INTERIM REPORT 1

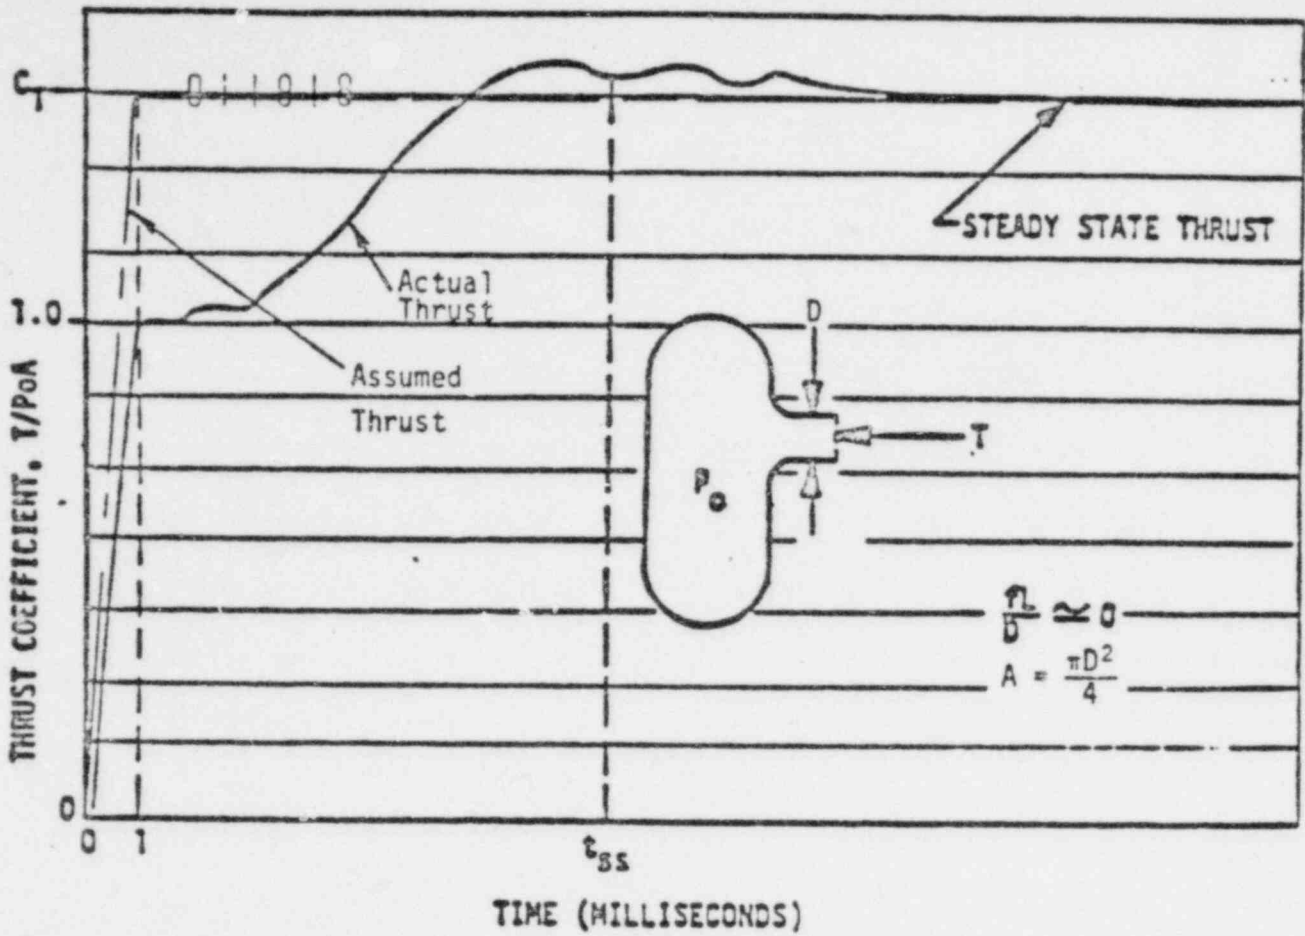
FSAR Section 3.6.2.2 states that the analysis of the thrust forces which result in the event of a pipe rupture is described in BN-TOP-2. Contrary to the intent of BN-TOP-2, the steady-state thrust forces rather than the transient peak thrust forces were used in the energy balance techniques for the design of HELBA pipe whip restraints (see attachment, Figure B). Design documents have been released for construction/fabrication and most of the restraints have been installed.

A. Thrust Force Transient, Very Low Friction Flow

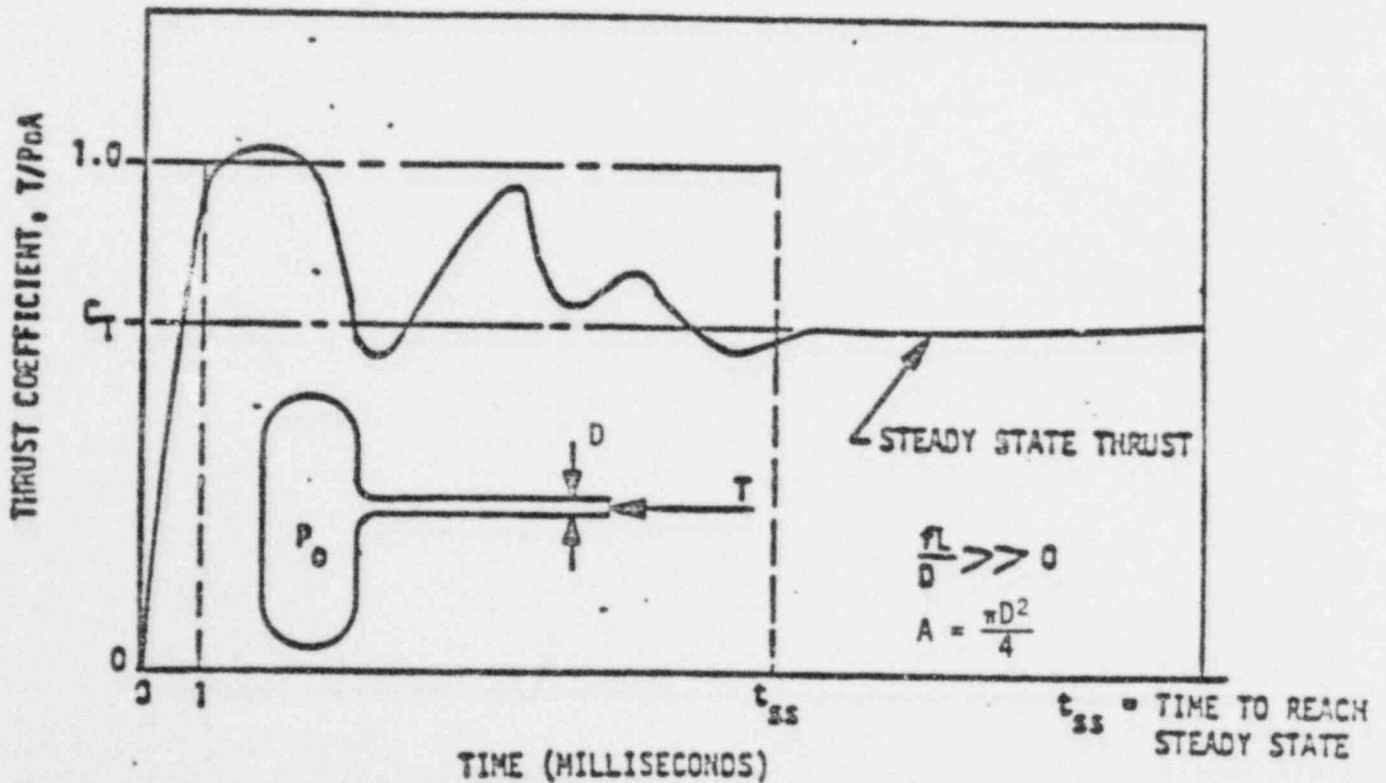
B. Thrust Force Transient, Friction Flow
