U.S. NUCLEAR REGULATORY COMMISSION
OFFICE OF INSPECTION AND ENFORCEMENT

IE Circular No. 78-04

INSTALLATION ERRORS THAT COULD PREVENT CLOSING OF FIRE DOORS

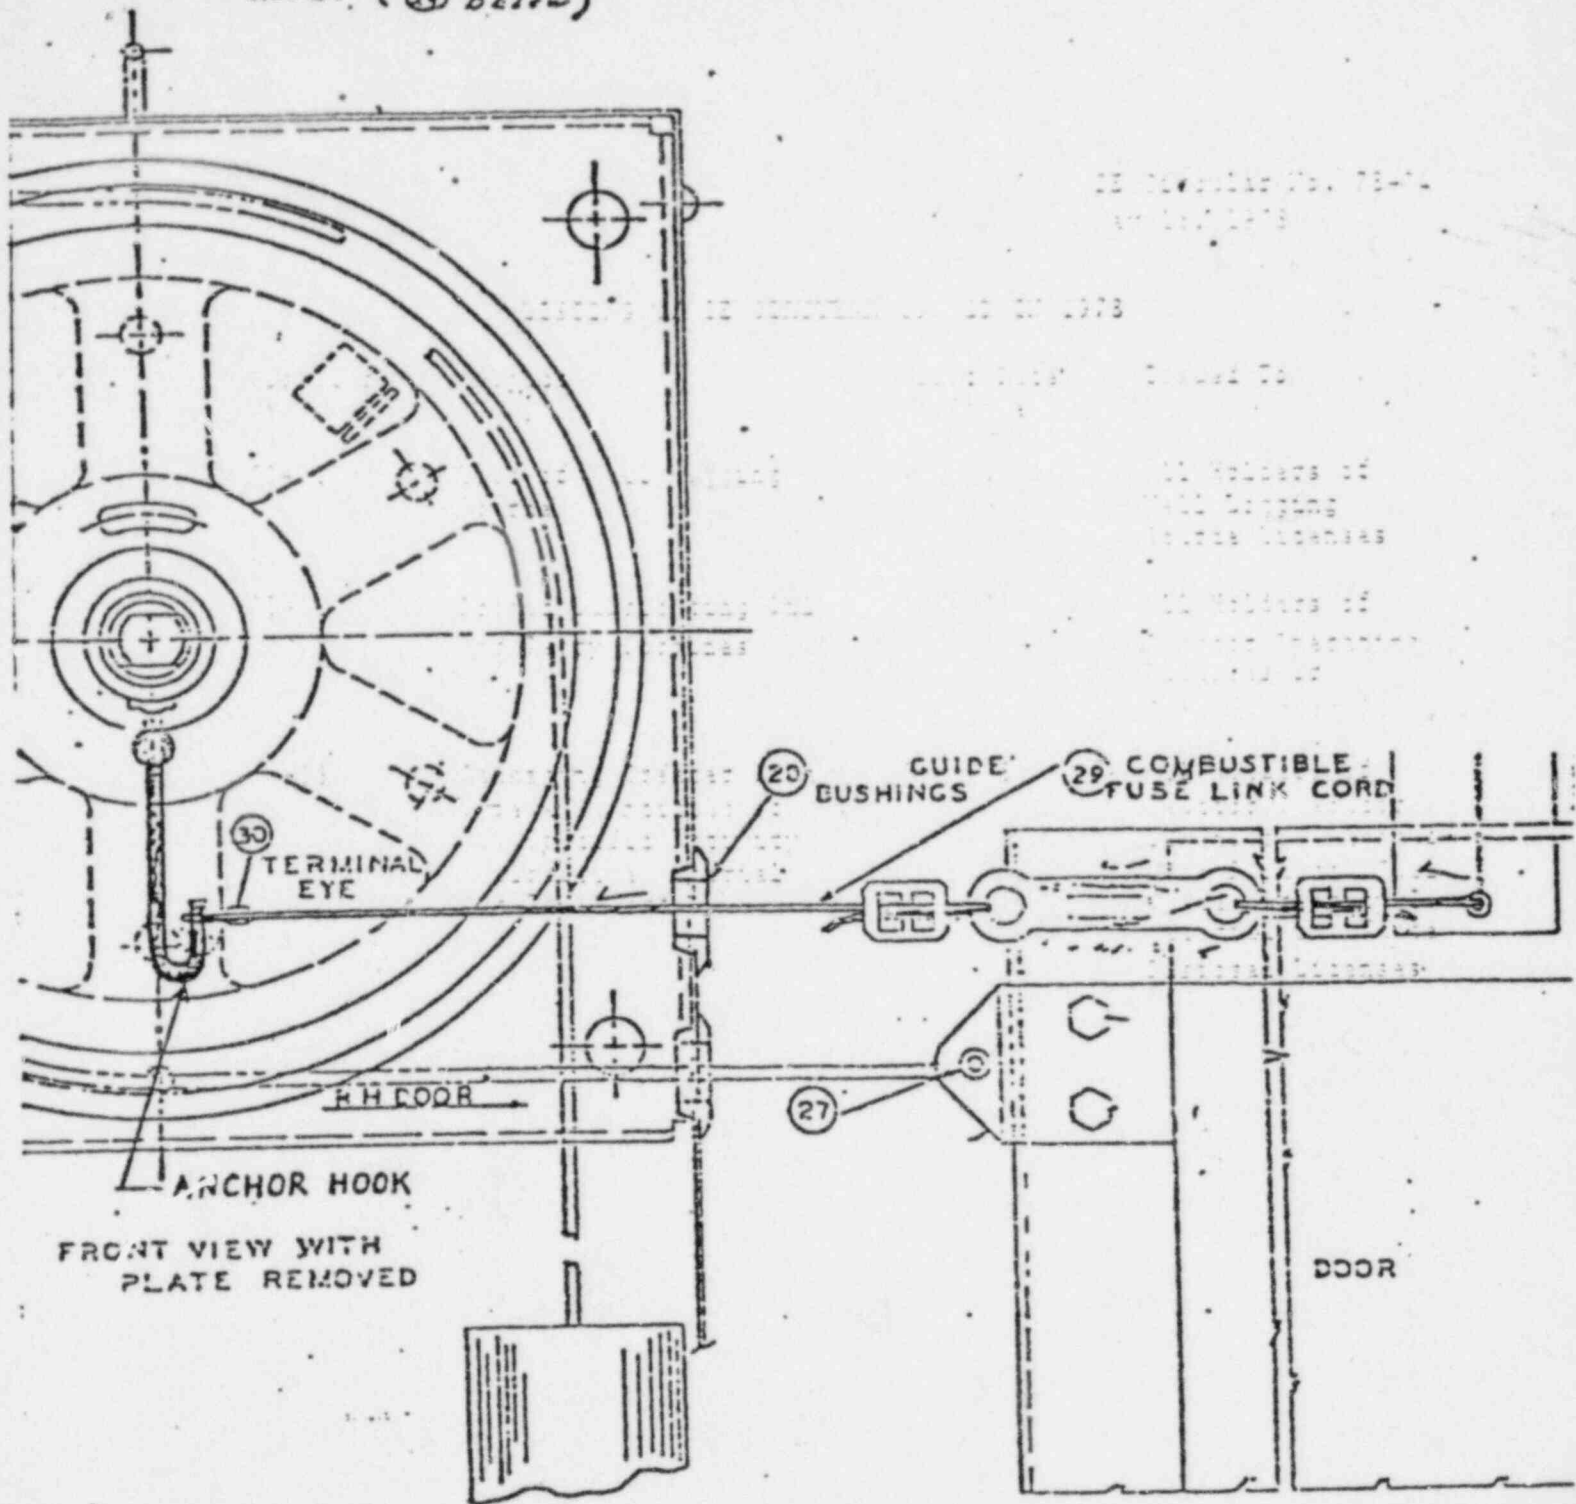
The mechanism involved are D and H Pyromatic door closers manufactured by Mesker (see attached drawing). Each unit is powered by a suspended weight which rotates a pulley arrangement to draw the fire door closed. Closure is normally prevented by a fuse link cord which acts through a lever arm. This device, called the "fuse link anchor hook," prevents rotation of the pulleys, unless the fuse links are severed by fire.

The first improper installation was the replacement of the combustible fuse cords by "S-Hook" type chain. The replacement was necessary due to random failures of the original fuse link cord. However, the cord (or chain) passes through an opening in the case containing the mechanism, and the S links tended to spring open and catch on the edges of this opening. This problem was aggravated in some instances by the lack of guide bushings which are normally installed to facilitate the passage of the chain through the opening.

Another error discovered was the mispositioning of the fuse link anchor hook. Following severance of the fuse link, the pulleys rotate clockwise and a correctly installed anchor hook is rotated through an angle that permits the terminal eye on the end of the fuse link cord to fall free. This prevents the cord (or chain) and the remains of the fuse link assembly from becoming entangled in the rotating mechanism. However, some anchor hooks were found to be installed with the curved section extending to the left (relative to the front view shown). This position can cause the terminal eye to remain hooked during rotation, instead of falling free. These errors actually caused the jamming of fire door closers during tests that followed their discovery.

CORD WAS REPLACED WITH SASH
CHAIN BECAUSE OF RANDOM FAILURES
OF THE COMBUSTIBLE FUSE LINK
CORD. (29 BELOW)

The corrective actions were to replace the "S" type chain with flat sash chain, install the missing bushings and to correctly orient the fuse link anchor hooks.

It is recommended that all holders of reactor operating licenses and construction permits determine if any fire door closers of this type are installed in their facility(ies). If this is the case, it should be verified that they are installed in accordance with the manufacturers design and that improper installations, such as described herein, do not exist.
