YANKEE ATOMIC ELECTRIC COMPANY

January 20, 1975

In response to Reference (b), we conducted an investigation at the Yankee Rowe plant to determine whether the failure of any non-Category I (seismic) equipment could result in flooding or release of chemicals that could jeopardize safe shutdown of the facility. This investigation was carried out in accordance with the AEC criteria entitled, "Guidelines for Review of Non-Category I Systems Whose Failure Could Cause Flooding of Safety Related Equipment".

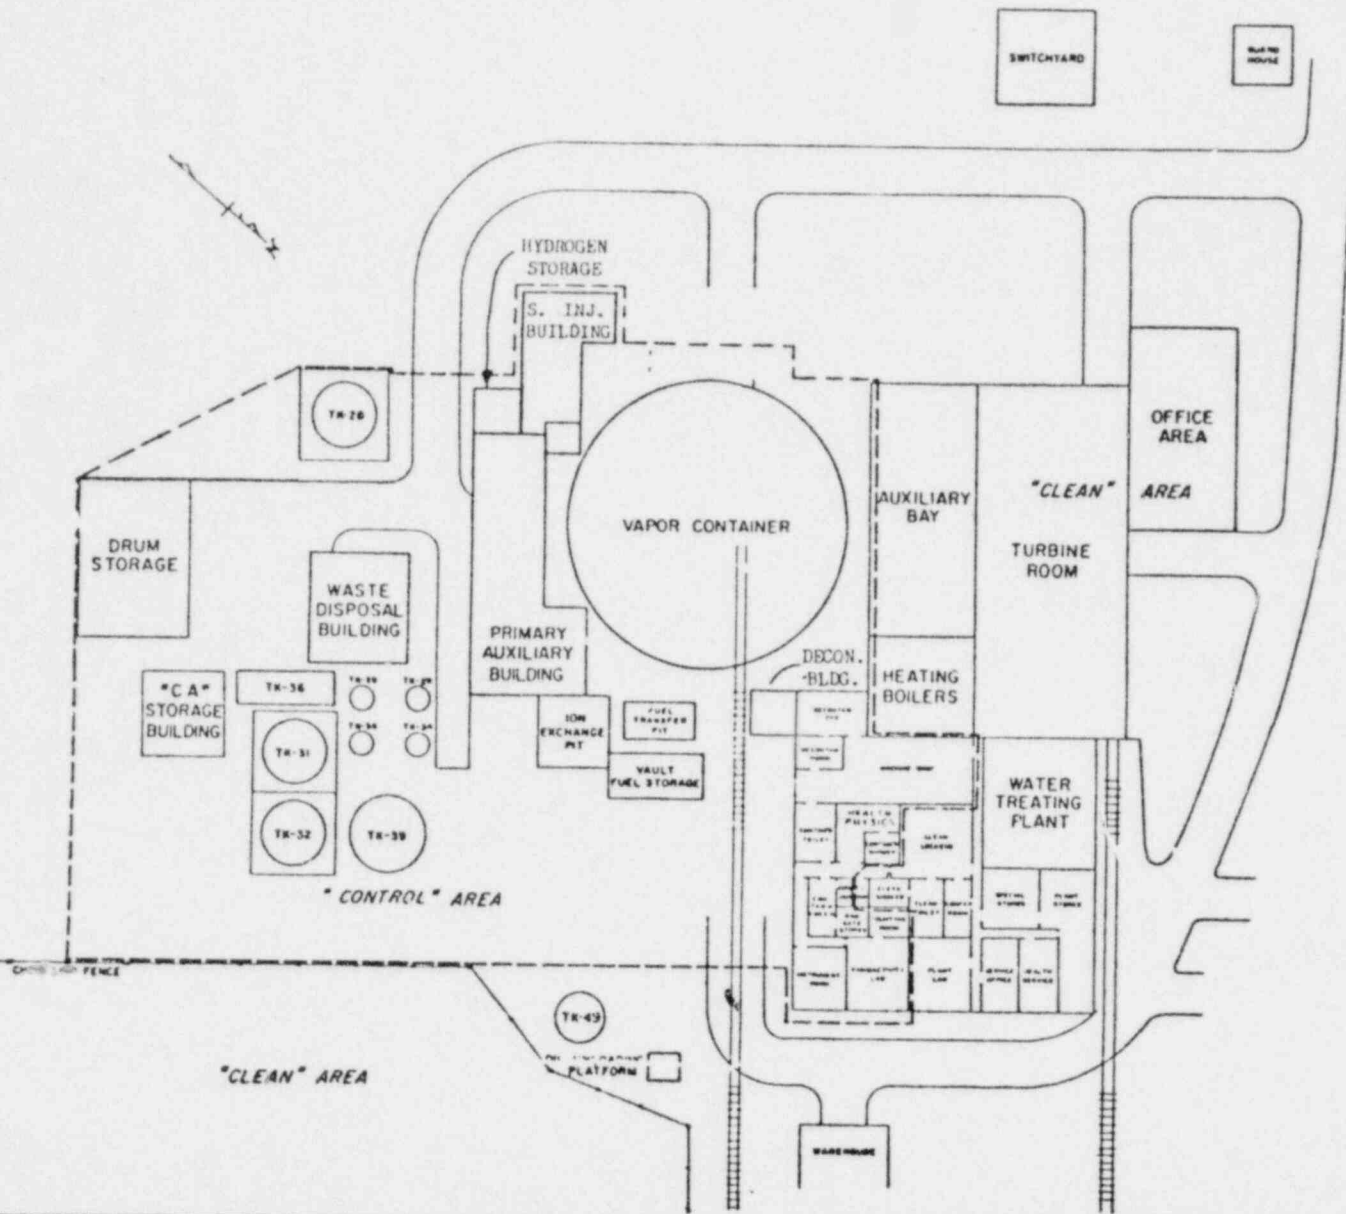
YANKEE NUCLEAR POWER STATION	SITE BUILDING ARRANGEMENT	Figure 1
---------------------------------	---------------------------	----------

The Turbine Building and Primary Auxiliary Building contain safety related equipment required for safe shutdown of the plant. Heat removal can be provided by the equipment located in either building. These buildings are separated as shown in Figure 1; therefore, simultaneous flooding of both buildings from a single pipe rupture is not possible.

All chemicals used in the plant are stored either in the Water Treatment Room or in a warehouse; these are shown on Figure 1. Thus,
