Portland General Electric Company

February 6, 1981

Re: Portland General Electric Company et al.
(Trojan Nuclear Plant) Docket No. 50-344
(Control Building Proceeding)

This letter is a report of instances in which an assumption made by Licensee in the course of the Control Building proceeding has been proven to be incorrect and two instances in which commitments made by the Licensee in the course of that proceeding were not met.

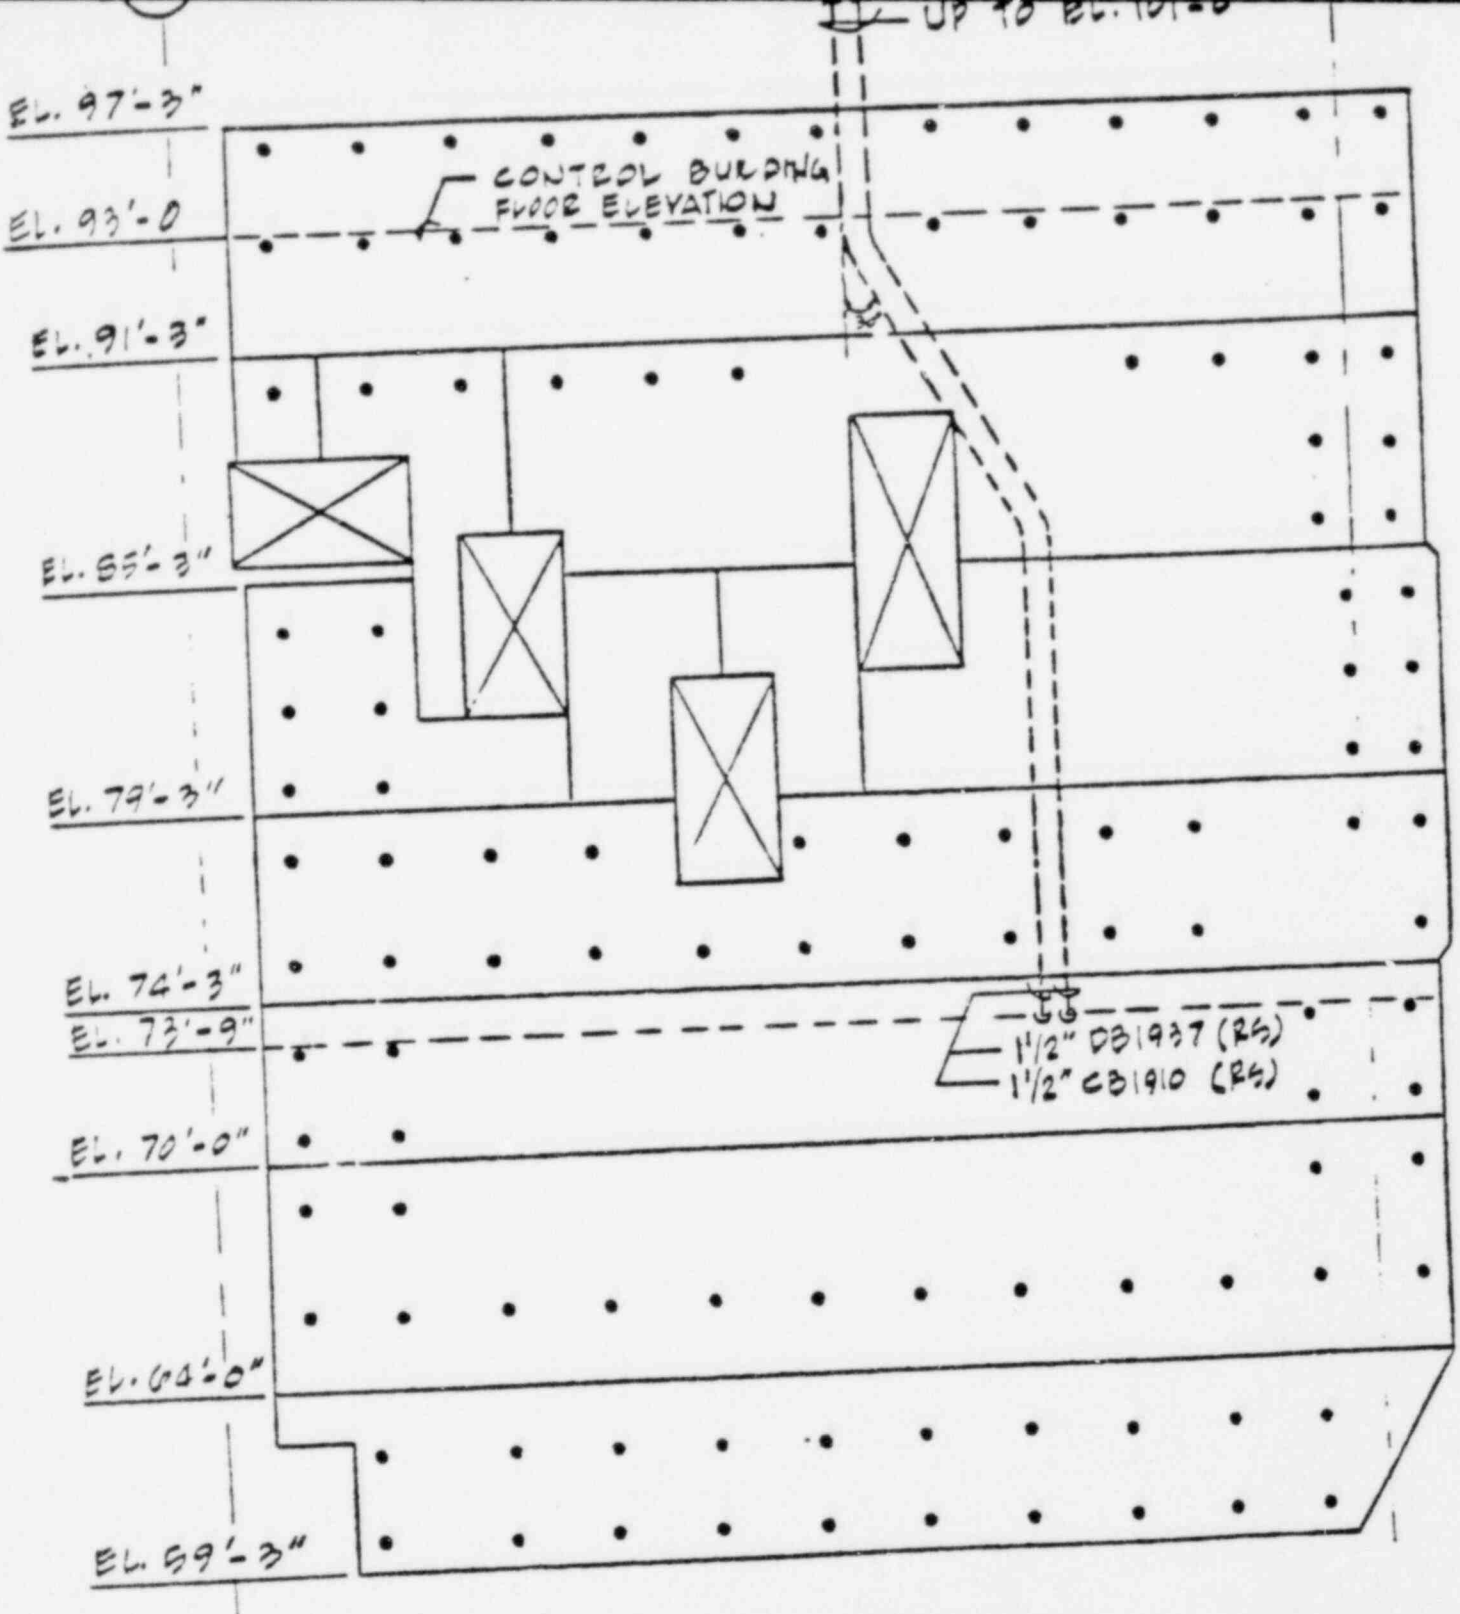
FIGURE I-1

Nevertheless, as added assurance that there is no significant safety concern, we have further reviewed the consequences of the encased wiring being completely cut. Our review has shown that two existing conduits, CB1910 and DB1937, are routed in the Control Building from the Electrical Auxiliaries Room (el. 65') to the Control Room (el. 93'). The major portion of these conduits is embedded in the Control Building wall as shown on the attached Figure 1-1.

CONTROL BUILDING
(VIEW FROM TURBINE BUILDING TOWARDS CONTROL BUILDING)

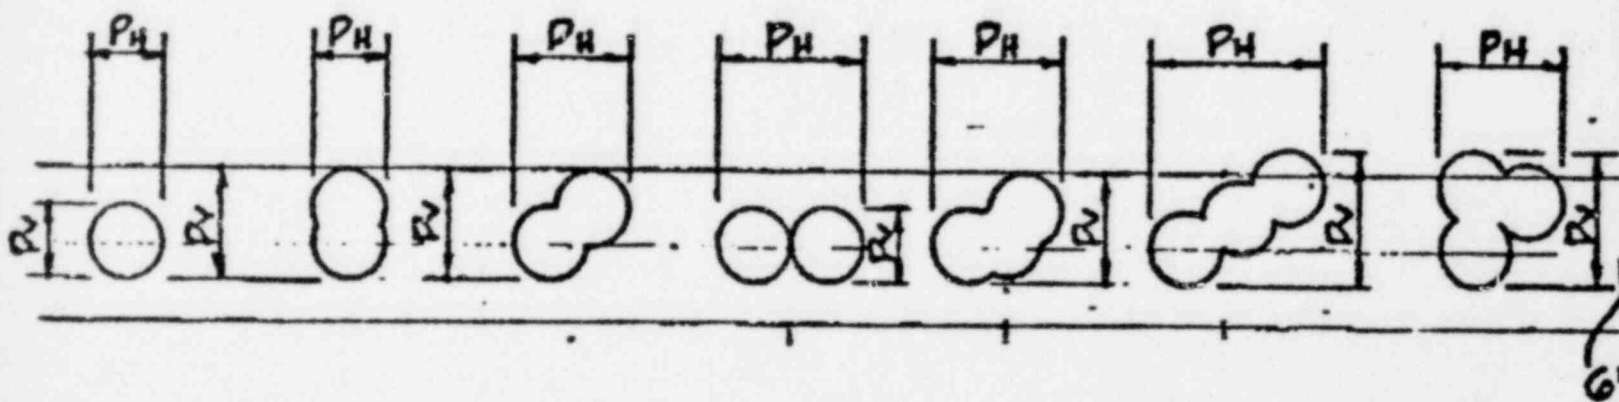
TYPICAL EXAMPLES

Hole Projection: See sketch below.

P_H = Hole horizontal projection

P_V = Hole vertical projection

If the band is vertical, reverse subscripts.
