UNITED STATES  
NUCLEAR REGULATORY COMMISSION  
REGION II  
101 MARIETTA ST., N.W., SUITE 3100  
ATLANTA, GEORGIA 30303

Report Nos. 50-325/80-18 and 50-324/80-15

Facility Name: Brunswick Plant

Inspection at Brunswick near Southport, NC

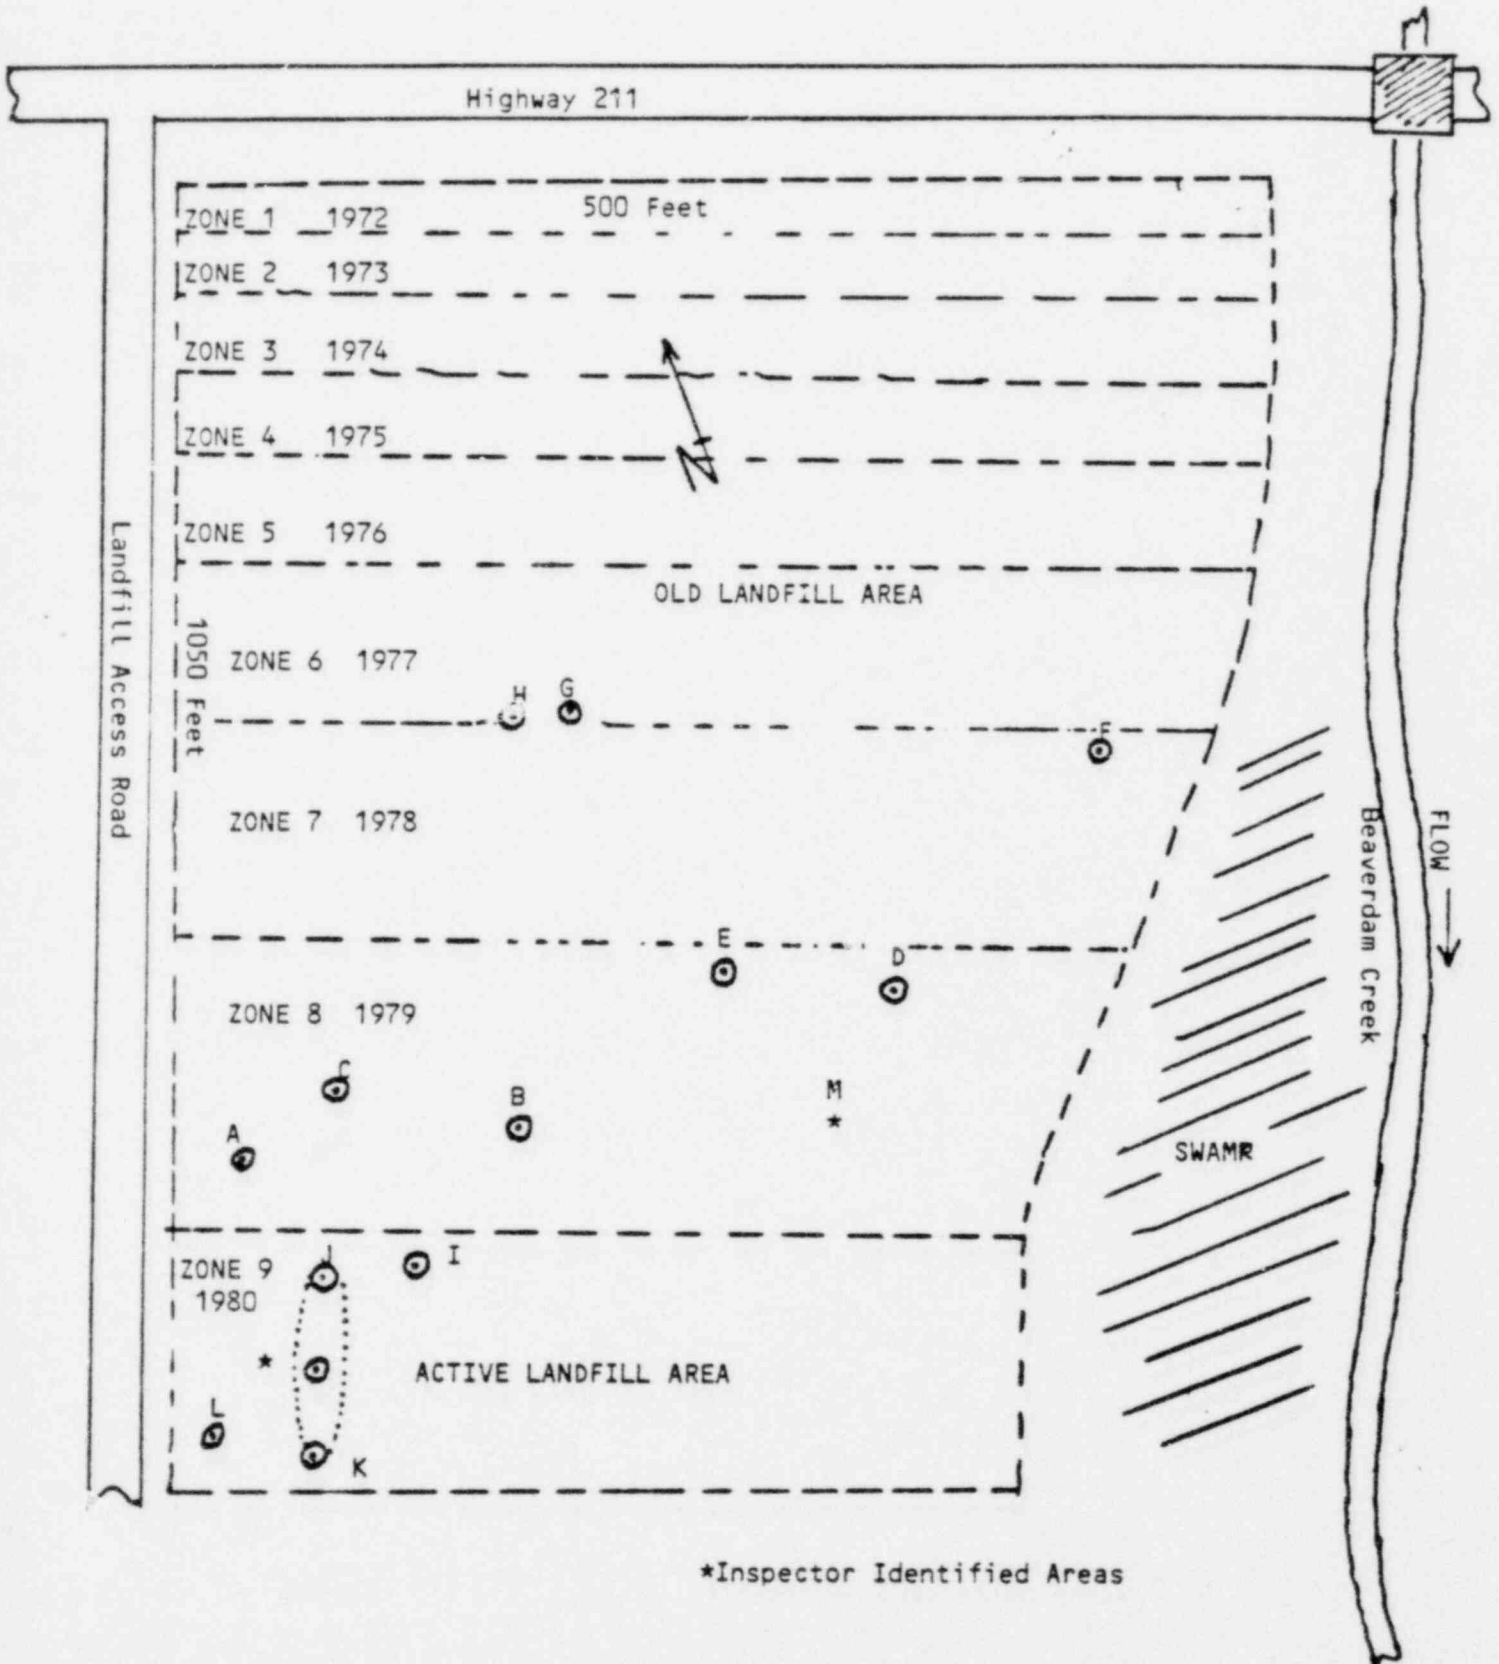
Figure 1

On April 28, 1980, in the company of a licensee representative, the inspector identified an area in the landfill where background levels of radioactivity exceeded normal levels by a factor of 10 - 20. The inspector and licensee representative subsequently dug out of the ground a bucket identified by the licensee representative as having originated at BSEP as part of a shipment of clean trash released to the unrestricted area from the site. Dose rates subsequently measured by the licensee on the bucket were up to 100 mRem/hr on contact. The licensee representative returned to the plant, informed his management, and returned to the landfill with appropriate equipment and personnel to contain and recover the radioactive material. The inspector remained at the landfill during this time to ensure unauthorized persons would not receive exposure due to the uncovered bucket. The BSEP Plant General Manager, RC&T Supervisor, and two RC&T technicians returned to take charge of the radioactive material at the landfill, and the inspector returned to the power plant to notify Region II of the event.

Sketch of Brunswick County Southport Landfill  
With Initial Survey Points Identified

\*Inspector Identified Areas
