DUKE POWER COMPANY
POWER BUILDING
422 SOUTH CHURCH STREET, CHARLOTTE, N. C. 28201

June 28, 1974

Re: RO:II:TNE
50-269/74-4

DUKE POWER COMPANY
OCONEE UNIT 1
RESPONSE TO AEC/RO REPORT NO. 50-269/74-4

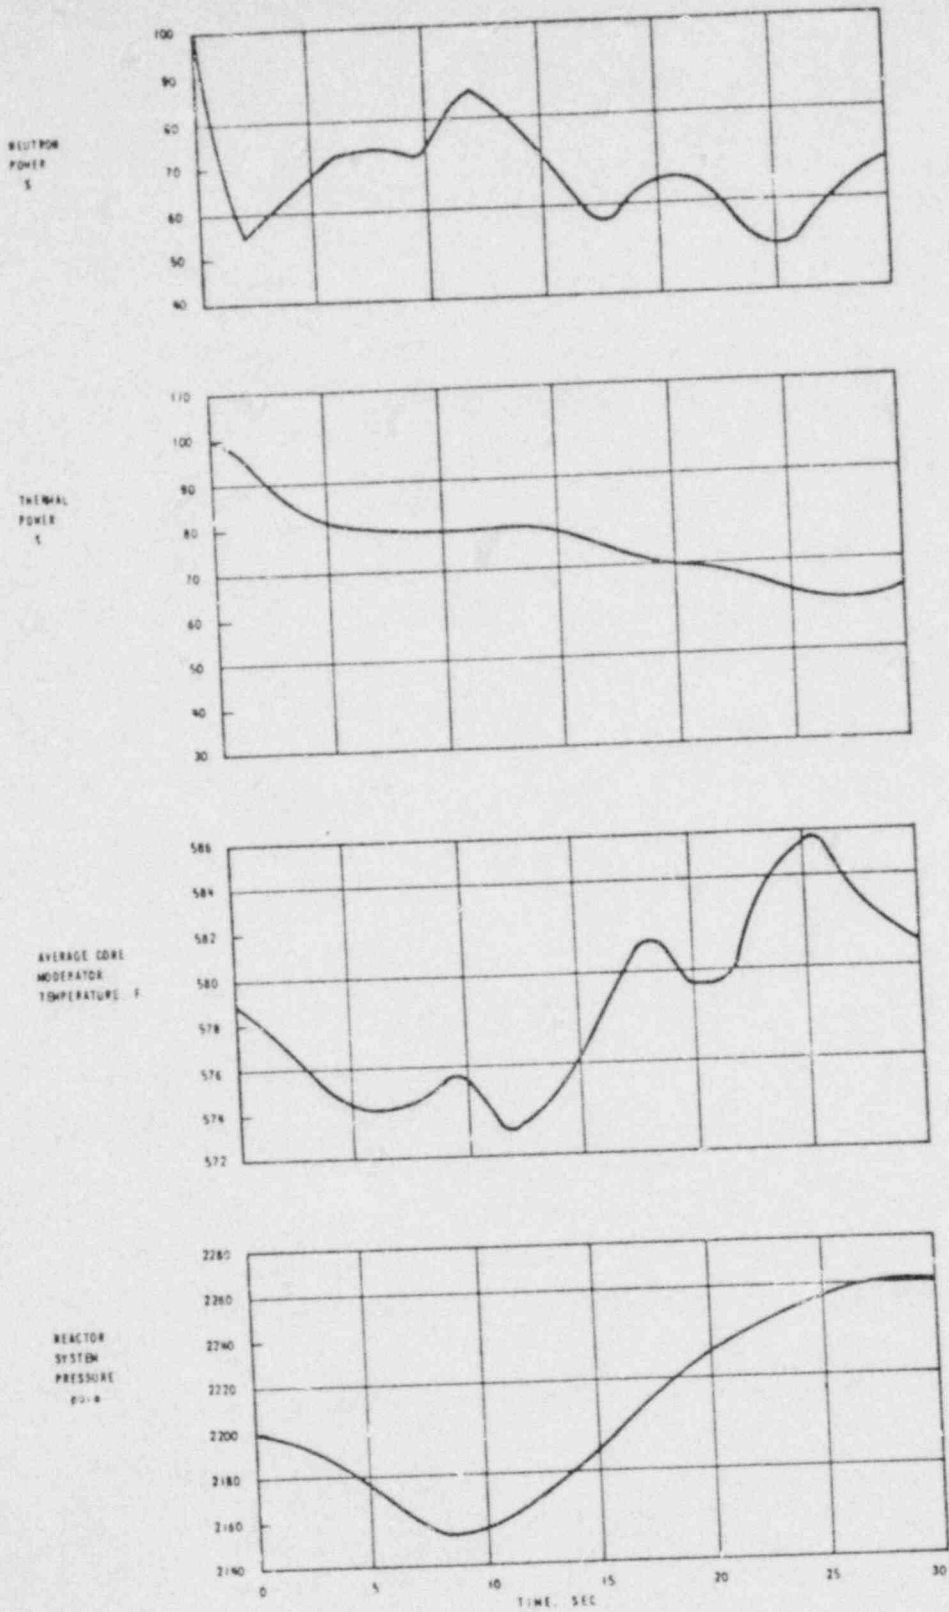
The results of the analysis with ICS action are presented in Figures 14-18 and 14-19. Figure 14-18 shows the response to a 0.46% $\Delta k/k$ dropped rod. The neutron power decreases rapidly to about 55 percent of rated power. This causes rapid decreases in the core moderator temperature and fuel temperature. These temperature decreases over-compensate for the worth of the control rod, and the power rises until the reduced steam generator demand begins to increase the inlet temperature and decreases the power. The thermal power levels out briefly at about 78 percent of its initial value but soon begins to decrease in response to the decreased steam generator demand. The pressurizer pressure swing is about ± 60 psi before returning to equilibrium.

0.46' DR/N ROD DUG FROM RATED POWER
 WITH AUTOMATIC RUNBACK TO 60% DEMAND
 IN 12 SECONDS

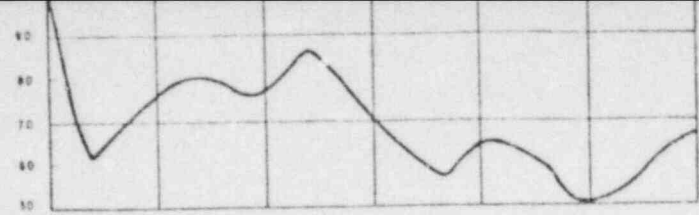
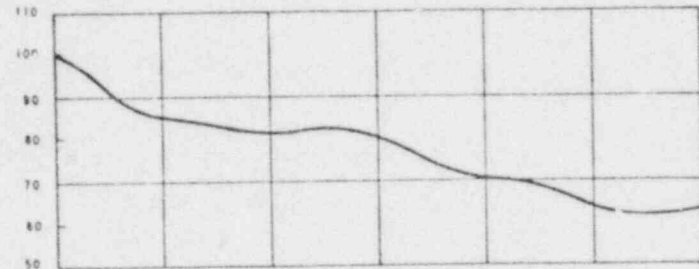
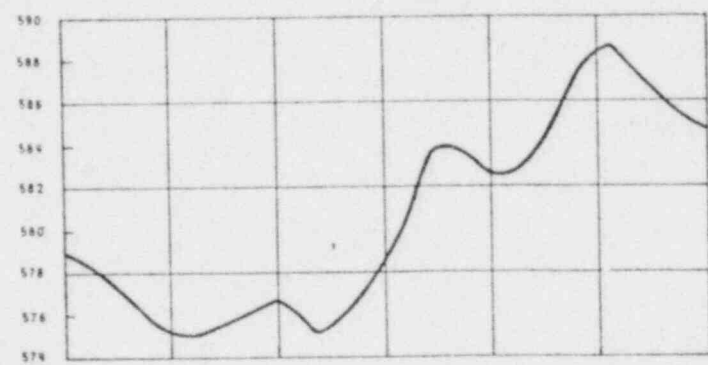
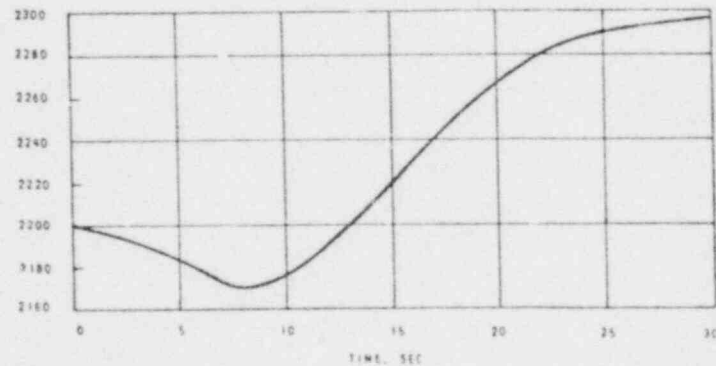
Figure 14-19 shows the results of the 0.36% $\Delta k/k$ rod drop. The initial neutron power decrease is slightly less in this case, resulting in the thermal power leveling off at 83 percent, a slightly higher value than in the 0.46% $\Delta k/k$ case. The pressurizer pressure peaks at a higher value due to this higher thermal power.

0.365 AX/M ROD DROP FROM RATED
POWER WITH AUTOMATIC PWRBACK TO
60% DEMAND IN 12 SECONDS

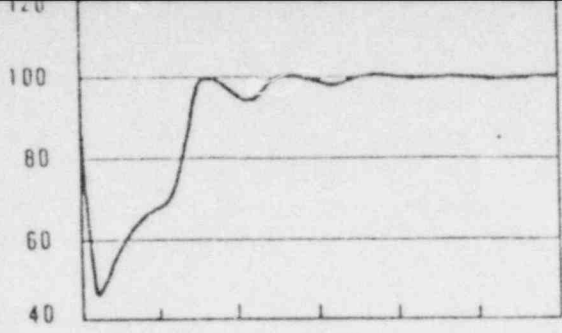
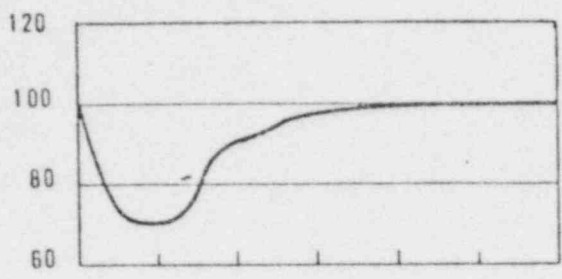
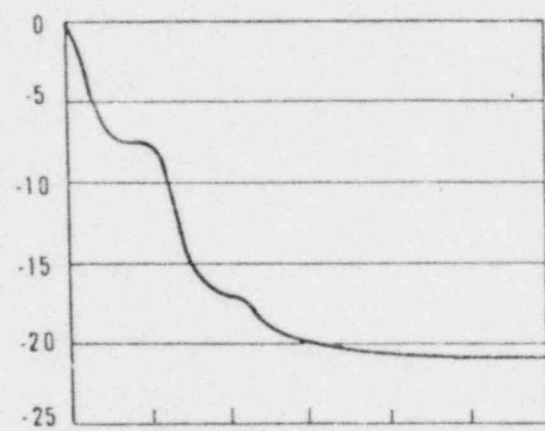
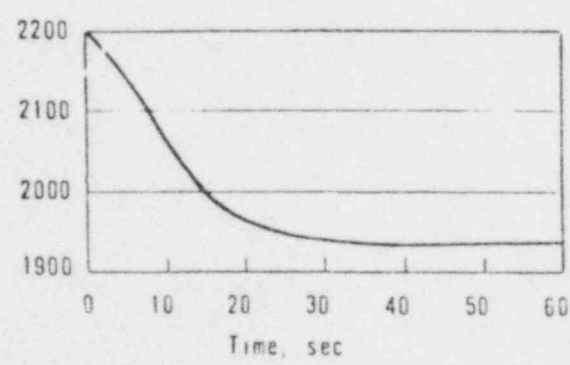
Figure 14-19a shows the results of a 0.65% $\Delta k/k$ dropped rod analysis conservatively based on no ICS action and operation at higher than rated power level of 2772 MWt. The neutron power decreases causing a rapid decrease in both the core moderator temperature and the fuel temperature. These temperature decreases overcompensate for the worth of the control rod, and the neutron power rises slightly above the initial neutron power level. The neutron power then decreases to below the initial power level and eventually levels out at the initial power level. The thermal power response is similar to the neutron power; however, the thermal power level never exceeds the initial power value. Both the core moderator temperature and pressurizer pressure decrease during the transient and level out at a value lower than the initial value.

0.65% Ak/k ROD DROP FROM RATED POWER AT EOL CONDITIONS (2772 MWT)
