U. S. ATOMIC ENERGY COMMISSION  
DIRECTORATE OF REGULATORY OPERATIONS

Report of Operations Inspection

RO Inspection Report No. 050-G10/74-13  
RO Inspection Report No. 050-010/74-09

Dresden Nuclear Power Station Units 1 and 2  
Morris, Illinois

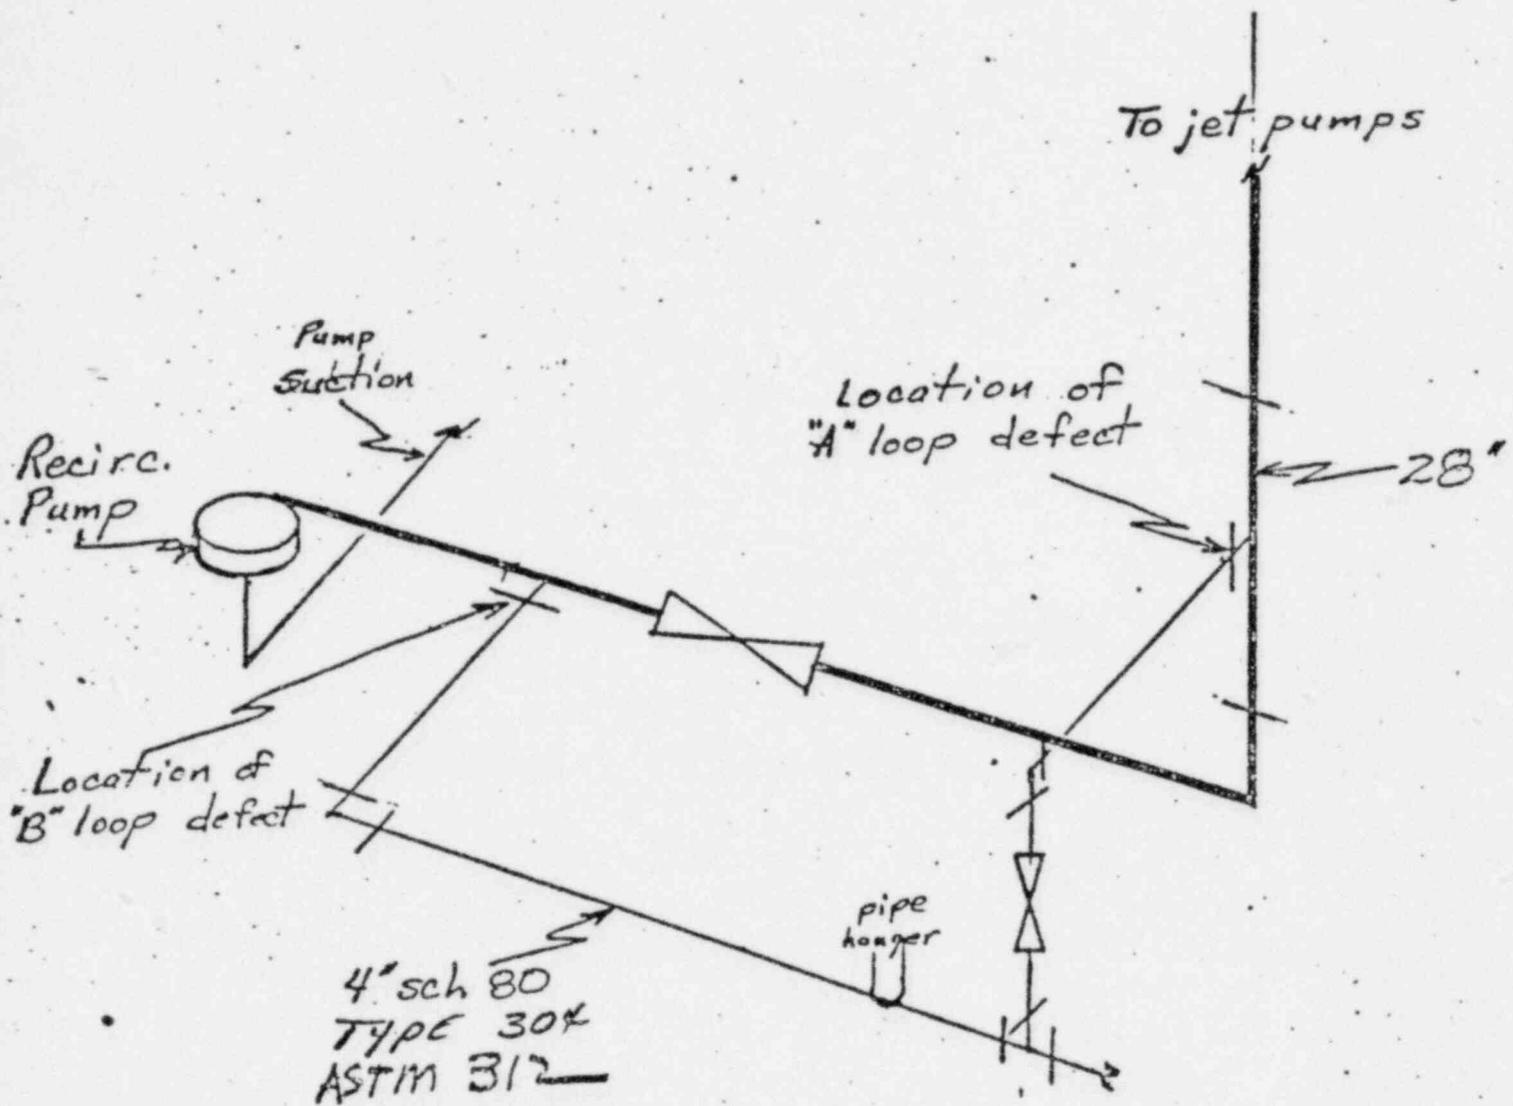
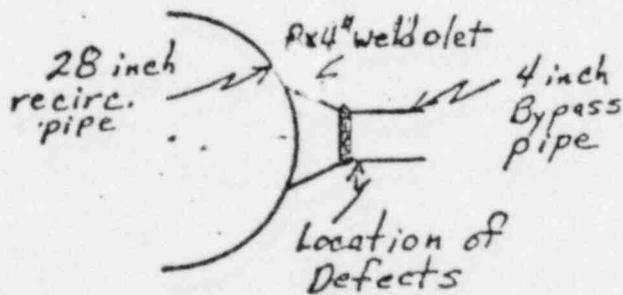
# Dresden 2 Recirculation Pipe Defects

On September 12, 1974, the unit was shutdown as the unidentified primary system leakage within containment was approaching the 5 gpm limit. On September 13, the licensee discovered a circumferential crack in the four-inch stainless steel bypass line around the "B" recirculation pump discharge valve. On September 15, a similar failure was found in the "A" loop. Refer to attachment A for location and size of cracks.

OD and ID cracks  
in 4" pipe
