SUBJECT: Beaver Valley Power Station - Unit No. 2  
Docket No. 50-412  
Linear Indications in Gib Gusset Welds in Reactor Vessel  
Structural Support (Neutron Shield Tank)  
Significant Deficiency 80-03

Interim Report No. 2

Linear Indications In Gib Gusset Welds in Reactor Vessel

Beaver Valley Power Station - Unit No. 2

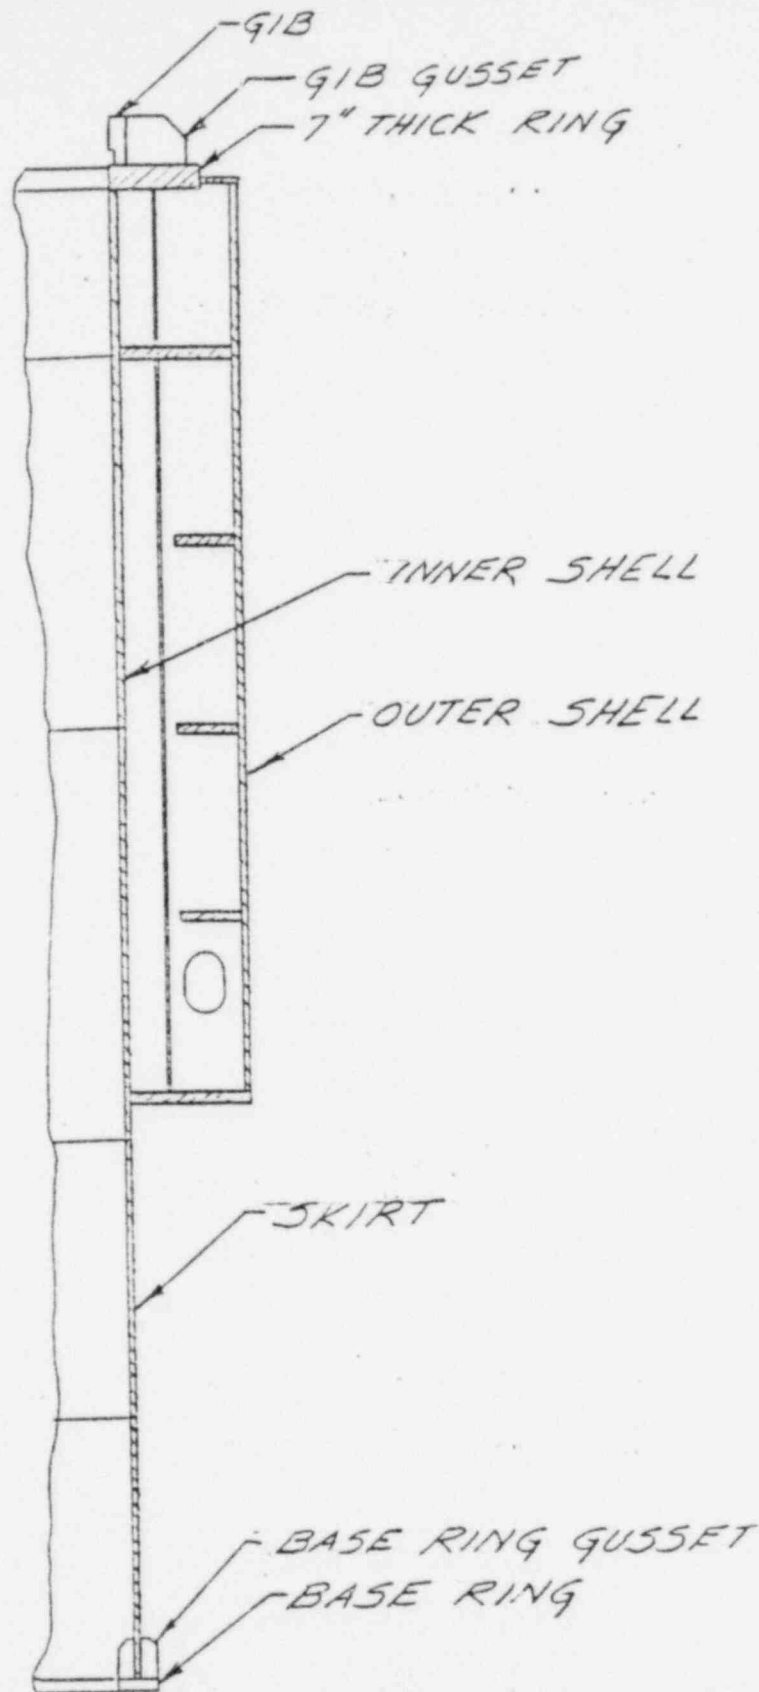
FIGURE -1

A major portion of an extensive reinspection of the Reactor Vessel Structural Support (RVSS) has been completed and the extent of weld deficiencies appears to be limited to the top section of the RVSS. A program for replacement of all gibs and gib gussets has been prepared and the selection of a qualified fabricator is underway.

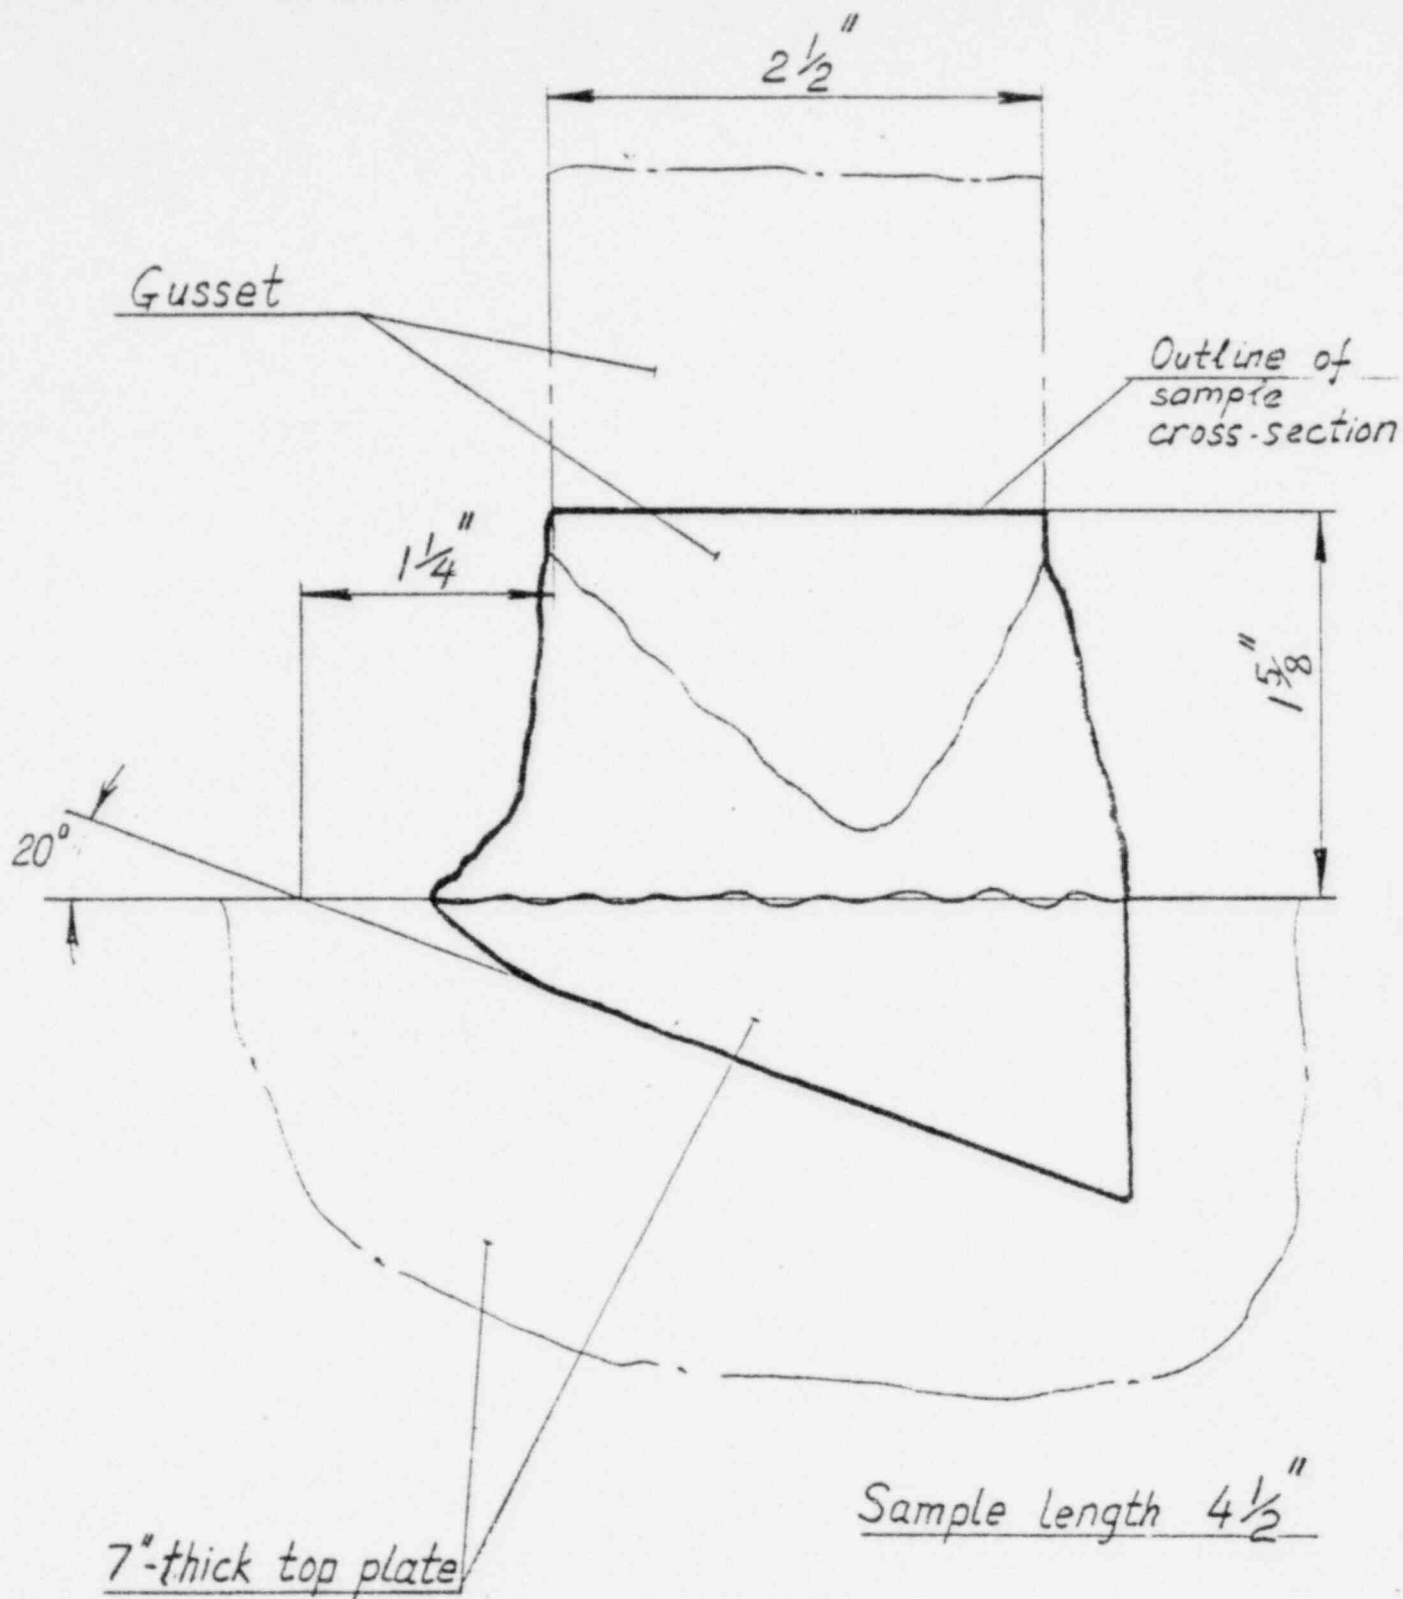
FIGURE 2

A weld sample (See Figure 2) was removed by drilling and cutting from the gib gusset that showed the most extensive ultrasonic indications. Material from the weld metal, gusset and top plate was taken from one of the sections for chemical analysis. The analysis showed no deviations from the specified chemistry or from normal trace elements.

Based on the reinspection performed to date, all the gibs (12 total) and all the gib gussets (48 total) will be removed and replaced, using a weld fabrication procedure/sequence (see Appendix I) that should eliminate the weld deficiencies that exist in this area of the support structure. An upgraded NDE program for the reworked gib and gib gusset welds has been established and is equivalent to the program for all the other welds on the structure, that were ultrasonically inspected by the vendor, and to acceptance criteria that would satisfy present code standards.

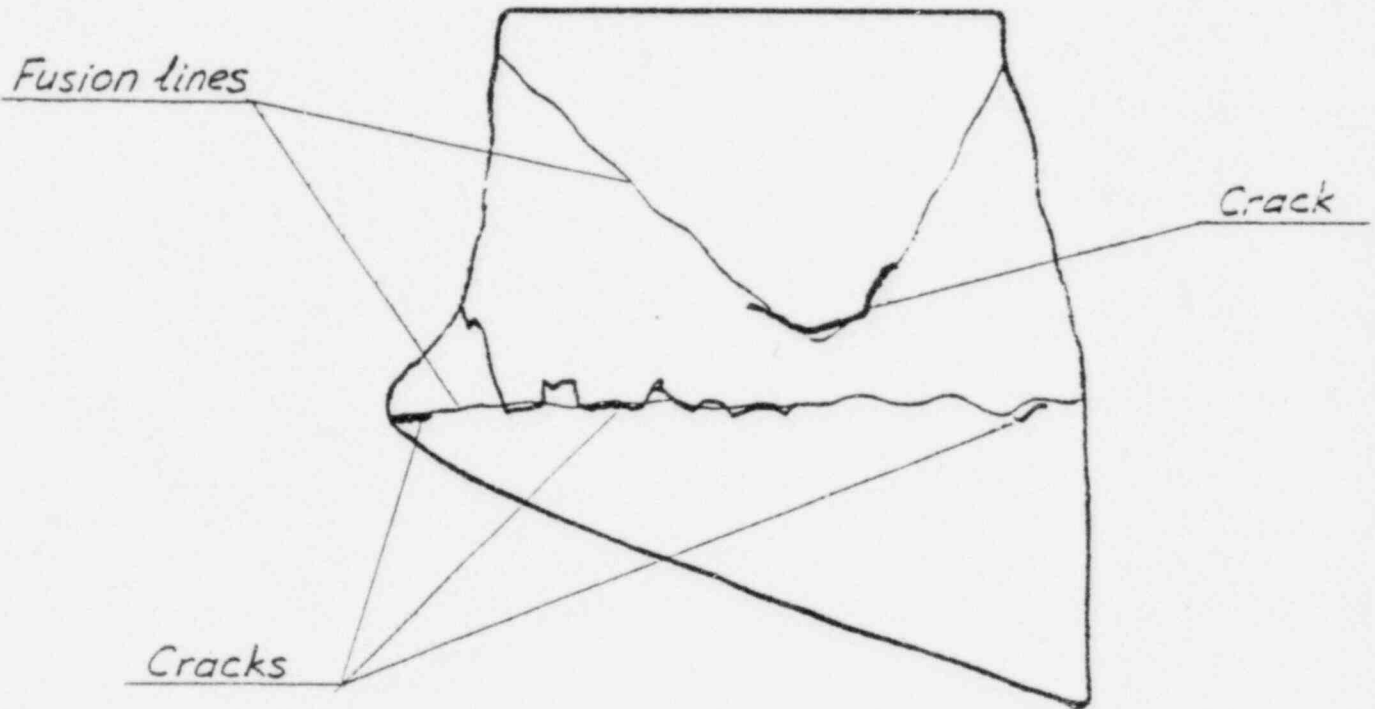
FIGURE 3

Macroscopic examination of polished and etched sections revealed various degrees of cracking, predominantly in the vicinity of the fusion zone of the top plate and along the weld-prep bevels of the gusset, the most severe as represented in Figure 3. The cracks in the top plate apparently initiated in the weld heat-affected zone, near the root of the weld, and propagated outward,

toward the weld surface, close to the fusion boundary, partially along the heat affected zone and partially through weld metal. It is now believed these cracks propagated during stress relief. The smaller cracks in the gusset and gib plates were located near the fusion boundary, close to the root of the weld, and have the appearance of delayed, cold, hydrogen-initiated cracks.

High temperature oxide on the fracture surface of both types of cracks indicates exposure to air above 800°F; clearly the cracks existed prior to, and/or developed during, stress relief. The cause of cracking is still being investigated. It is postulated at this time that the most probable cause of the defects was hydrogen delayed cracking aggravated by post weld heat treatment. There is no evidence of lamellar tearing in the top plate, which is fabricated from an electroslog remelted steel.
