UNITED STATES
NUCLEAR REGULATORY COMMISSION
OFFICE OF INSPECTION AND ENFORCEMENT
WASHINGTON, D.C. 20555

October 30, 1980

IE Information Notice No. 80-38: CRACKING IN CHARGING PUMP CASING CLADDING

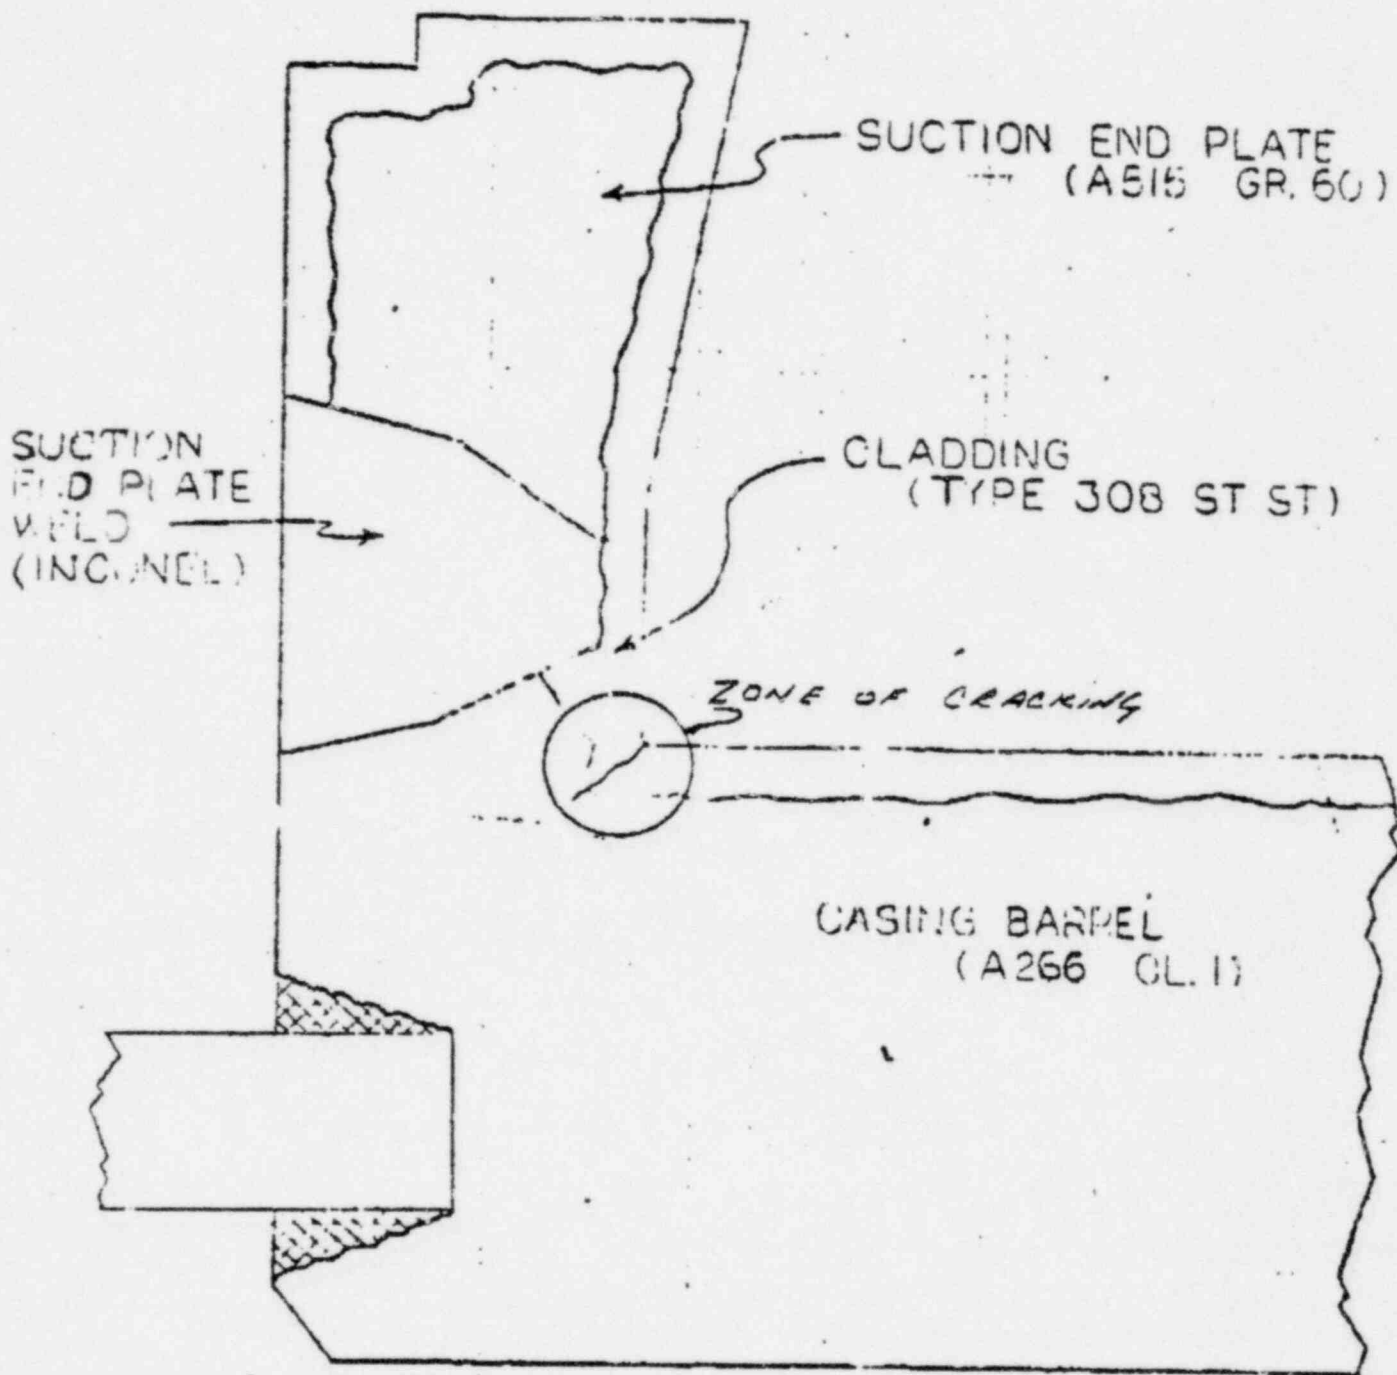
FIGURE 1

The pumps are 2-1/2 inch, 11 stage, Type IJ manufactured by the Pacific Pumps Division of Dresser Industries. The pump casing end assembly in the area of interest, Figure 1, consists of a suction end plate of A515 grade 60 carbon steel plate welded to the casing barrel forging of A266 class 1 carbon steel using an Inconel weldment. The entire inner surface is clad with type 308 stainless steel applied by submerged arc welding.

An in-situ ultrasonic examination conducted in late April confirmed clad cracking indications at the barrel case to end plate inner radius for approximately 330 degrees around the circumference and that the cracking possibly extended into the pump base material in the bottom 180 degrees of the assembly. A review of the original radiographs revealed crack like indications in the clad overlay, however, not to the extent observed during this examination.

Subsequently, the entire suction end of the pump was removed and cross sections metallographically examined to further evaluate the nature and extent of the cracking. It was determined that initiation and propagation of the clad cracks probably resulted from stress concentration and dilution effects in the initial corner bead pass due to the difficult access and bead sequencing required by the fairly sharp corner geometry. Extension of the cracks at the base metal-clad interface ranged to a depth of 1/16 inch maximum in the 1-1/2 inch thick base material. These crack tip areas were well blunted and slightly cavitated from corrosion effects due lengthy exposure to the localized boric acid attack. Examination of the crack morphology revealed that the clad cracking essentially arrested at the base metal-clad interface and that base metal corrosion progressed at a relatively slow rate.

The 1A charging pump was replaced with a new pump provided with a casing constructed entirely of stainless steel. The licensee is currently developing improved NDE procedures for examination of the three remaining pumps at the next refueling outage. Further, the licensee and pump manufacturer are developing repair procedures in the event cracks are discovered in the remaining pumps.

Based on the available information no immediate safety concern is indicated. However, the observed conditions reveal a potential source of pump degradation over long term operations. Therefore, to assure maximum availability, it appears prudent to perform a nondestructive examination of this pump type at the earliest practical time during the first code required in-service inspection interval and if cracking is confirmed, take appropriate corrective actions per the rules of ASME Section XI BP&V Code.
