UNITED STATES OF AMERICA
NUCLEAR REGULATORY COMMISSION

In the Matter of)
)
HOUSTON LIGHTING AND POWER COMPANY,)
 ET AL.)
)
(South Texas Project, Units 1 and 2))

NRC STAFF ADDITIONAL RESPONSE TO CCANP
"REQUESTS FOR INFORMATION"

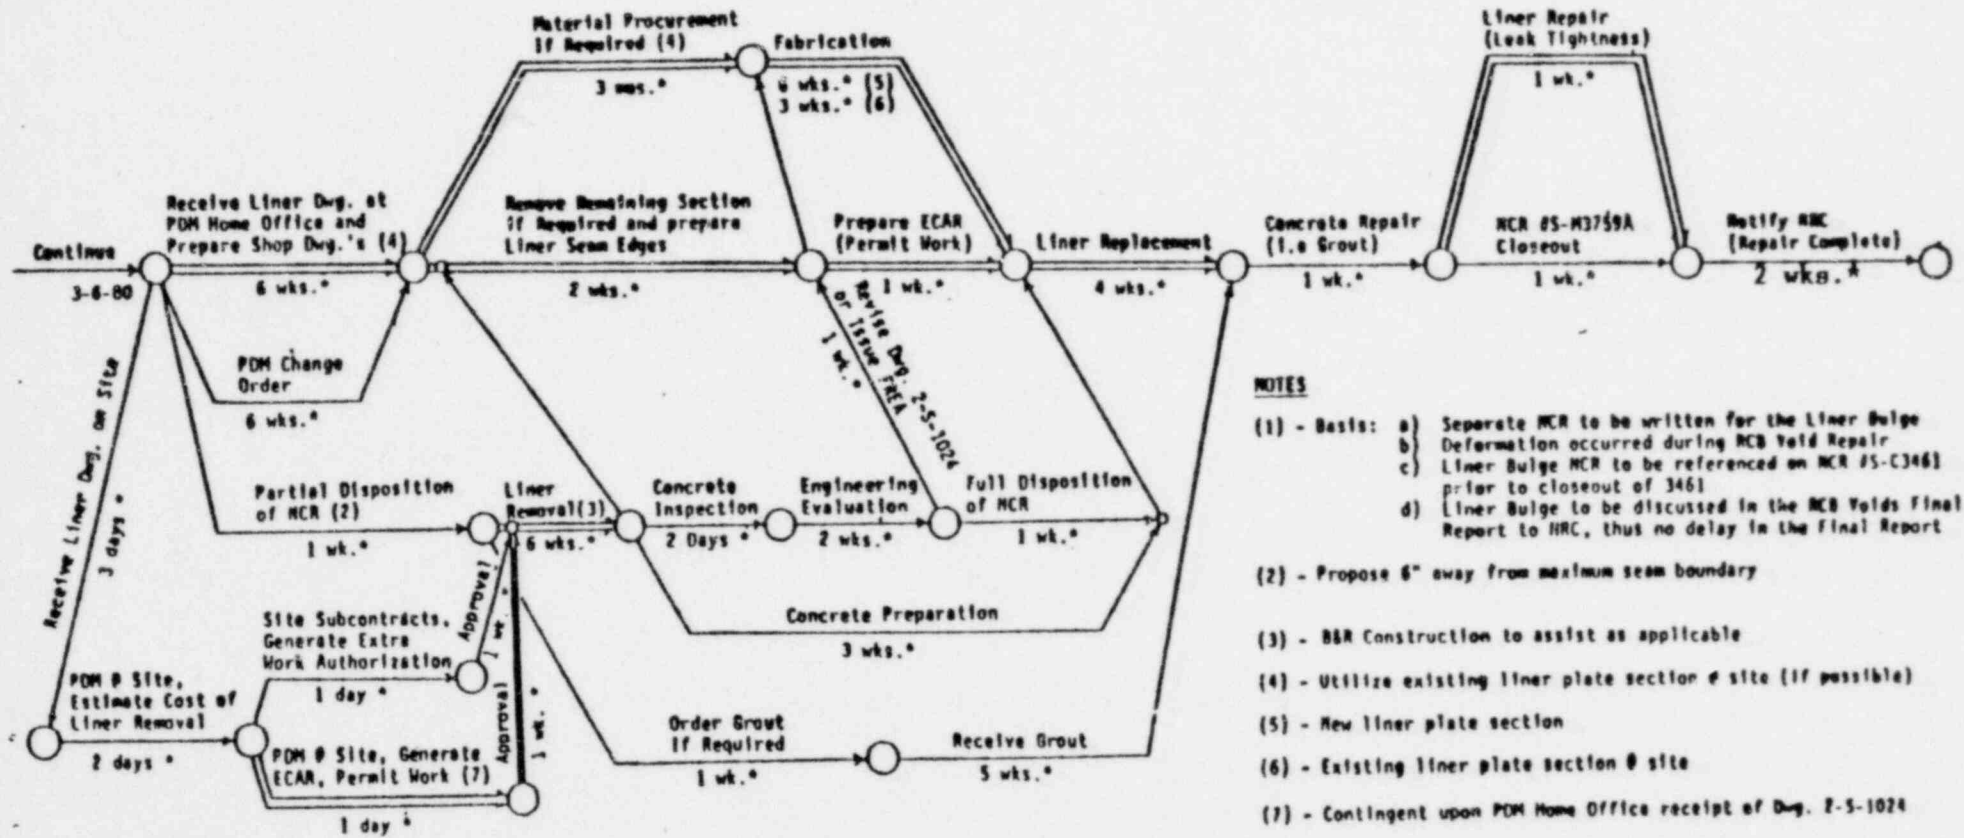
Liner Bulge Repair, MCR 2 Shell Wall

- (1) - Basis: a) Separate MCR to be written for the Liner Bulge Deformation occurred during MCR Void Repair b) Liner Bulge MCR to be referenced on MCR #S-C3461 prior to closeout of 3461 c) Liner Bulge to be discussed in the MCR Voids Final Report to HRC, thus no delay in the Final Report
- (2) - Propose 6" away from maximum seam boundary
- (3) - B&R Construction to assist as applicable
- (4) - Utilize existing liner plate section @ site (if possible)
- (5) - New liner plate section
- (6) - Existing liner plate section @ site
- (7) - Contingent upon PDM Home Office receipt of Dwg. 2-S-1024
