Public Service Company of Colorado

January 14, 1981
Fort St. Vrain
Unit No. 1
P-81014

REPORTABLE OCCURRENCE 80-075

REPORT NO. 50-267/80-075/03-L-0

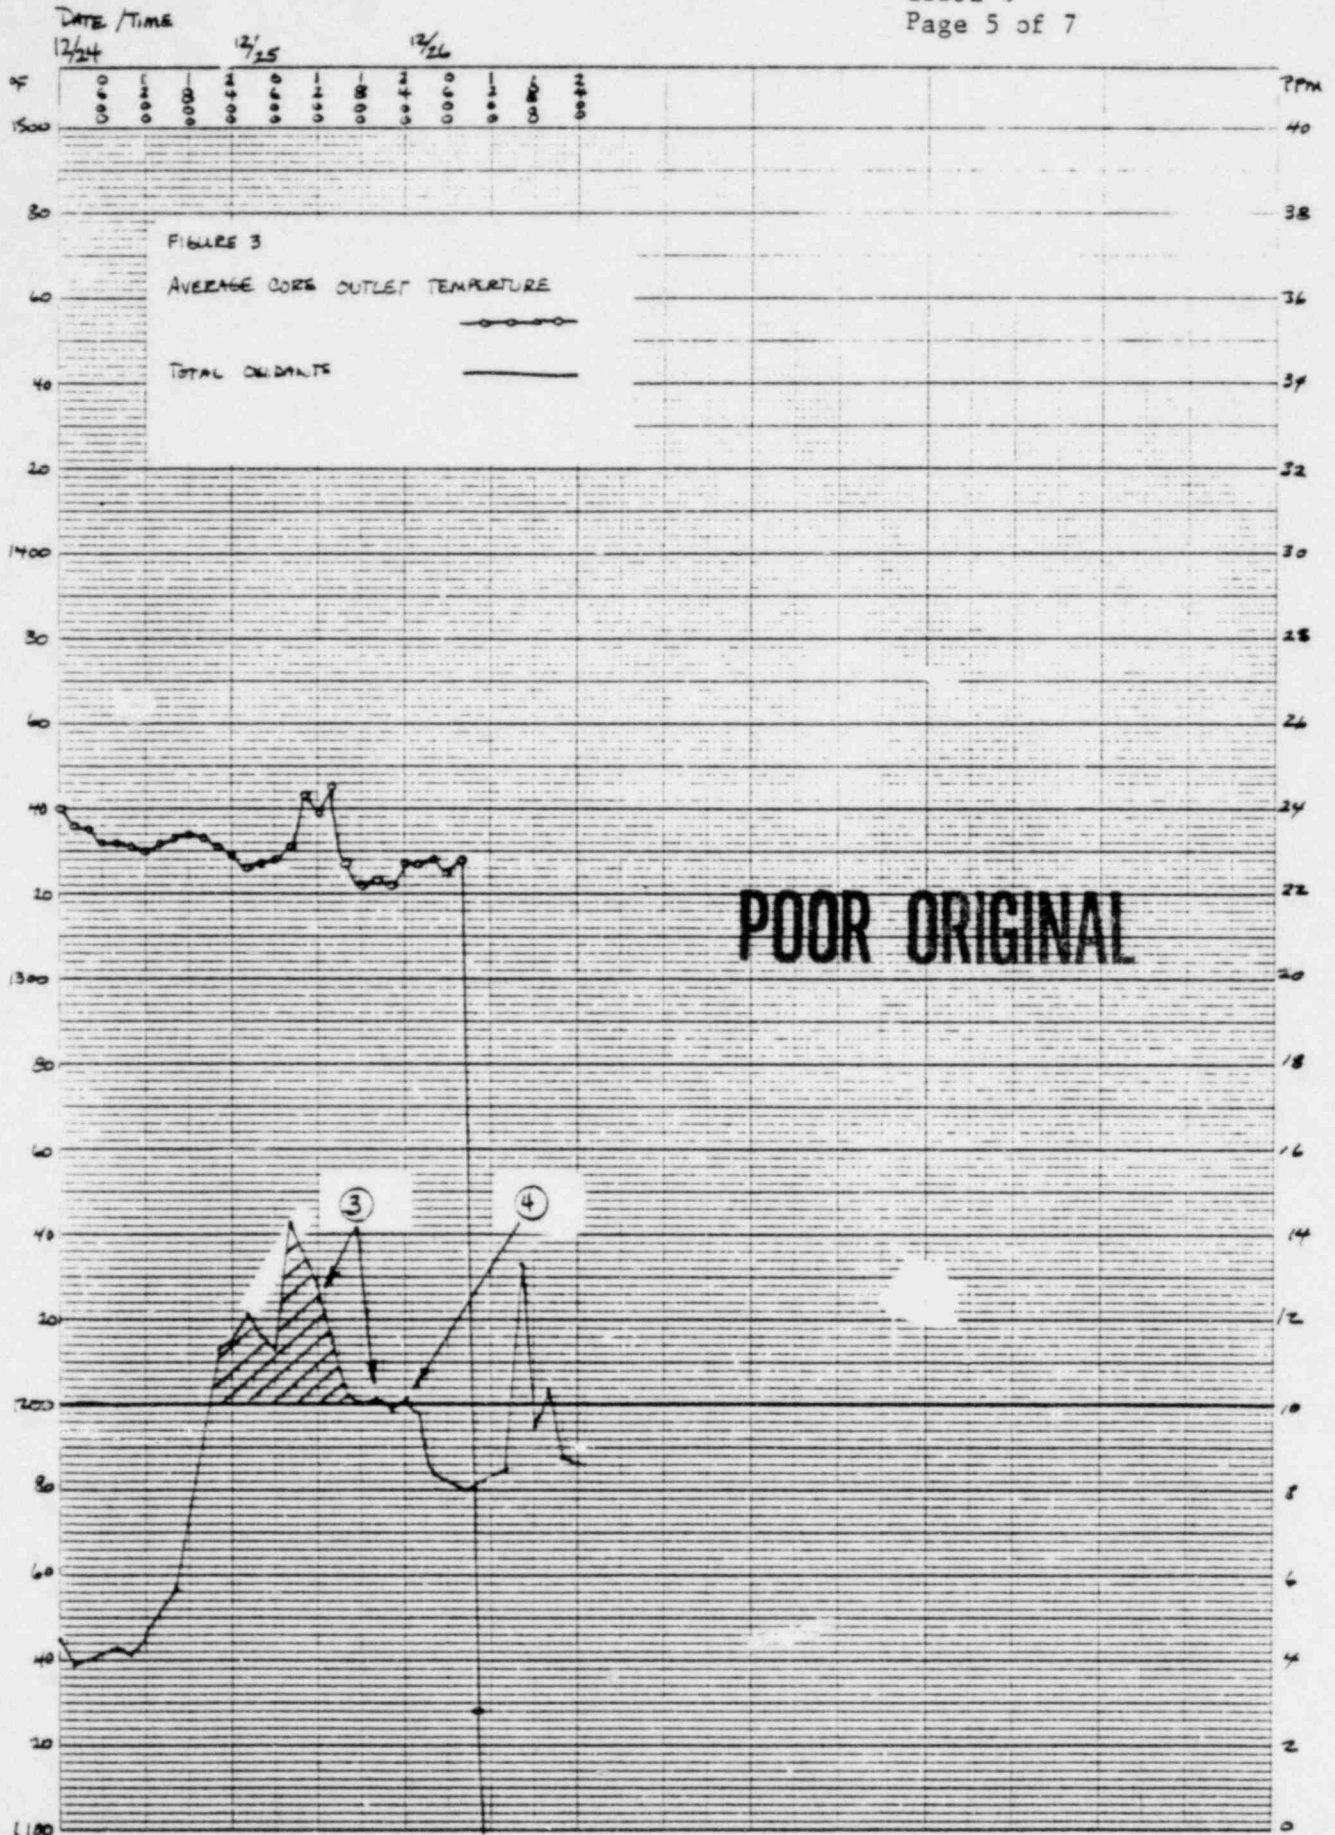
3. (See Figure 3.) Following the decrease of oxidants after event #2, the plant continued at power levels of about 68% until December 24, 1980, when oxidants again increased. The oxidants gradually decreased again until 2200 hours on December 25, when the total oxidants were 9.9 ppm.

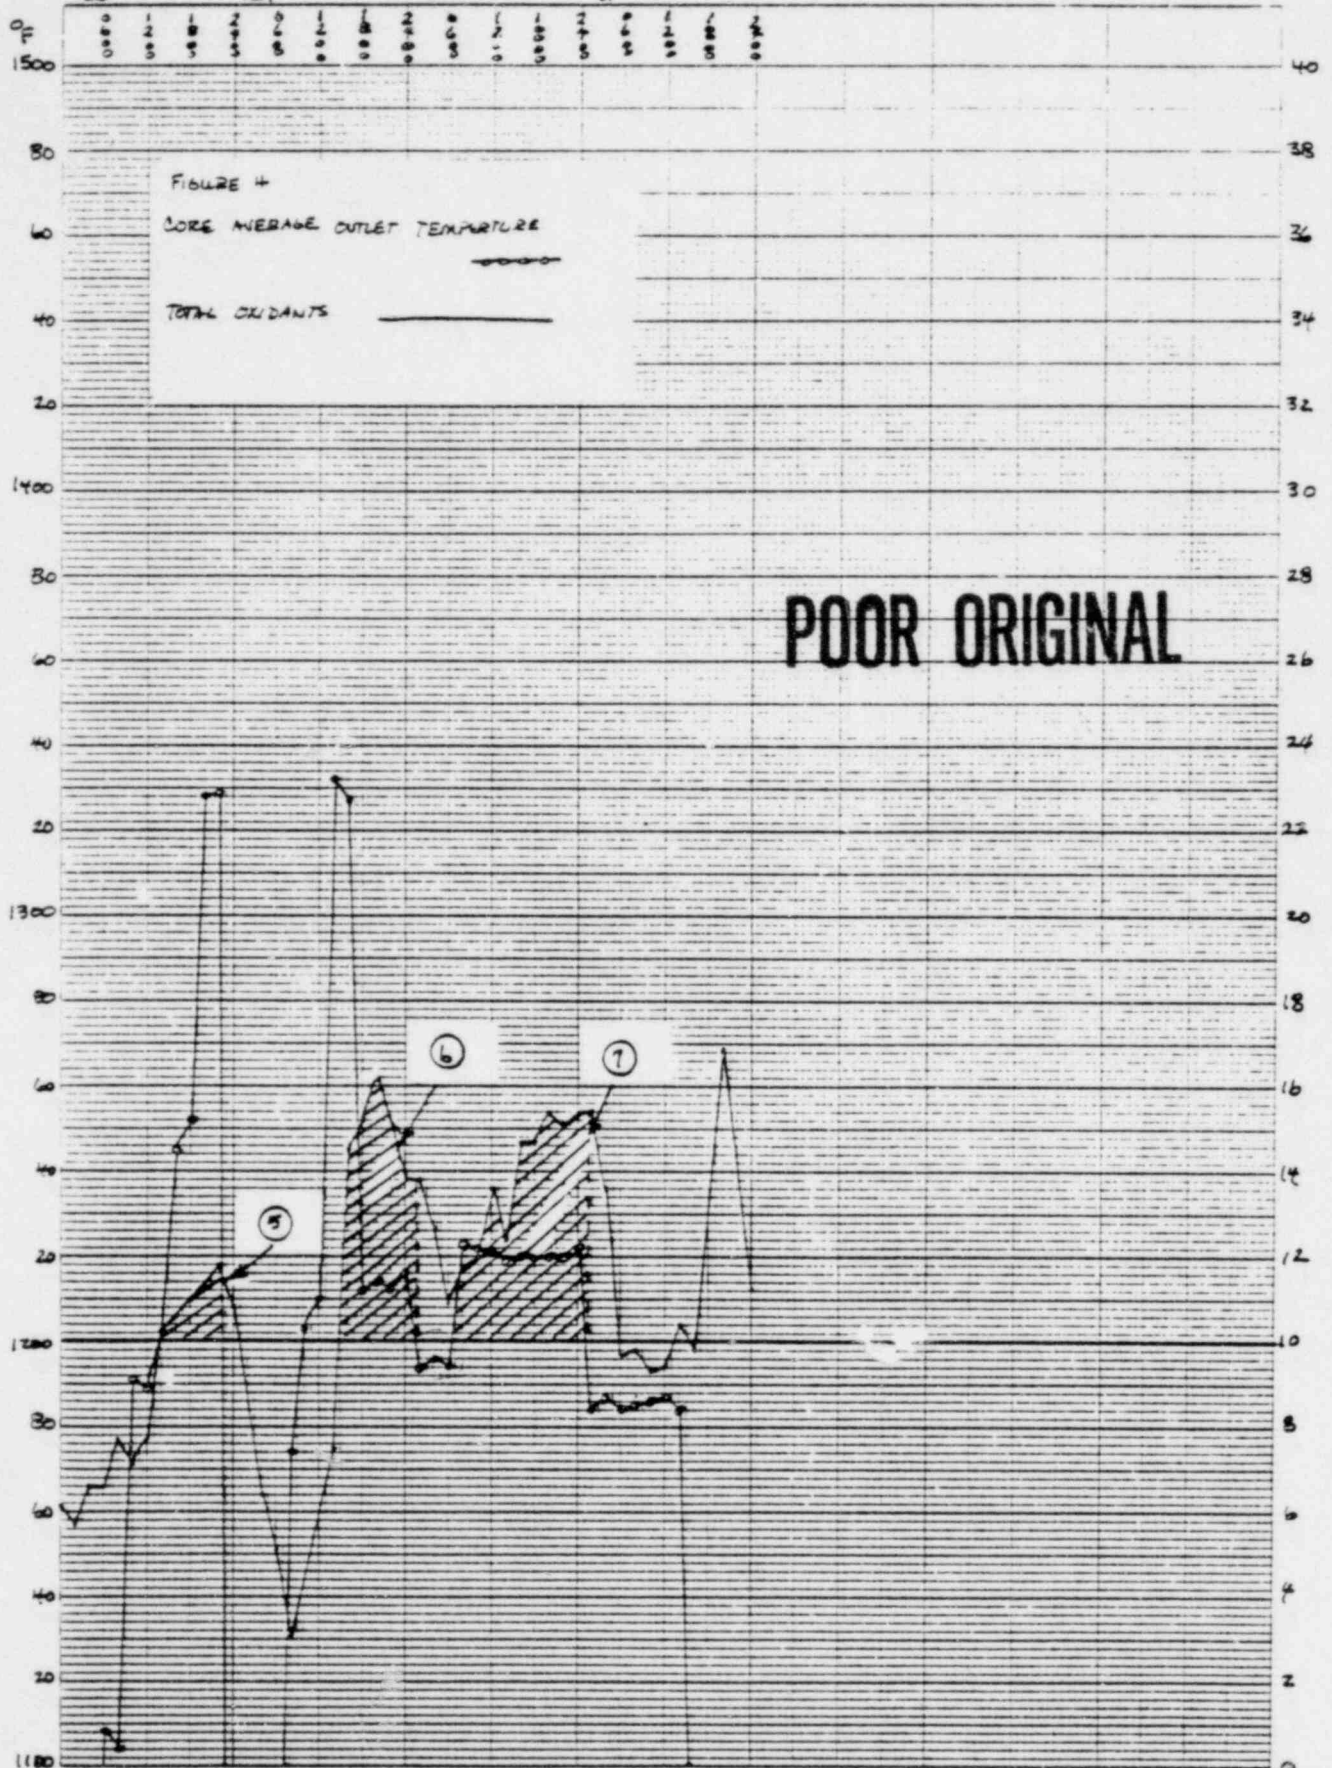
4. (See Figure 4.) On December 24, at midnight, the total oxidants again exceeded 10 ppm for one reading. Shortly thereafter, the plant was taken off line to repair a leak at a steam generator feedwater trim valve.
5. (See Figure 4.) On the return to power following the trim valve repair, the total oxidants again followed power and exceeded 10 ppm. While the oxidants were still increasing, the turbine and Loop 2 tripped due to a control problem with Loop 2 helium circulator steam bypass valve, PV-2244.
6. The repair to PV-2244 was completed and the plant returned to power.
7. The oxidants again followed the power increase and exceeded 10 ppm.
7. This continued until December 31, 1980, when the power was reduced to repair a valve.
