PRELIMINARY NOTIFICATION OF EVENT OR UNUSUAL OCCURENCE--PNO-III-81-11 Page 1 of 2

Facility: Toledo Edison Company  
Davis Besse 1 (Docket No. 50-346)  
Oak Harbor, OH

Subject: WATER IN CONTAINMENT ELECTRICAL PENETRATION

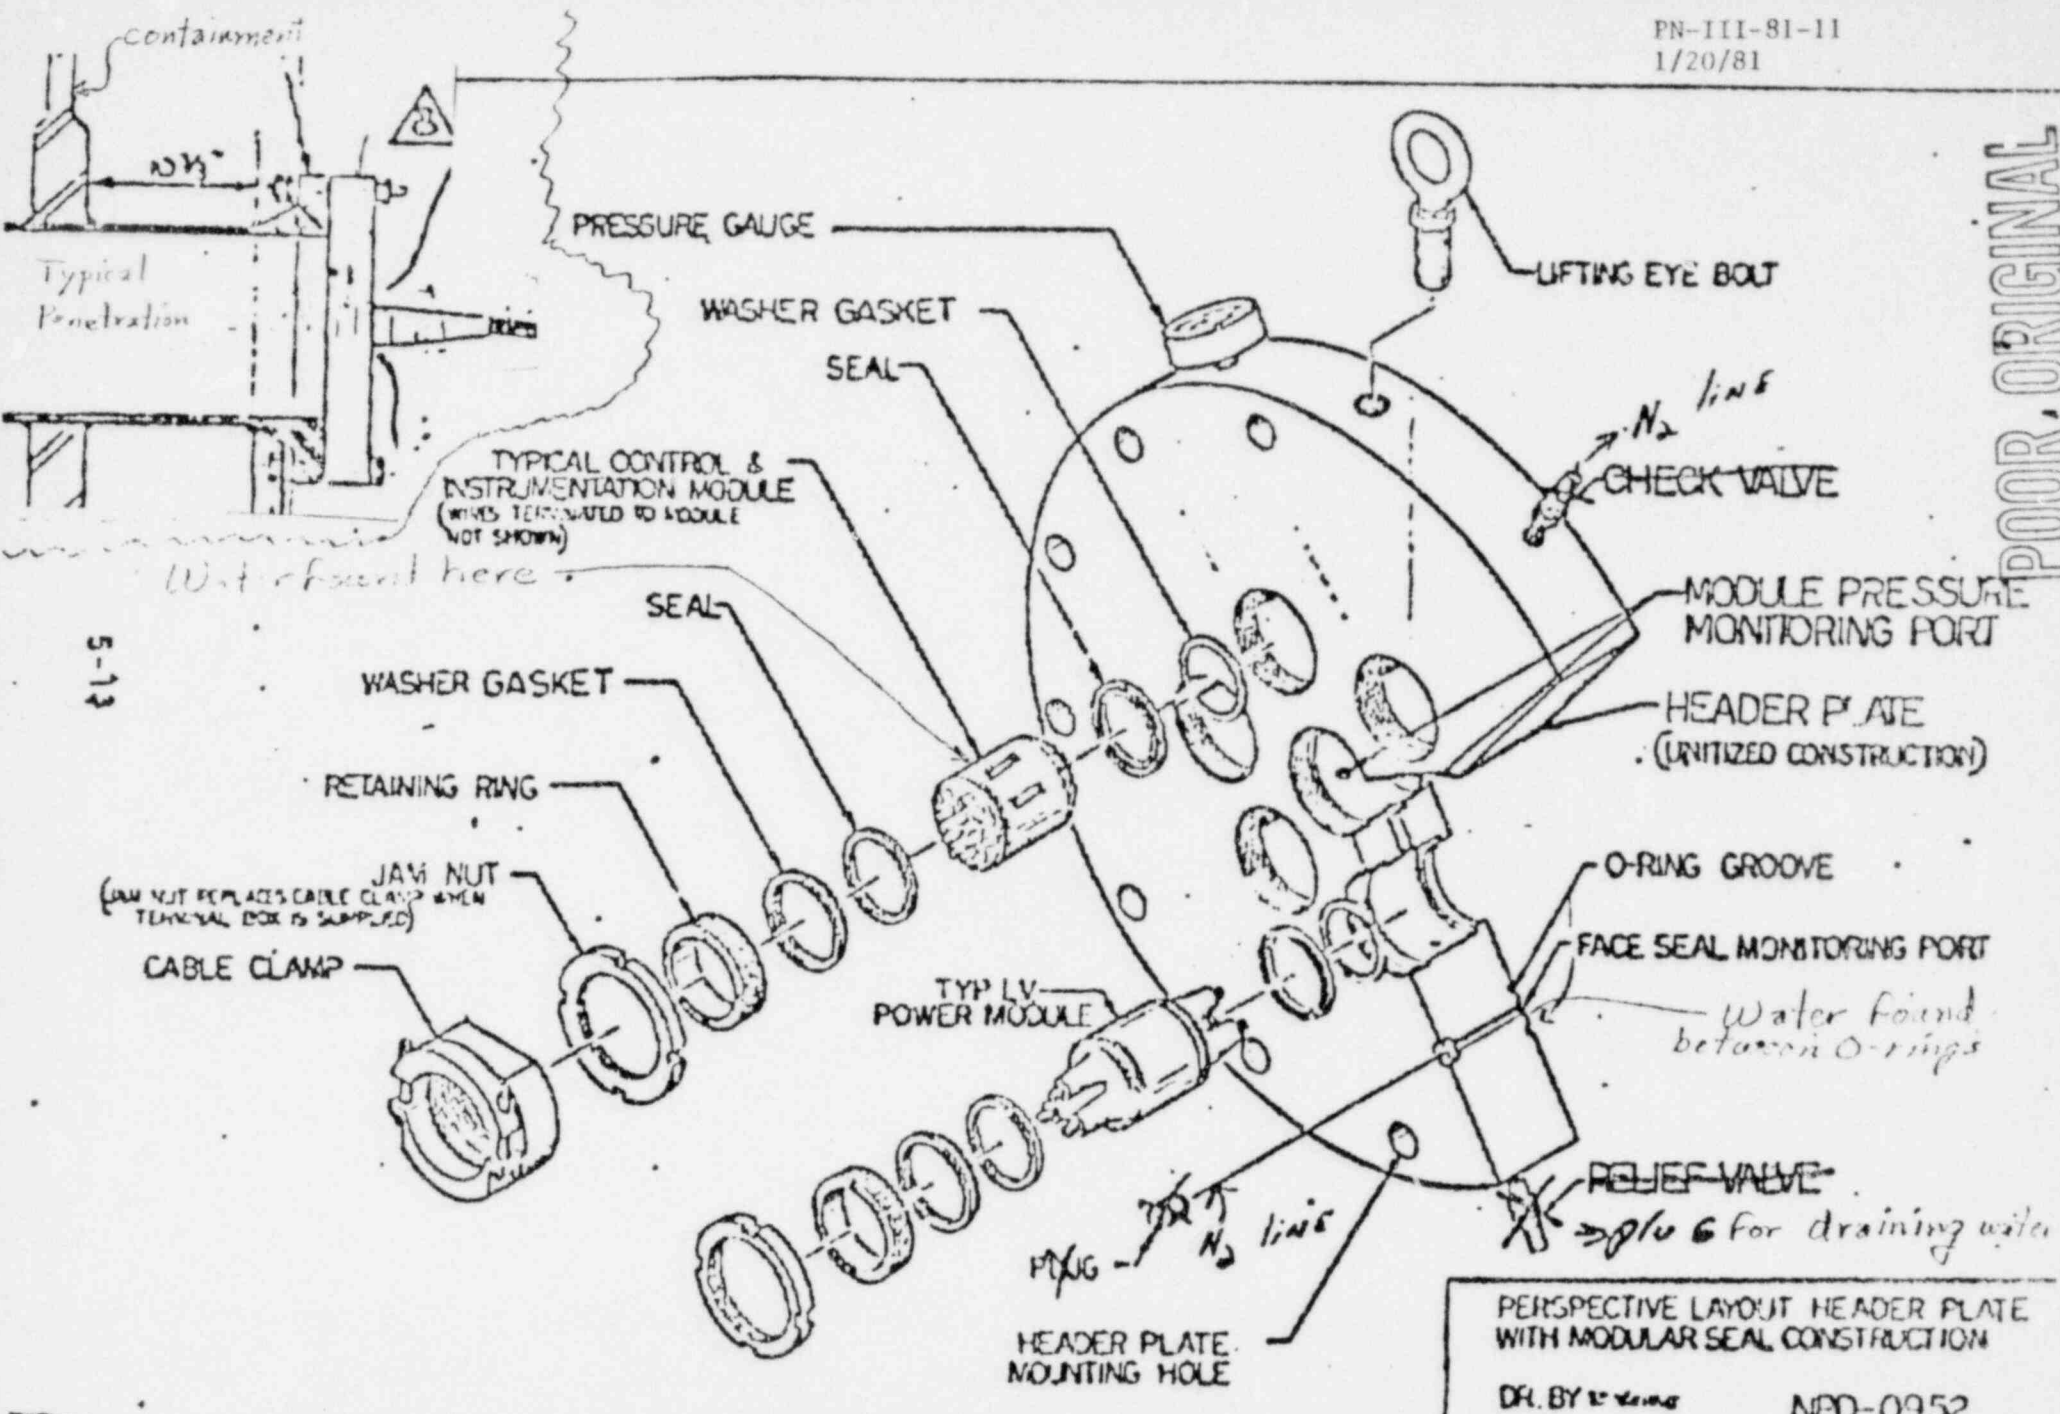
PERSPECTIVE LAYOUT HEADER PLATE  
WITH MODULAR SEAL CONSTRUCTION  
DR. BY [signature] NPD-0952

While replacing a pressure gauge in one of the containment electrical penetrations, the licensee found water in the penetration. A check of eleven other electrical penetrations in the EAST penetration room disclosed water in all eleven. A check of three penetrations in the WEST penetration room showed all were dry. The water found in each of the EAST penetrations was reported to be 100 cc's or less. Chemical analysis of the water has been done in an attempt to determine the source of the water. The water has a neutral ph (6.8 to 8.3), no boron, no hydrazine, no ammonia, and no radioactivity. The licensee has not yet identified the source of the water but is still investigating. The penetrations are maintained under a positive nitrogen pressure. The cryogenic nitrogen tank also supplies the cover gas to tanks in several water systems.

*Water found here*

*Water found between O-rings*

*plus 6 for draining water*

The licensee plans to inspect the electrical containment penetrations and to make sure that all are dry using recommendations from the manufacturer (Amphenol). The licensee's procedure for drying the penetrations will be reviewed by the NRC and this matter will be resolved before the reactor goes back into operation. The unit is presently in cold shutdown for replacement of reactor coolant pump seals.
