DUKE POWER COMPANY

Re: McGuire Nuclear Station
Docket Nos. 50-369 and 50-370

SAFETY EVALUATION OF UHI HOLDDOWN ASSEMBLY SPRINGS

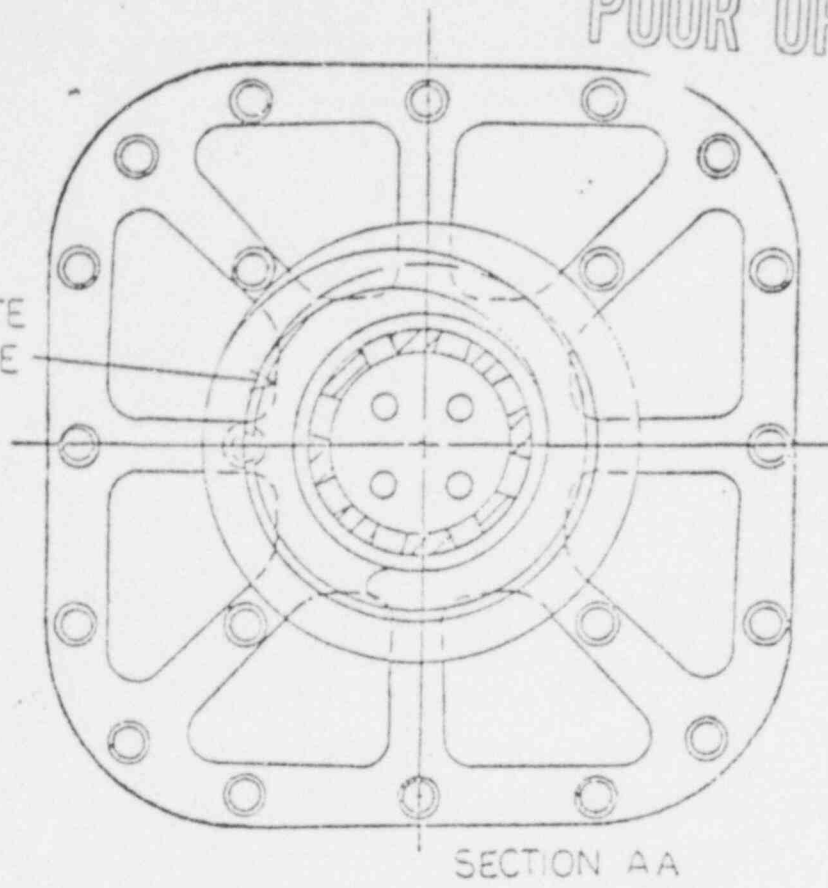
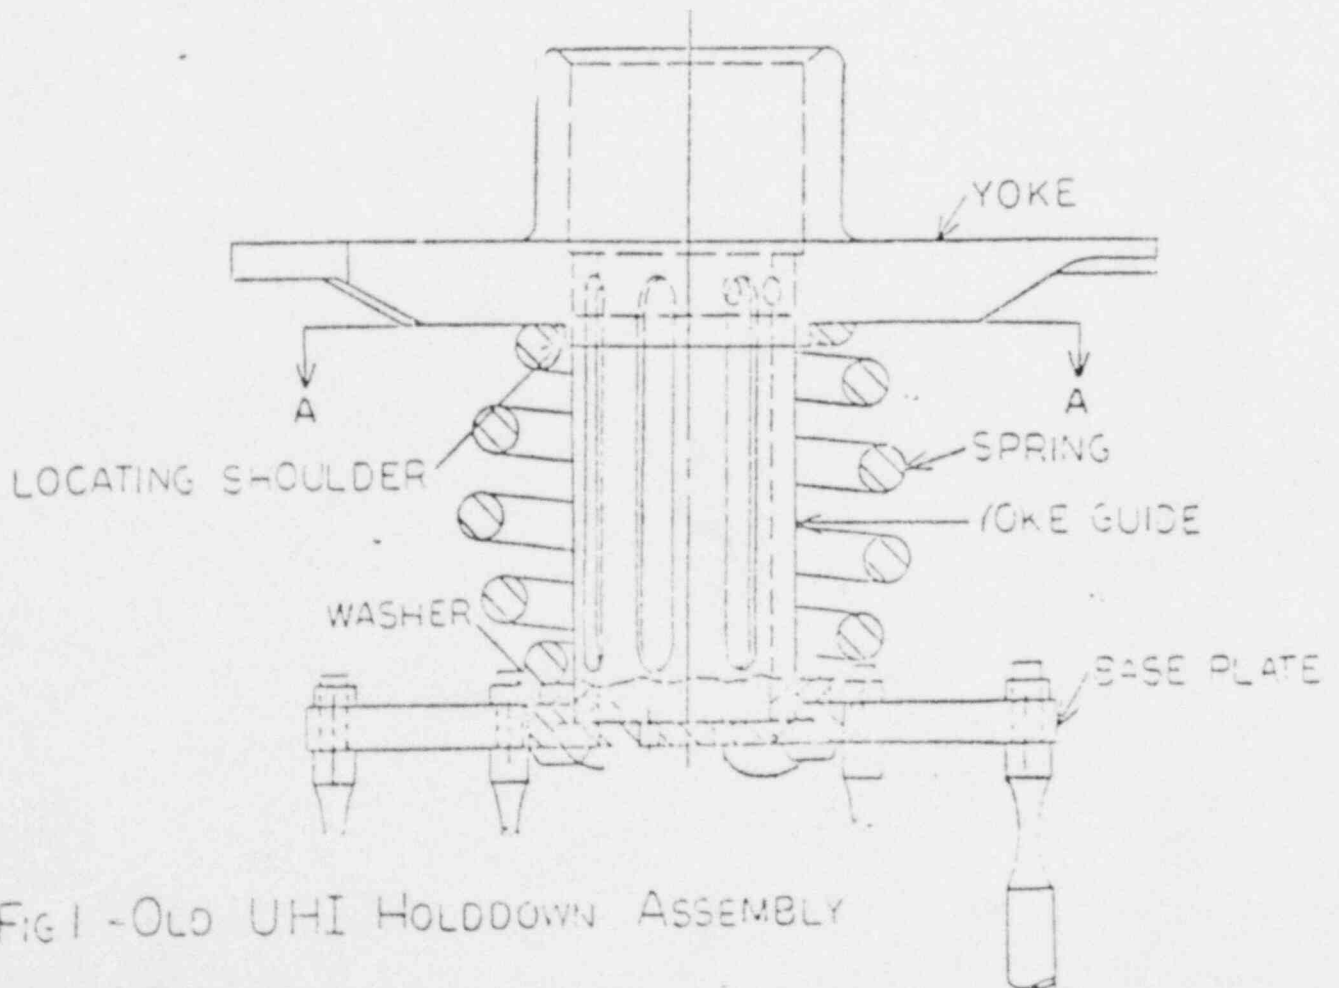
FIG 1 - Old UHI HOLDDOWN ASSEMBLY

During an April 1980 first cycle refueling of a non-domestic Upper Head Injection (UHI) reactor, difficulty was encountered in engaging the holddown assembly of a non-fuel bearing component. Close inspection of the holddown assembly revealed that the spring beneath the yoke was broken, allowing the yoke to tilt such that the handling tool finger would not engage. Inspection of all holddown assemblies disclosed that 31 of the total 132 assemblies contained springs that were either cracked or broken. An inspection at a second foreign UHI plant revealed 9 cracked or broken springs out of 132.

Westinghouse has examined the consequences of operation with broken springs and has concluded that operation with springs of the old design (See Figure 1) in non-fuel bearing components for one cycle and application of the new spring design for other components do not constitute a safety concern. The evaluation considers a most limiting practical case of spring breaks of the type generally observed in the examination of spring breaks in the foreign UHI reactor or all springs broken near the center with the two parts intertwining with each other.

There is no visual evidence of any loose parts. Breaks as reported from examination of an affected foreign UHI reactor (plant A) were clean with no evidence of fragmentation. The spring design is such that the end coils are inactive and the close tolerances with the hub of the holddown assembly ensures the spring ends on either side of the observed breaks are fully captured.
