Event Description

Eddy current examinations of tubing in both Prairie Island Unit 2 steam generators (S.G. No. 21 and No. 22) were performed (January 7-18, 1980), during the recent refueling outage. In addition to complying with Technical Specification requirements, the examination plan was focused on the peripheral tubes in the inlet side of both steam generators. These examinations of the peripheral tubes were planned to determine if there were any signs of tube damage due to foreign objects.

## APPENDIX A

### EXAMINATION OF REMOVED TUBE

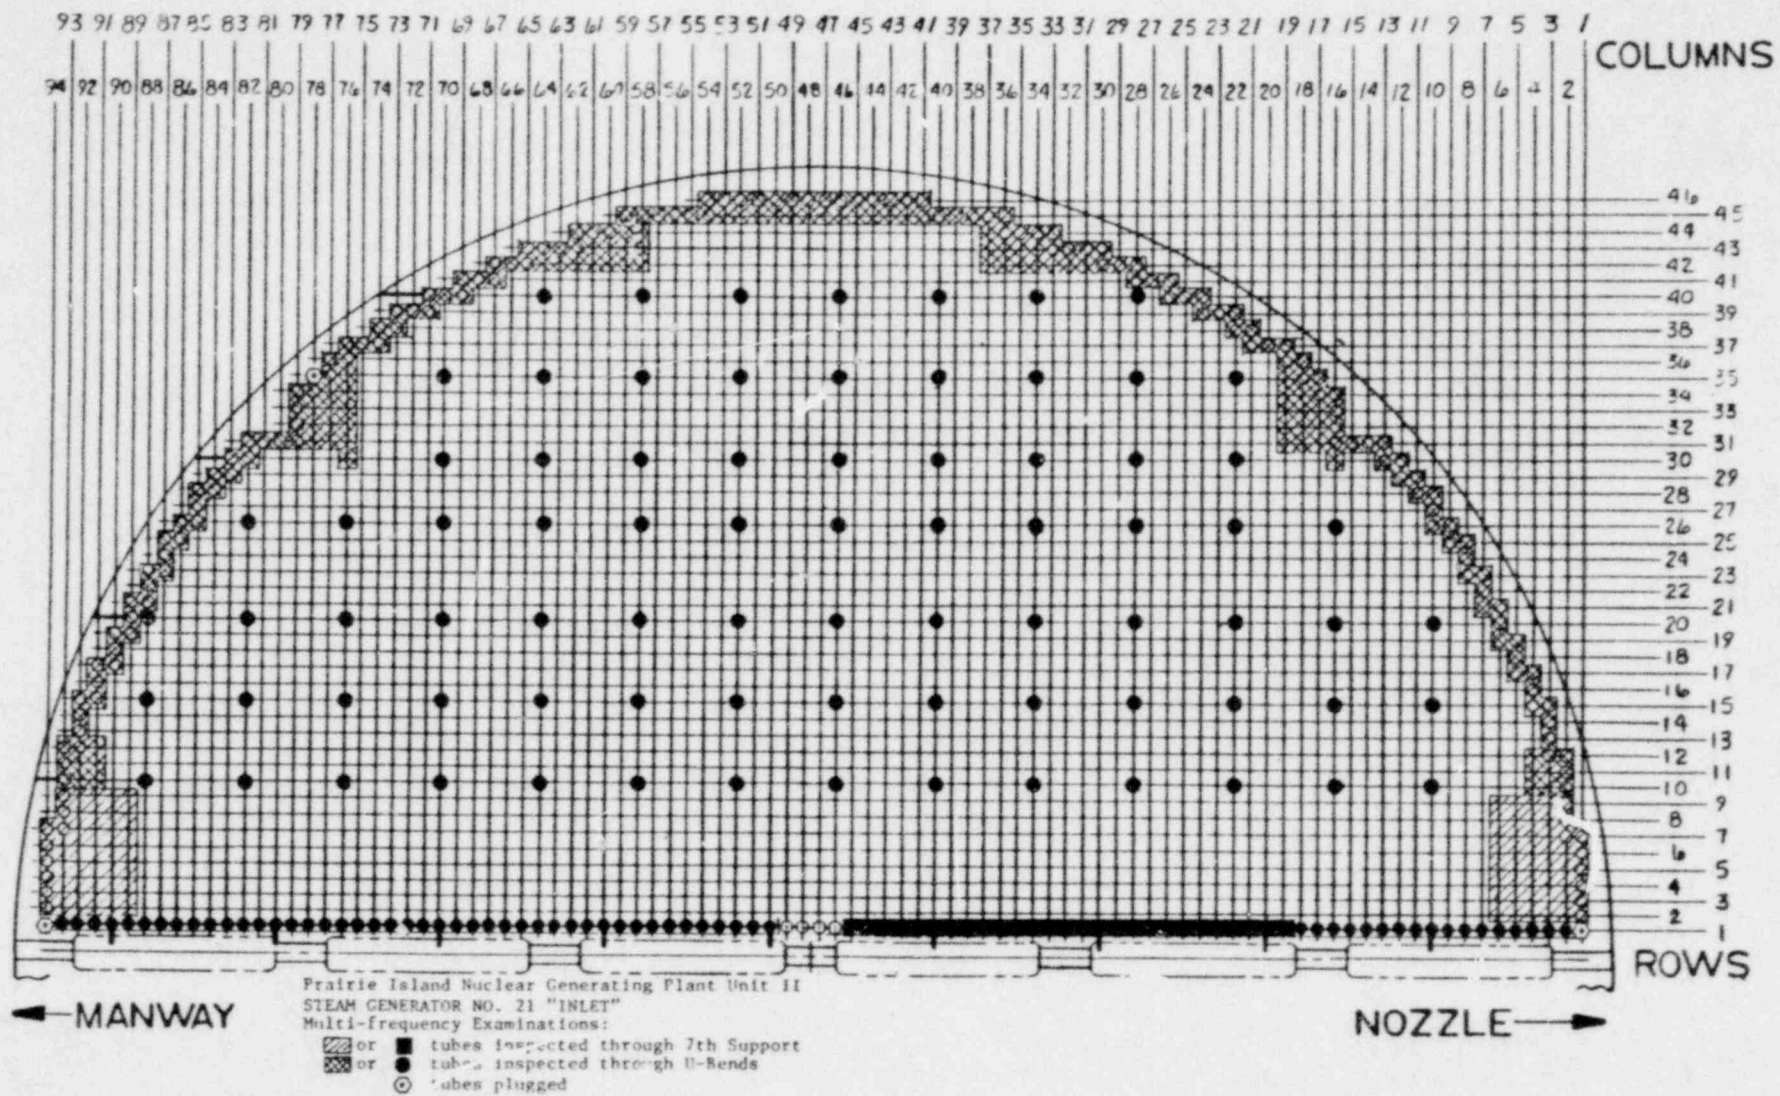
Figure 1

A similar inspection was performed on S.G. No. 22 and resulted in similar findings. Figures 1, 2, 3 and 4 identify the tubes that were inspected and those tubes that were plugged for the inlet and outlet side of both steam generators. Table I identifies the percentage of tubes that were inspected and Table II provides a tabulation of the number of deteriorated tubes for each steam generator.

The plugging criterion of the Technical Specification is 50% of tube wall thinning. Additional conservatism was used and all tubes that had areas of wall thinning greater than 43% were plugged. In addition, as a preventive measure, the tubes that are directly in line with the tube lane blocking devices, which are the row 1 column 1 and the row 1 column 94 tubes, were plugged in both steam generators. (This measure was taken even though improvements in design were made to assure proper location and locking of these blocking devices.) Table III identifies all the tubes that were plugged during this outage.

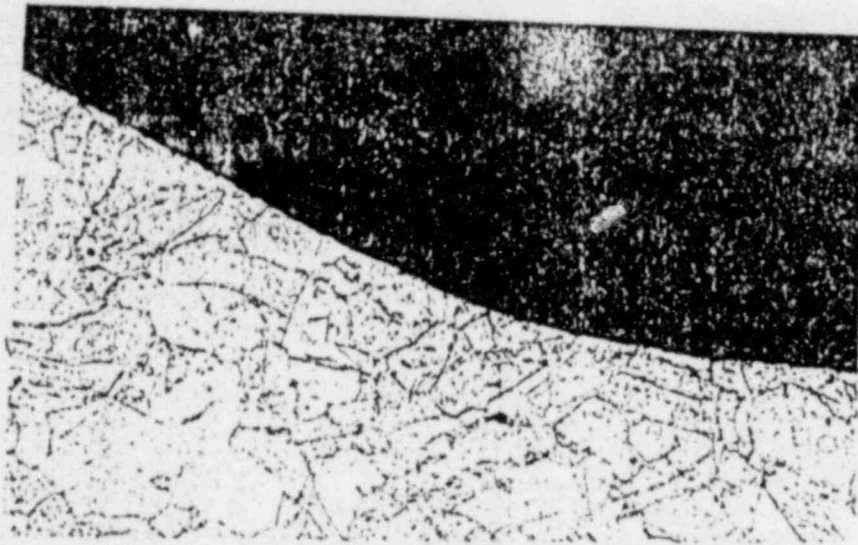
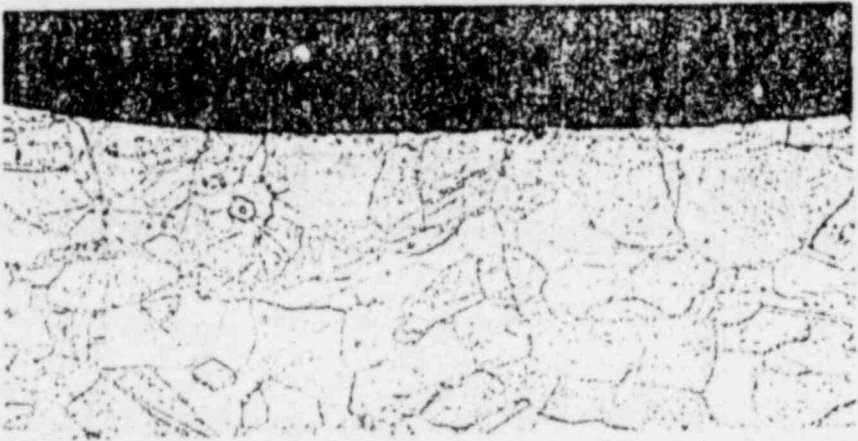
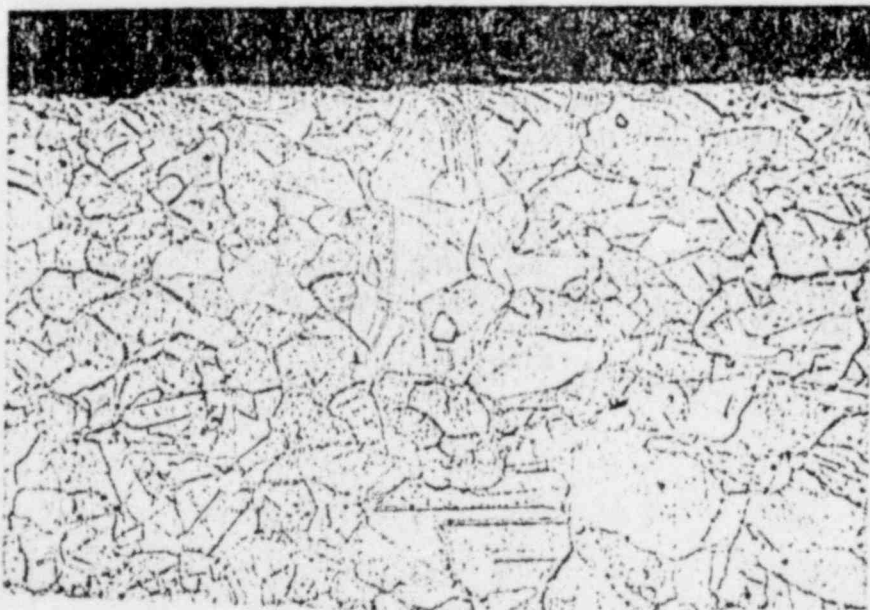
Several metallographic samples have been prepared from the 1st and 2nd support plate areas. Representative photographs are seen in Figures 2 and 3. Figure 2 is a half ring sample taken near the area of deepest attack on support zone #2. Figure 3 shows representative areas in the etched condition. No intergranular attack and no cold working of the surface is seen in the damaged area.

The lack of evidence of surface cold work, adduced both from the micro-hardness traverses and the metallography, essentially eliminate wear and vibration as the primary cause of the degradation. The most likely cause is corrosion, caused by the local concentration of an as yet undetermined contaminant in the crevices formed between the tubes and the tube support plate holes.

FIGURE 3: Polished and etched 1/2 ring from support zone 2 as shown in previous figure.

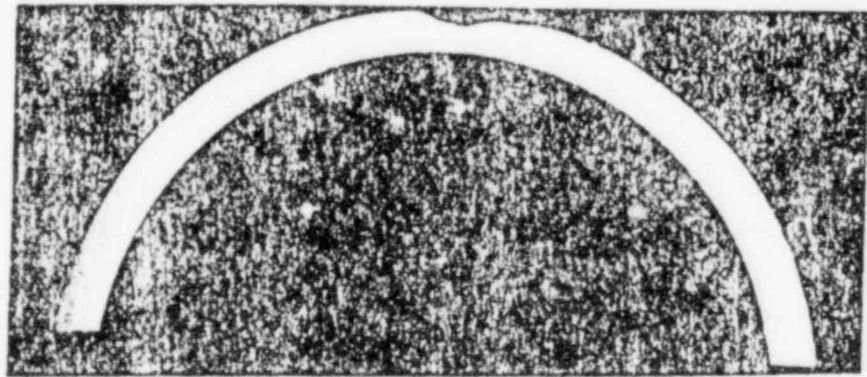
Knoop microhardness traverses were done on samples from both the first and second support zones. Figures 2 and 4 give the results for support #2. It can be seen that hardnesses near the surface of the damaged zone (Figure 2) are less than that outside the damaged zone (Figure 4). The higher readings in the unaffected region are normal and are due to surface work hardening imparted by the final belt polishing operation of the tubing during manufacture. Figure 5 gives similar results obtained on support zone #1.

FIGURE 4: Microhardness reading taken in the unetched region of the sample prepared from the second support zone. These numbers can be compared to those in Figure 2 taken in the damaged area.

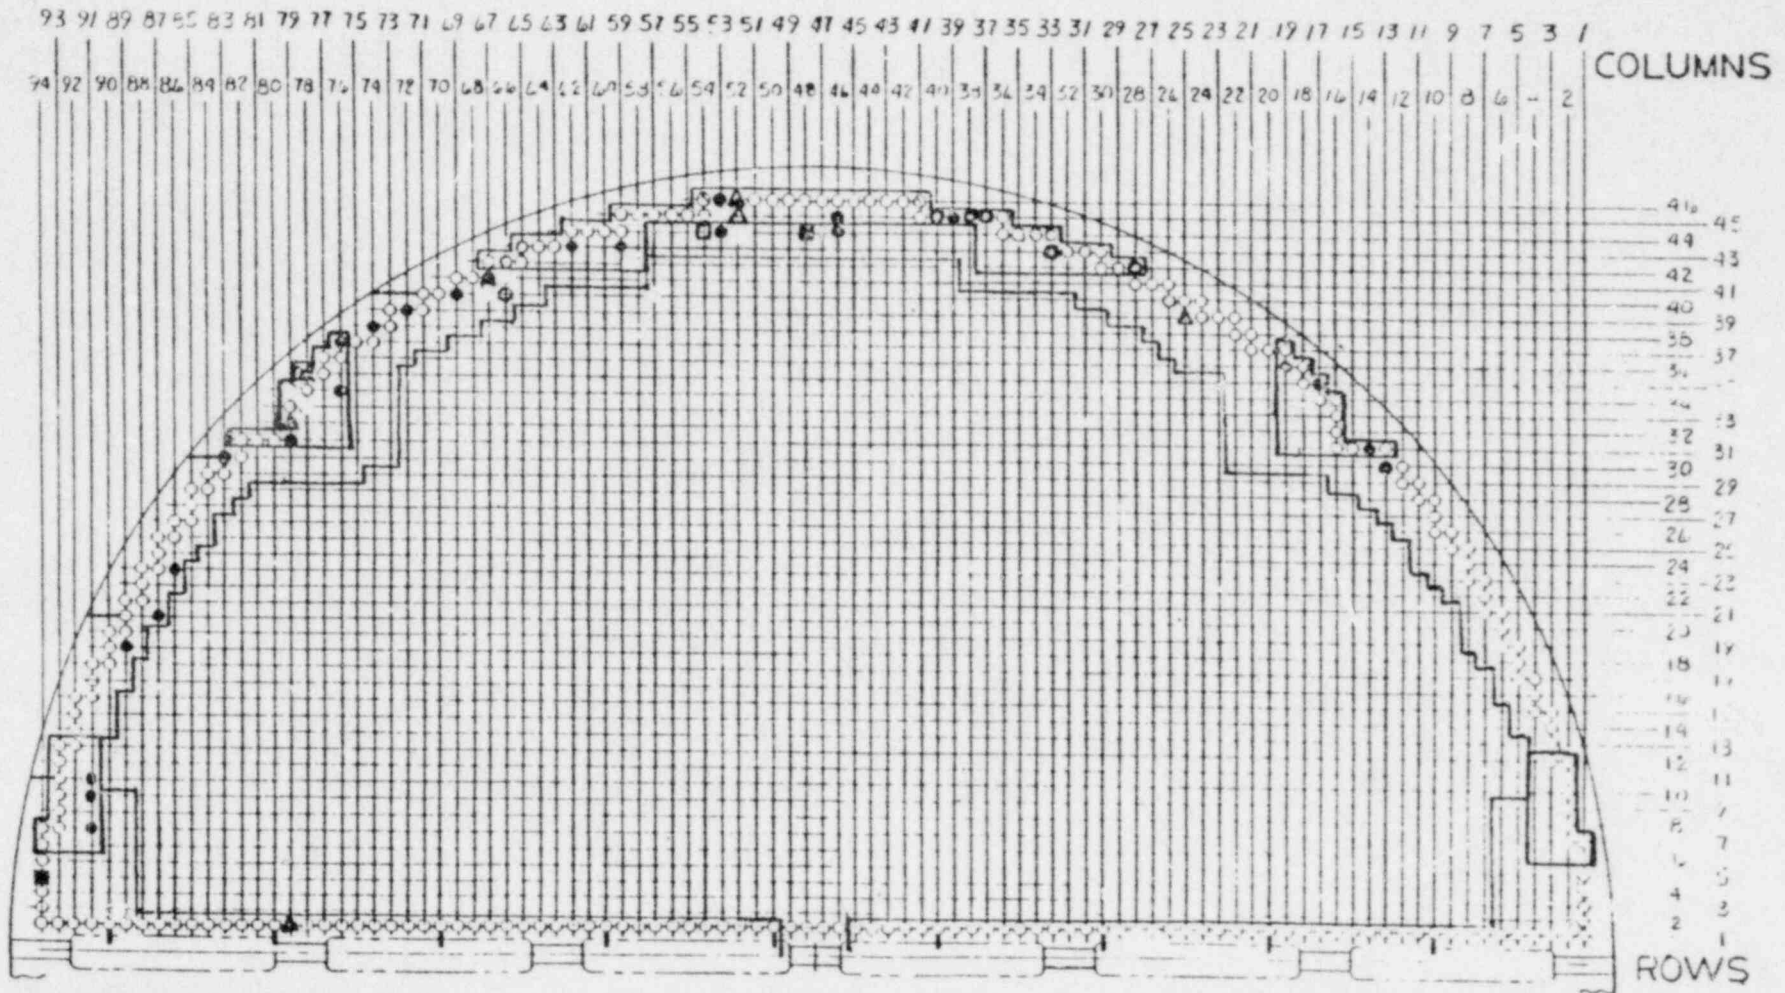
PRAIRIE ISLAND # 2  
SG 21 OUTLET  
1/80

- <20%
- 20-29%
- △ 30-39%
- ◇ 40-49%
- x >50%
- Open #2 TSP
- Dark #1 TSP

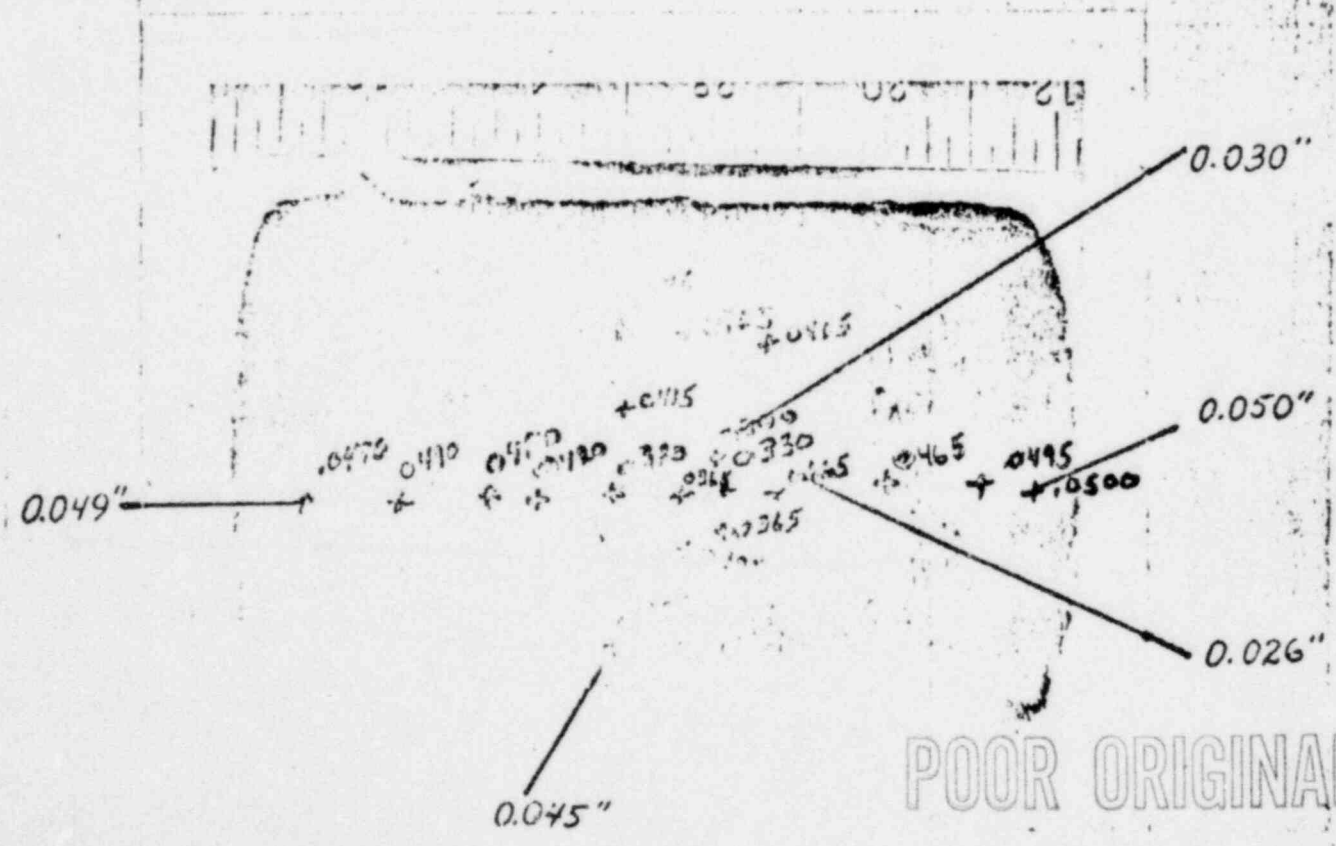
Prairie Island Tube R34C79 COLD LEG

FIGURE 1: Painted micrometer measurements showing amount of wall remaining for support zones 1 and 2. The design wall thickness is 0.050".

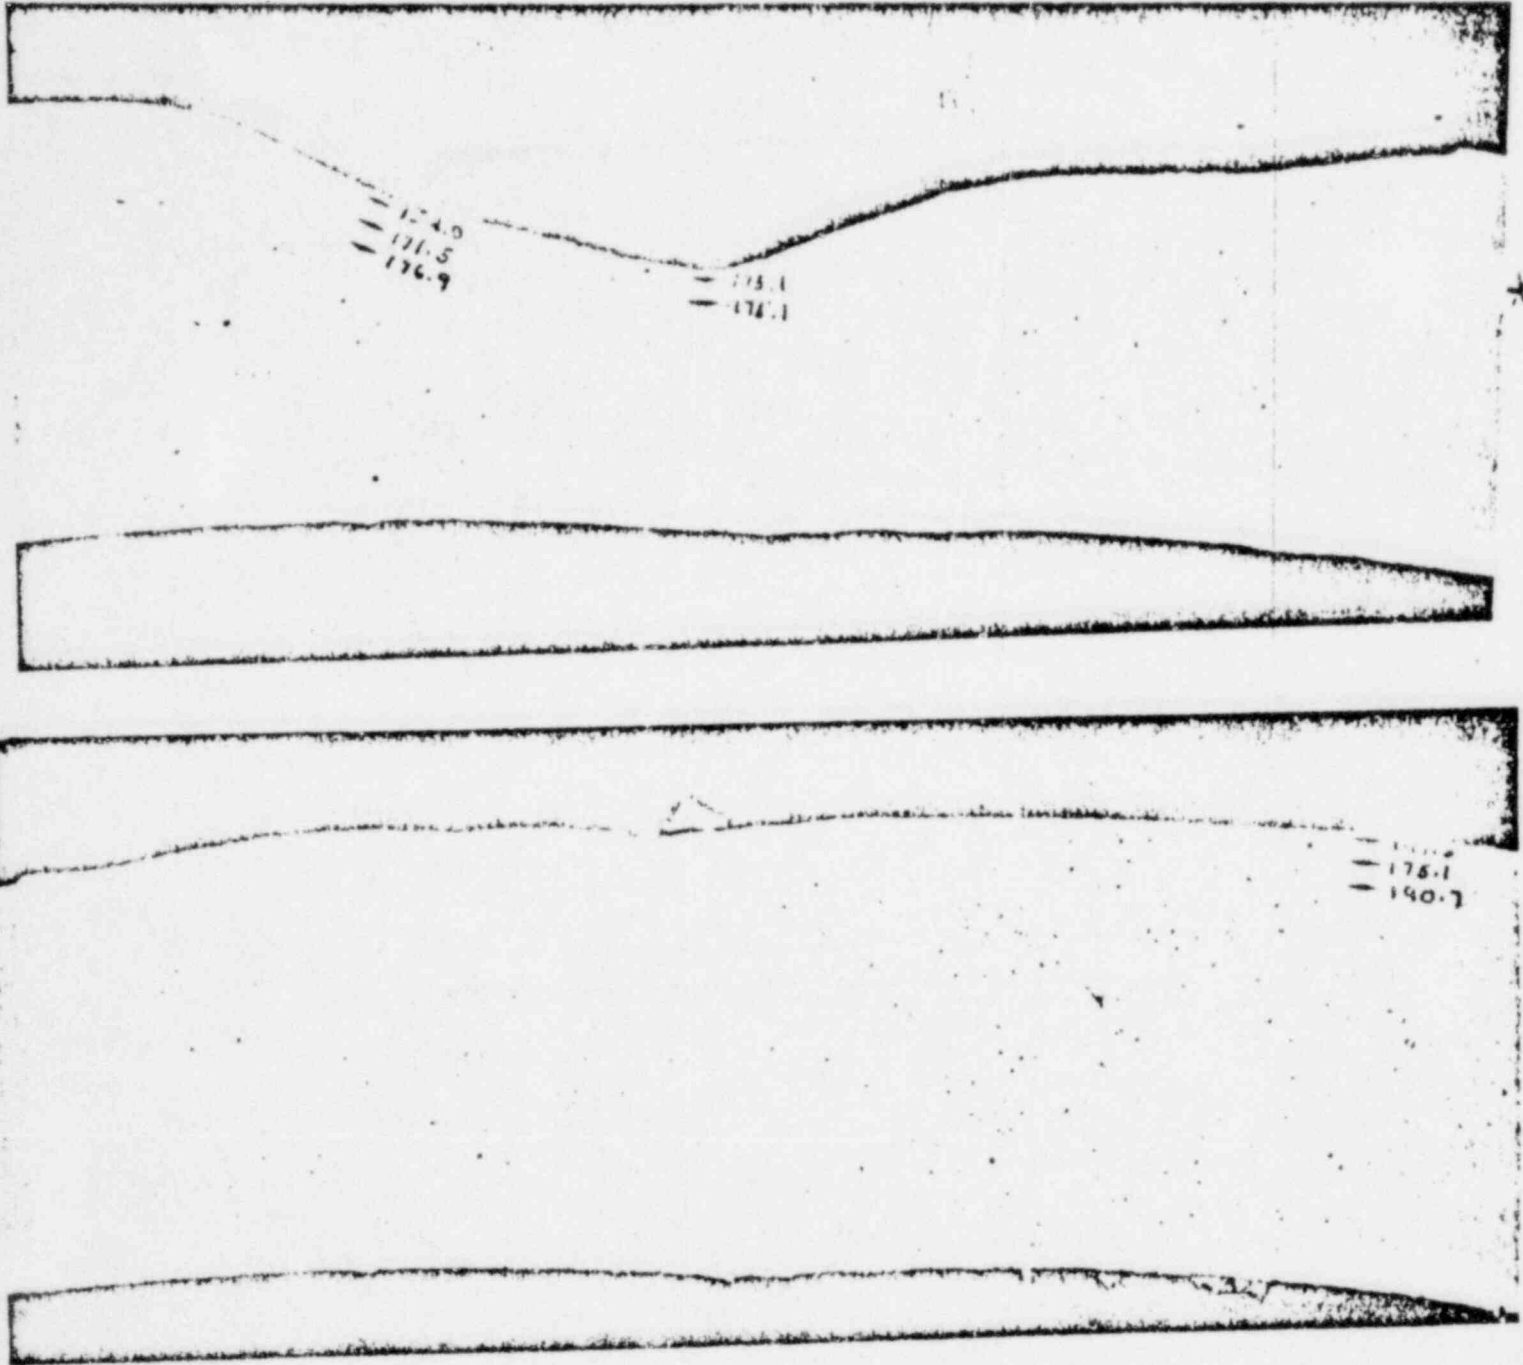
FIGURE 2: Polished 1/2 ring from support zone 2 near the area of deepest attack.  
 \* designated matching surfaces

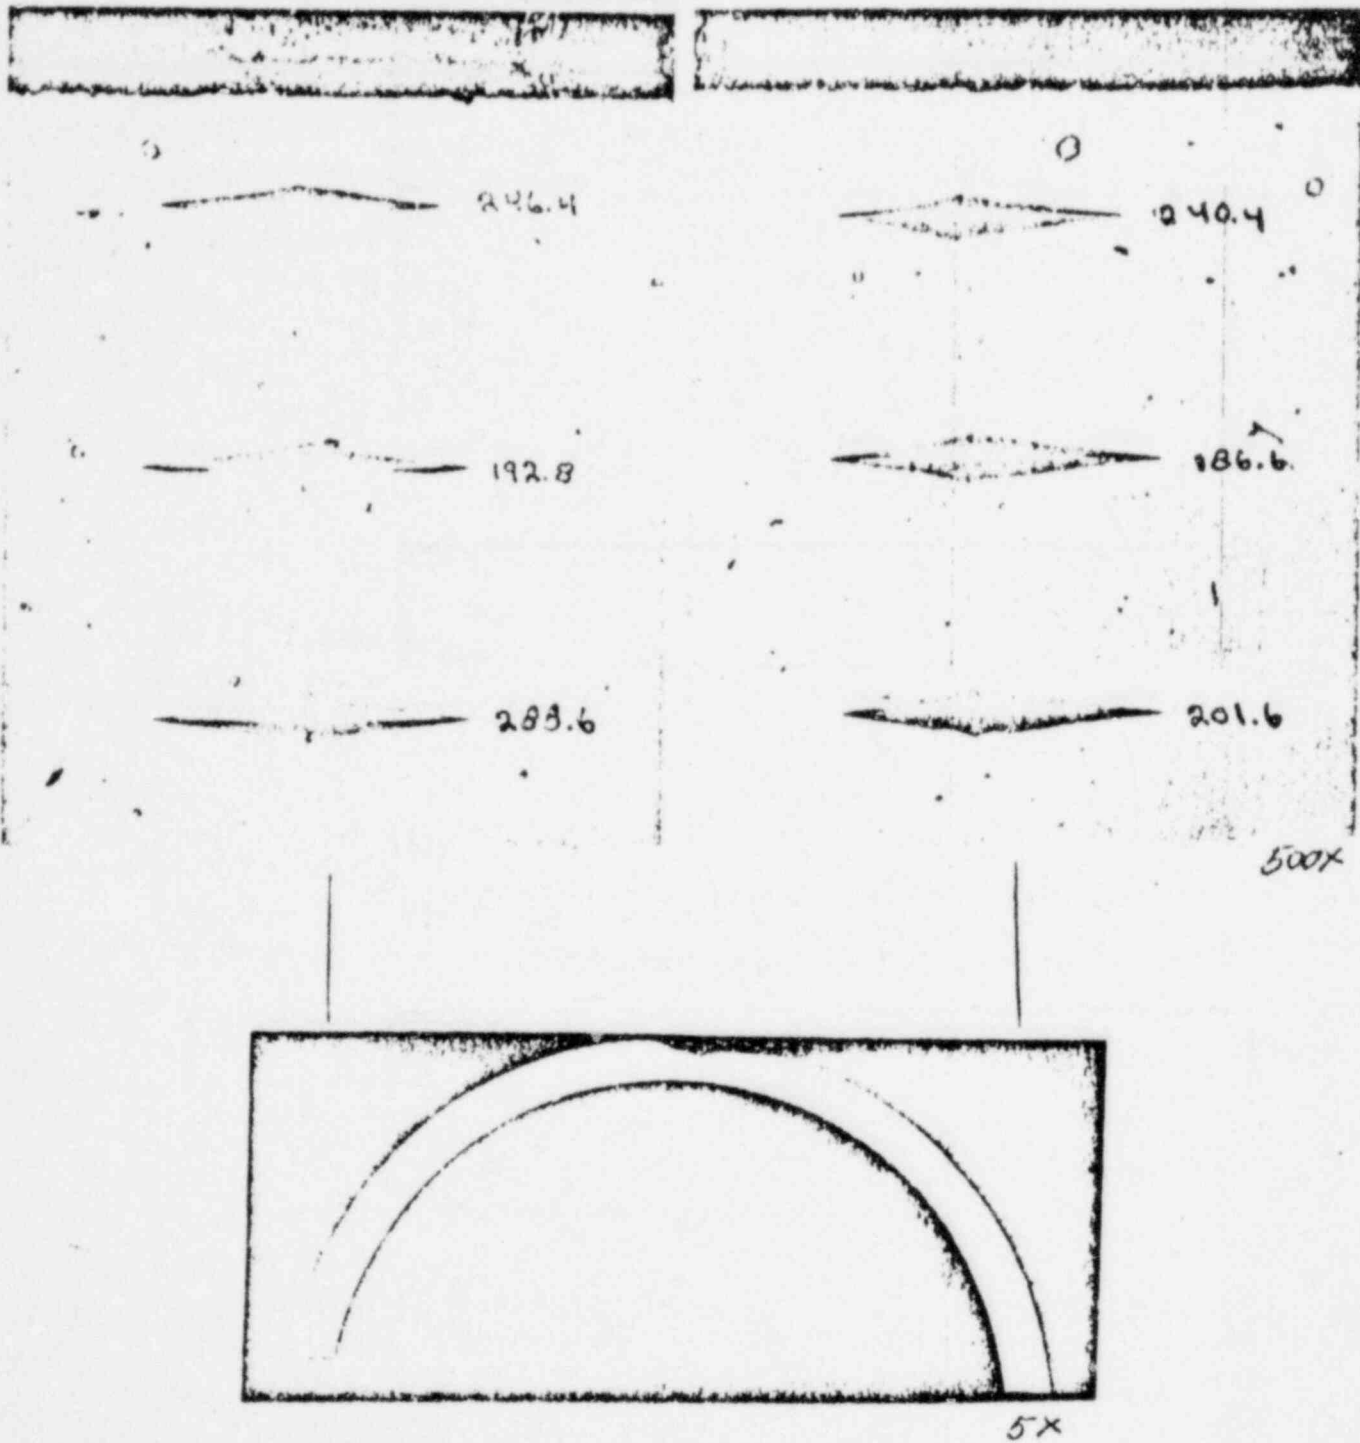
FIGURE 4: Microhardness reading taken in the unetched region of the sample prepared from the second support zone. These numbers can be compared to those in Figure 2 taken in the damaged area.

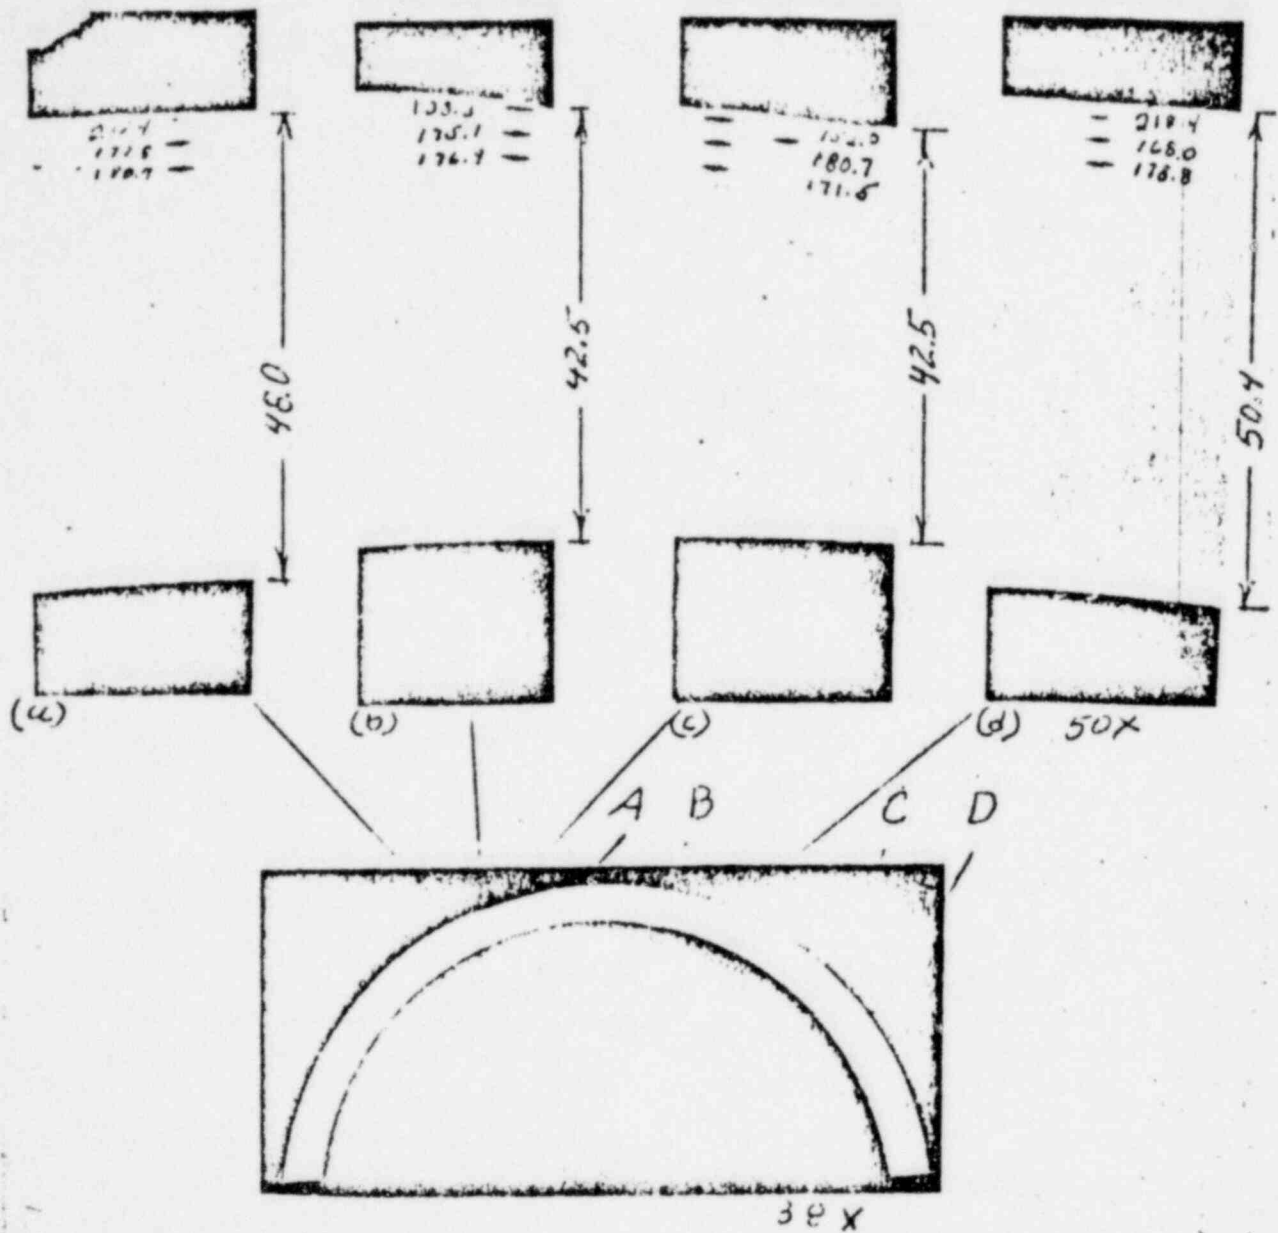
FIGURE 5: Knoop microhardness readings and wall thickness measurements 1/16 mils taken on a half ring sample prepared from support zone 1.

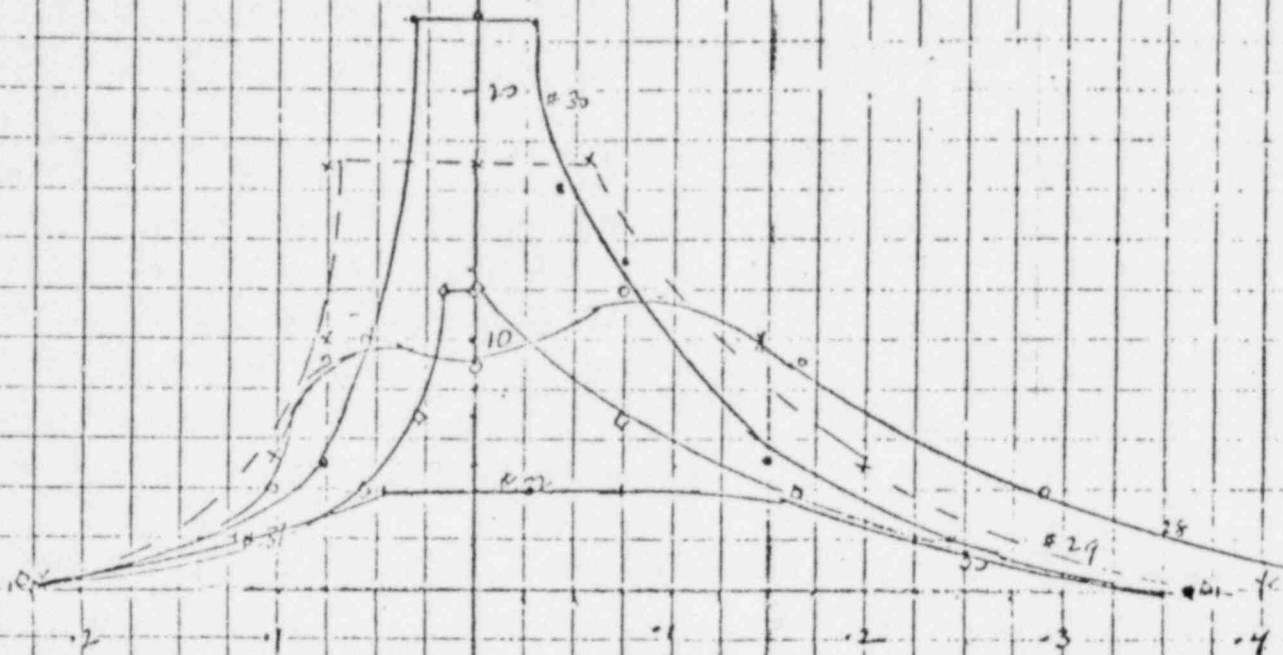
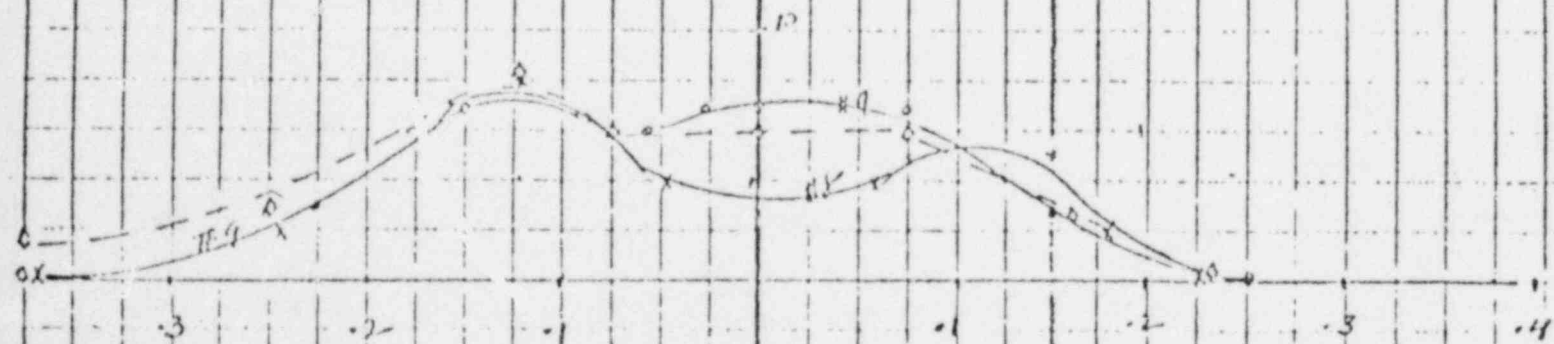
- PROFILE OF CORRODED AREAS ON PRAIRIE ISLAND 2 R34 C79
  - TSP #2 AREA .060 x .1875 = .011 SQ. IN.
  - TSP #1 AREA .24 x .1875 = .045 SQ. IN.
