UNITED STATES  
NUCLEAR REGULATORY COMMISSION  
WASHINGTON, D. C. 20555

SUBJECT: HUMAN FACTORS ENGINEERING CONTROL ROOM DESIGN REVIEW/AUDIT - SUMMER

HUMAN FACTORS ENGINEERING CONTROL ROOM  
DESIGN REVIEW/AUDIT  
V. C. SUMMER

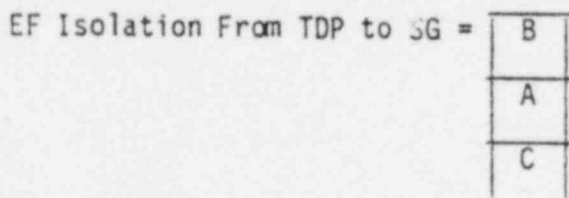
#### 4.4 EMERGENCY FEEDWATER SYSTEM PANEL (622 & 623)

- a. Arrangement of control strings is not always optimum

(Category 1 )
