Armed Forces Radiobiology Research Institute

AFRRI R-84 Annual Report  
October 1980

## REPLACEMENT OF THE AFRRI-TRIGA REACTOR TRANSIENT ROD

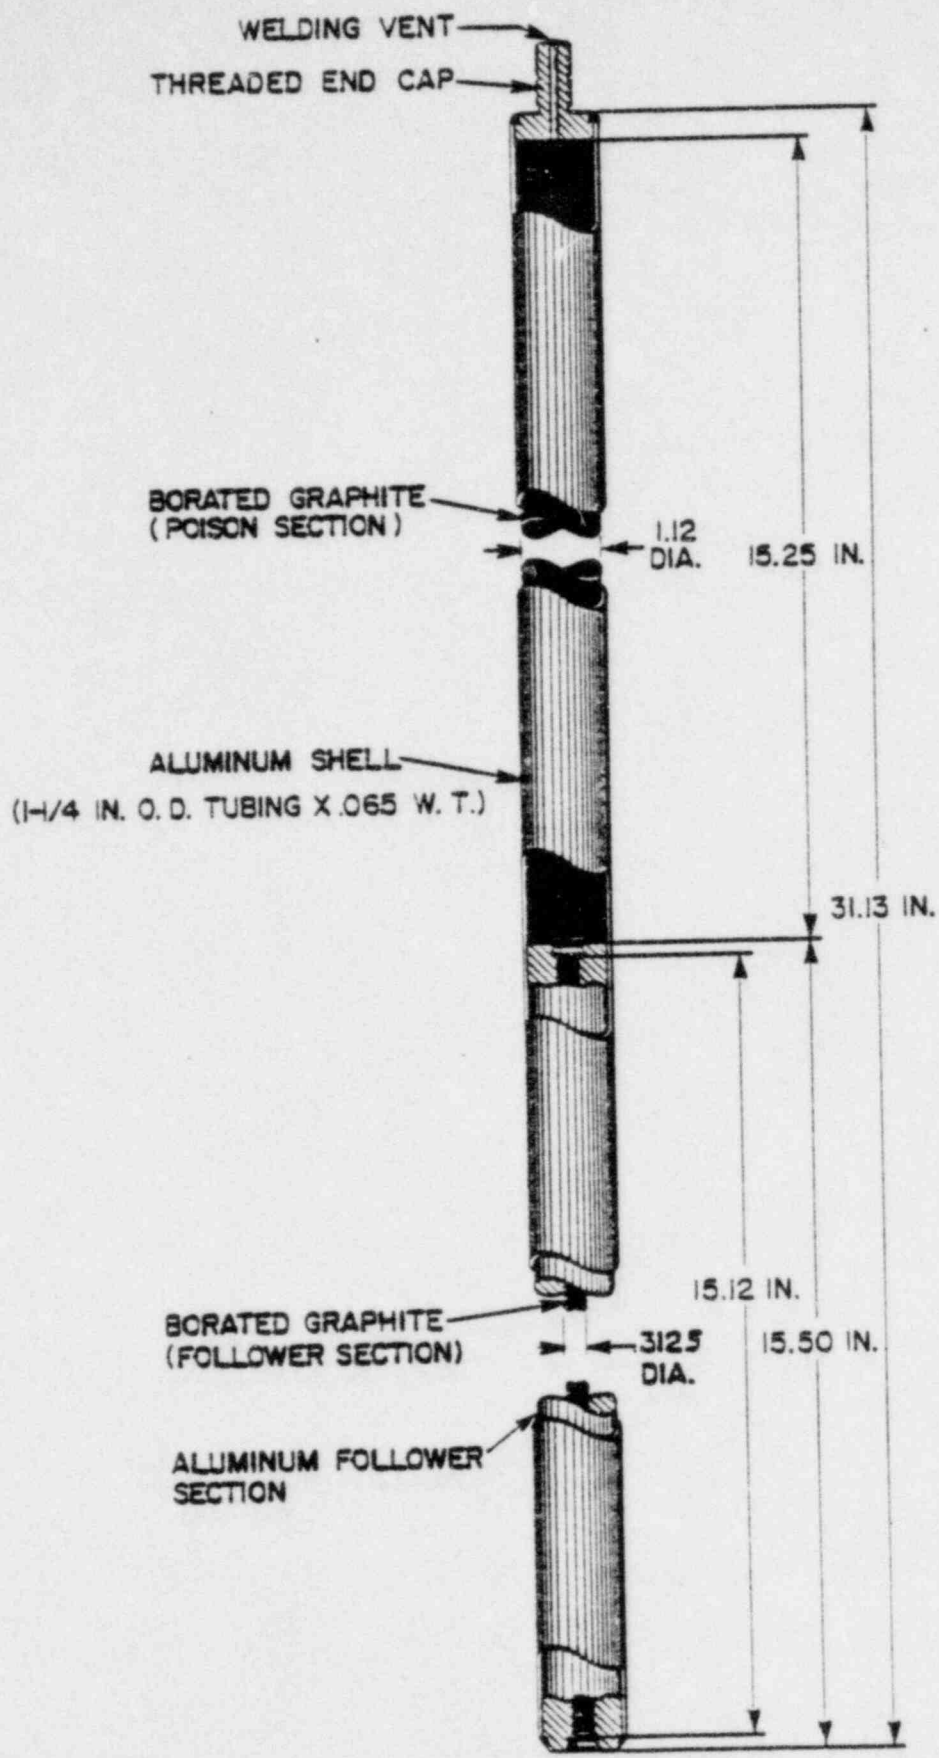
Transient Rod  
Figure 1

The only difference in a poison followed control rod and an aluminum followed control rod is the addition of a 5/16" diameter core of poison material in the core of the aluminum cylinder that comprises the lower section of the rod (see Figure 1).

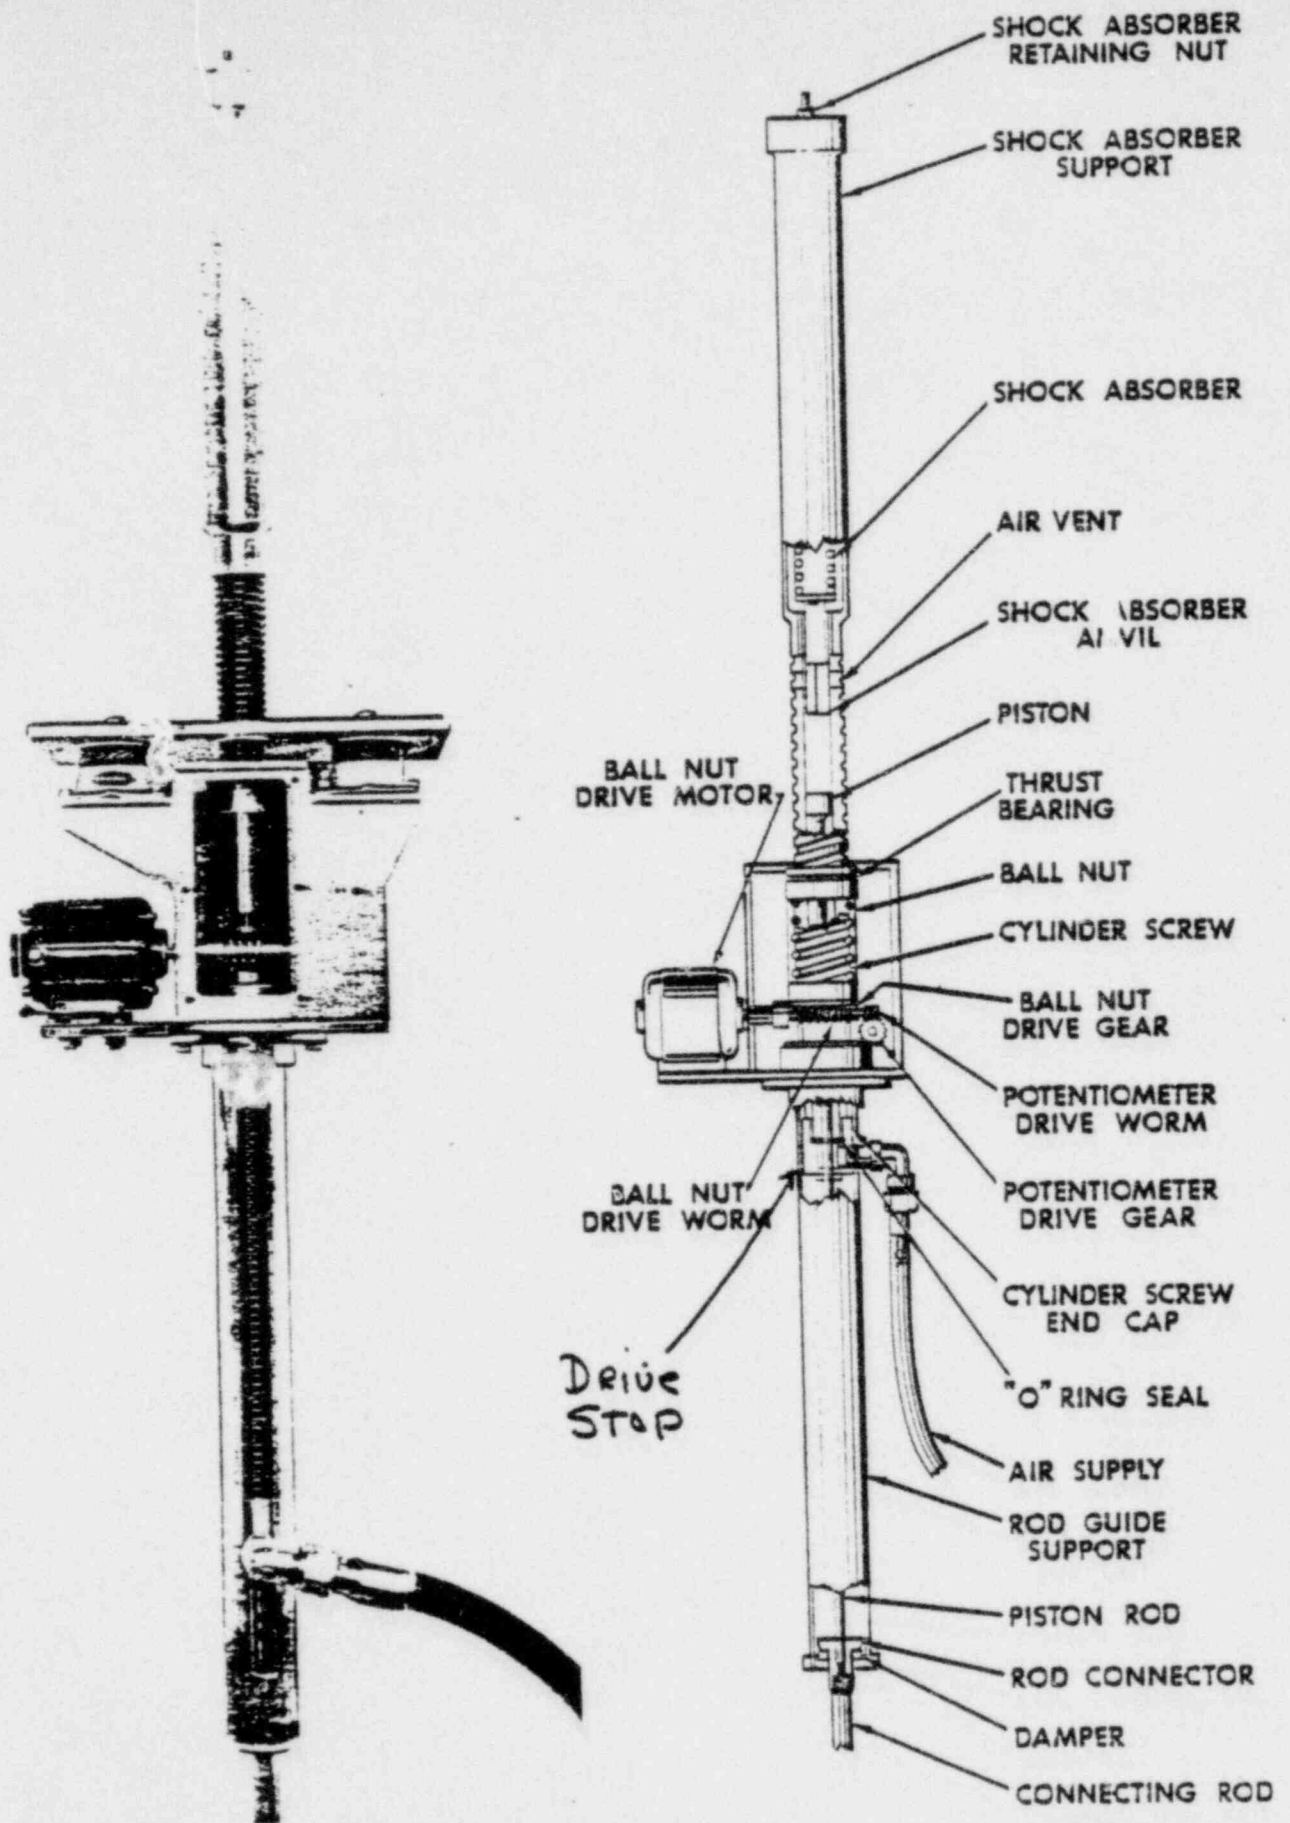
Transient Rod Drive Mechanism

The technical specifications contained in AFRRRI License R-84 states (Section II, part A-2) "The maximum step insertion of reactivity shall be \$3.28 (2.3% delta K/K) in the pulse mode." With a transient rod worth \$4.09, it would be possible for an operator to inadvertently insert reactivity above that in the specification. To prevent such an occurrence, a physical stop has been placed on the transient drive such that the limit of \$3.28 cannot be exceeded. This is accomplished by stopping the rod drive at approximately 11 inches of travel rather than the full 15 inches previously available (See Figure 2 for stop location).

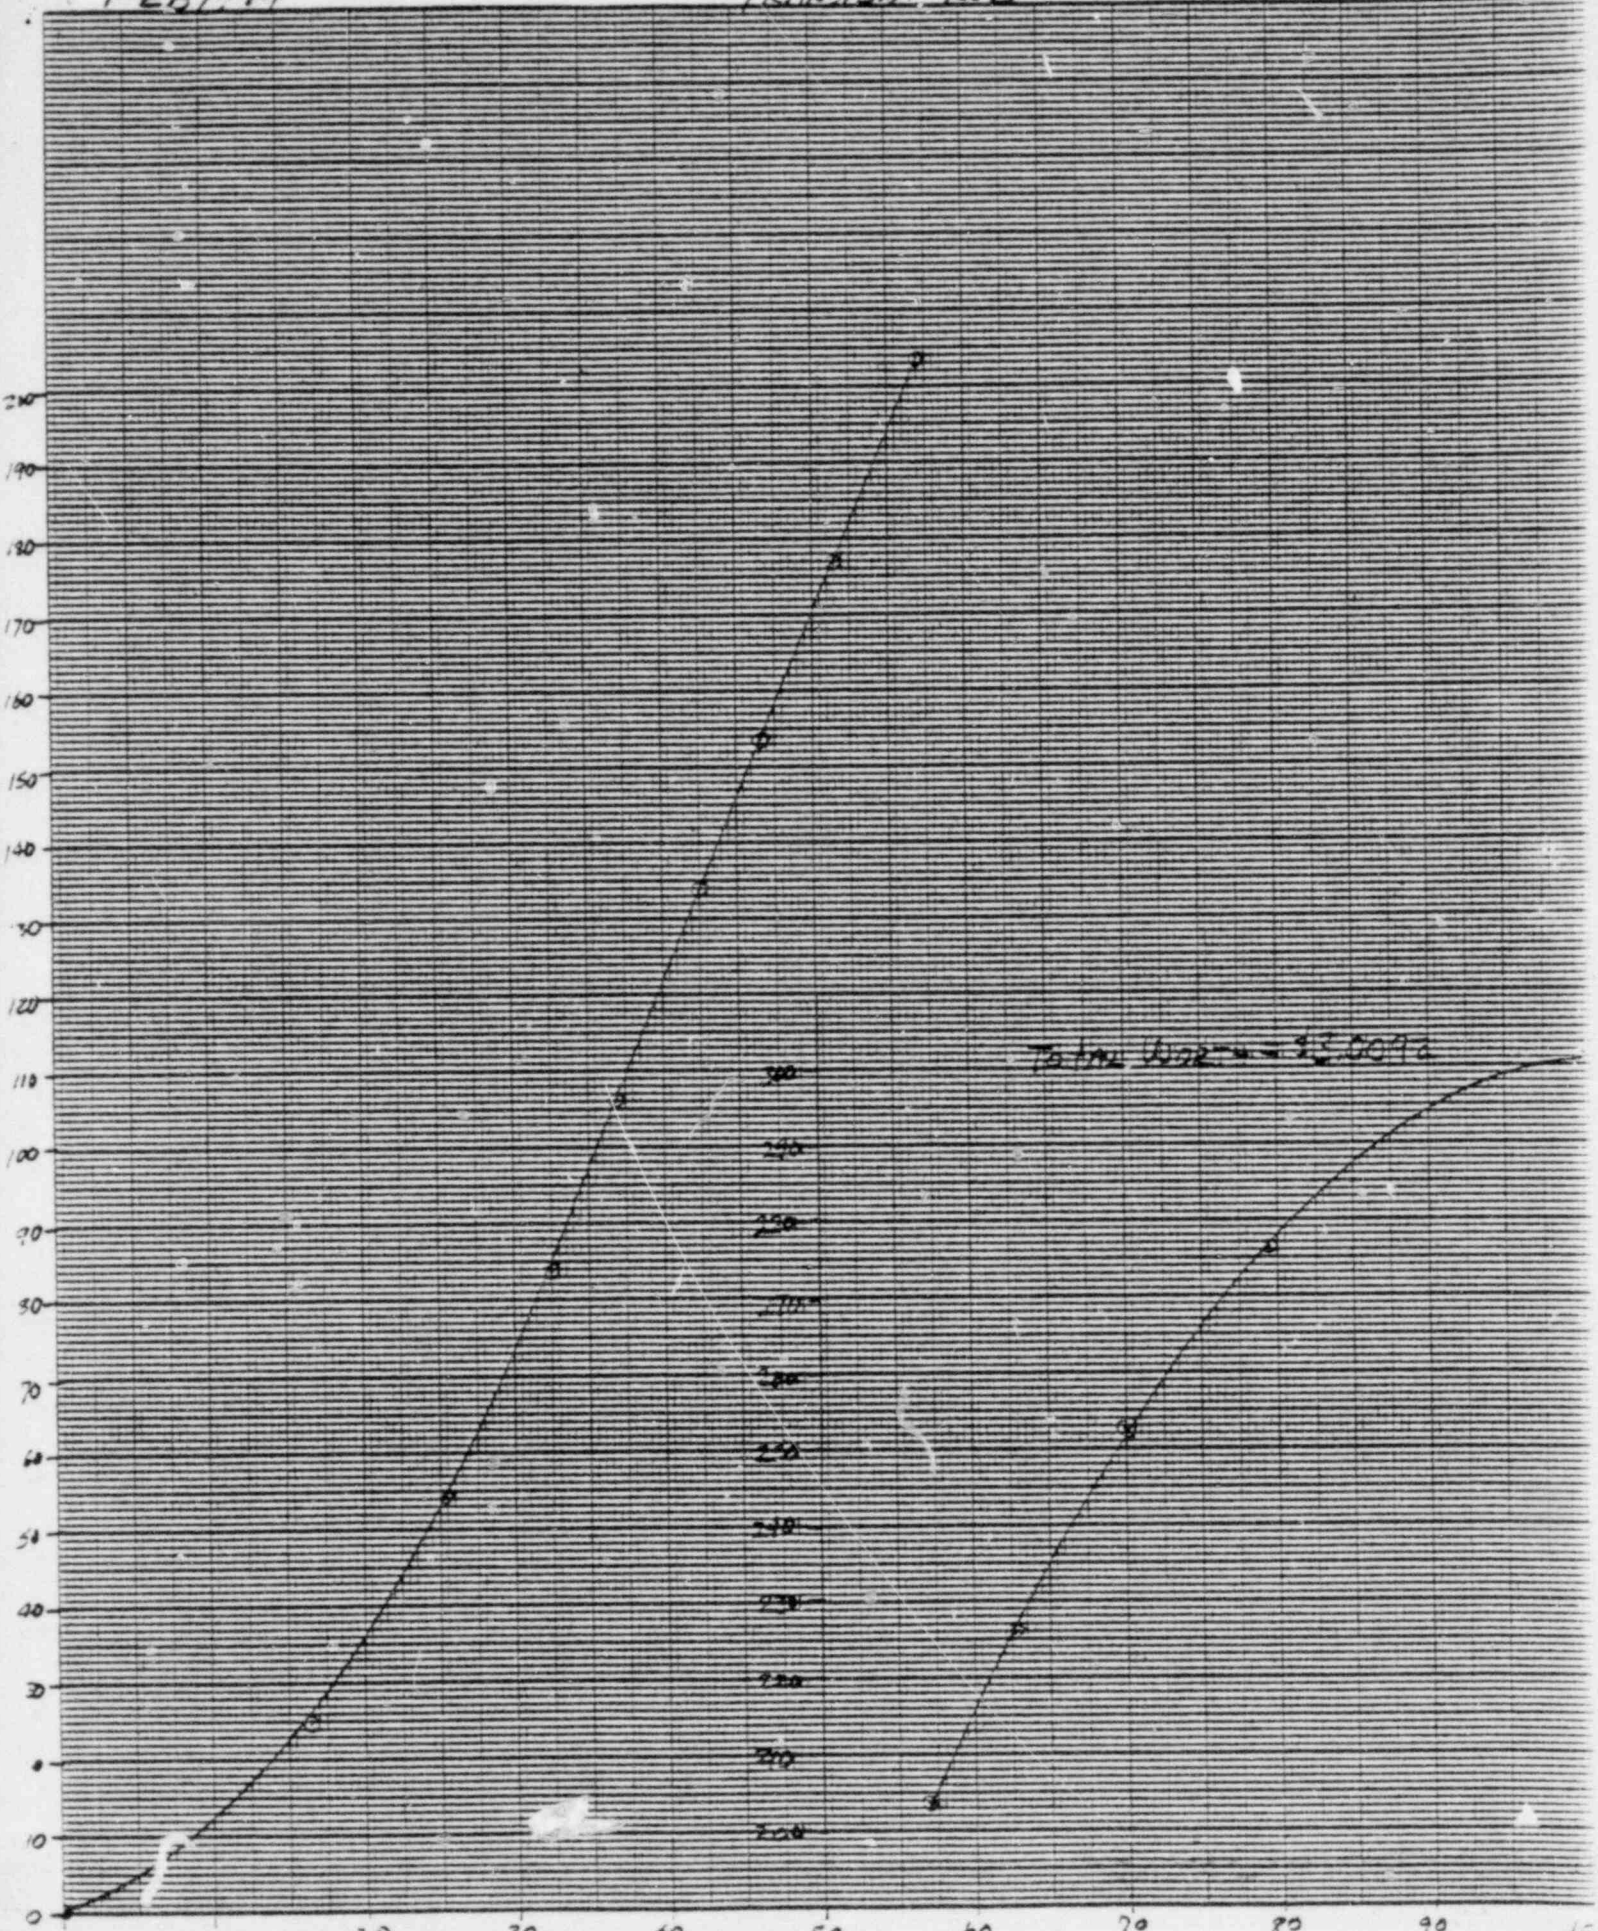
Total Worth = 33.0092

For a pulse of \$4.09 the maximum measured fuel temperature would be 578 degrees centigrade.
