REVIEW OF PROPOSED 5th DAM RAISE
UPPER TAILINGS POND EMBANKMENT SYSTEM
LISBON VALLEY OPERATIONS
RIO ALGOM CORPORATION

U.S. Nuclear Regulatory Commission
NMSS

John D. Nelson and Steven R. Abt
Geotechnical Engineering Program
Civil Engineering Department
Colorado State University
Fort Collins, Colorado 80523

October 1, 1980

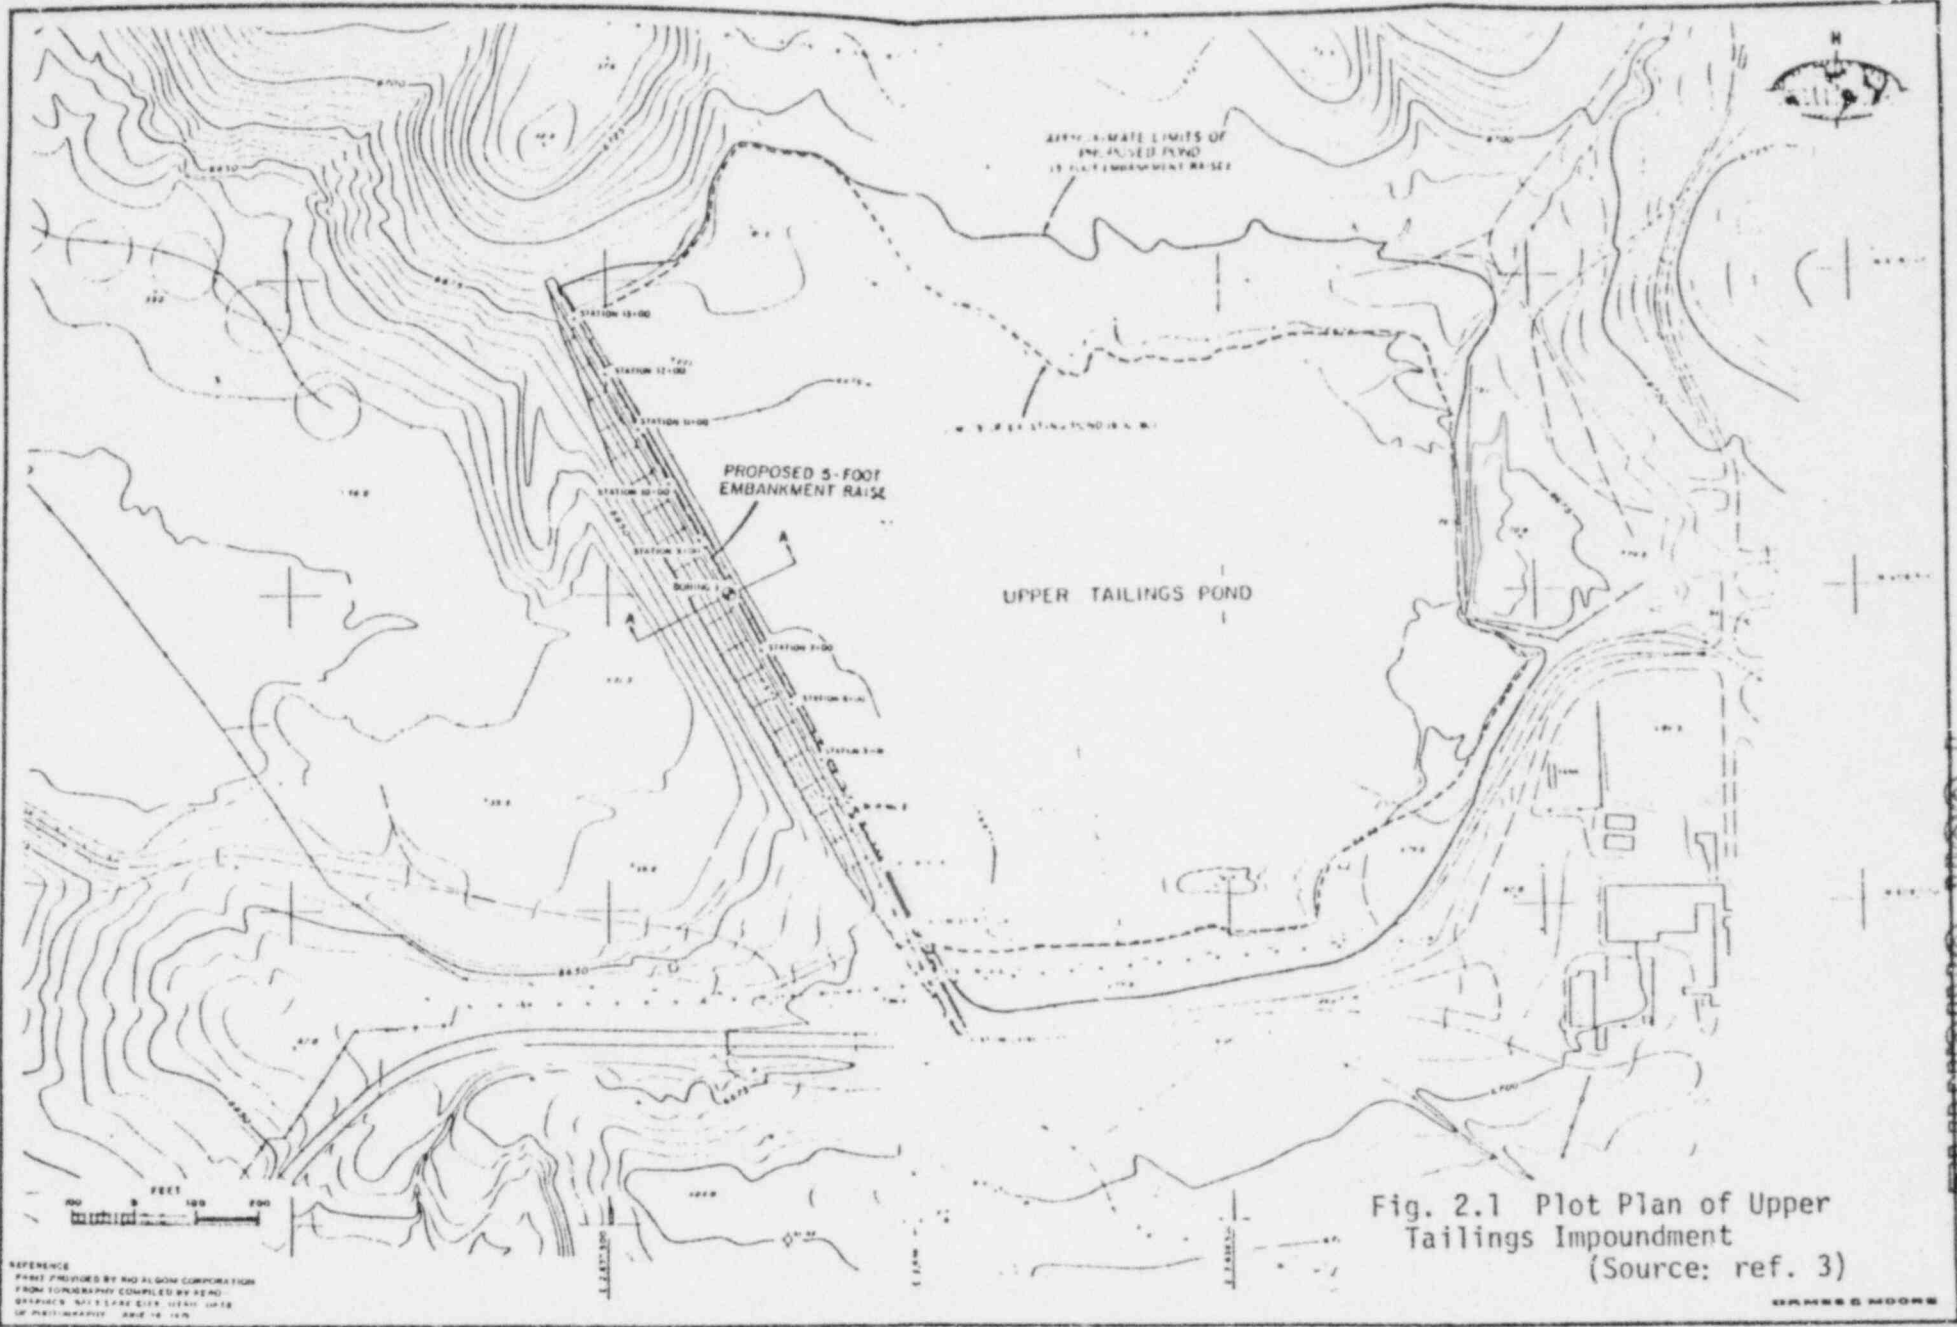
Fig. 2.1 Plot Plan of Upper Tailings Impoundment
(Source: ref. 3)

The existing embankment and soil properties are described in the report by Dames and Moore dated August 22, 1980 (ref. 3). Figure 2.1 shows a plan view of the existing embankment and the proposed five-foot embankment raise. Figure 2.2 shows the critical embankment section through the existing embankment and the proposed five-foot embankment raise.

Borings were advanced at locations 1 and 2 as shown in Figure 2.1.

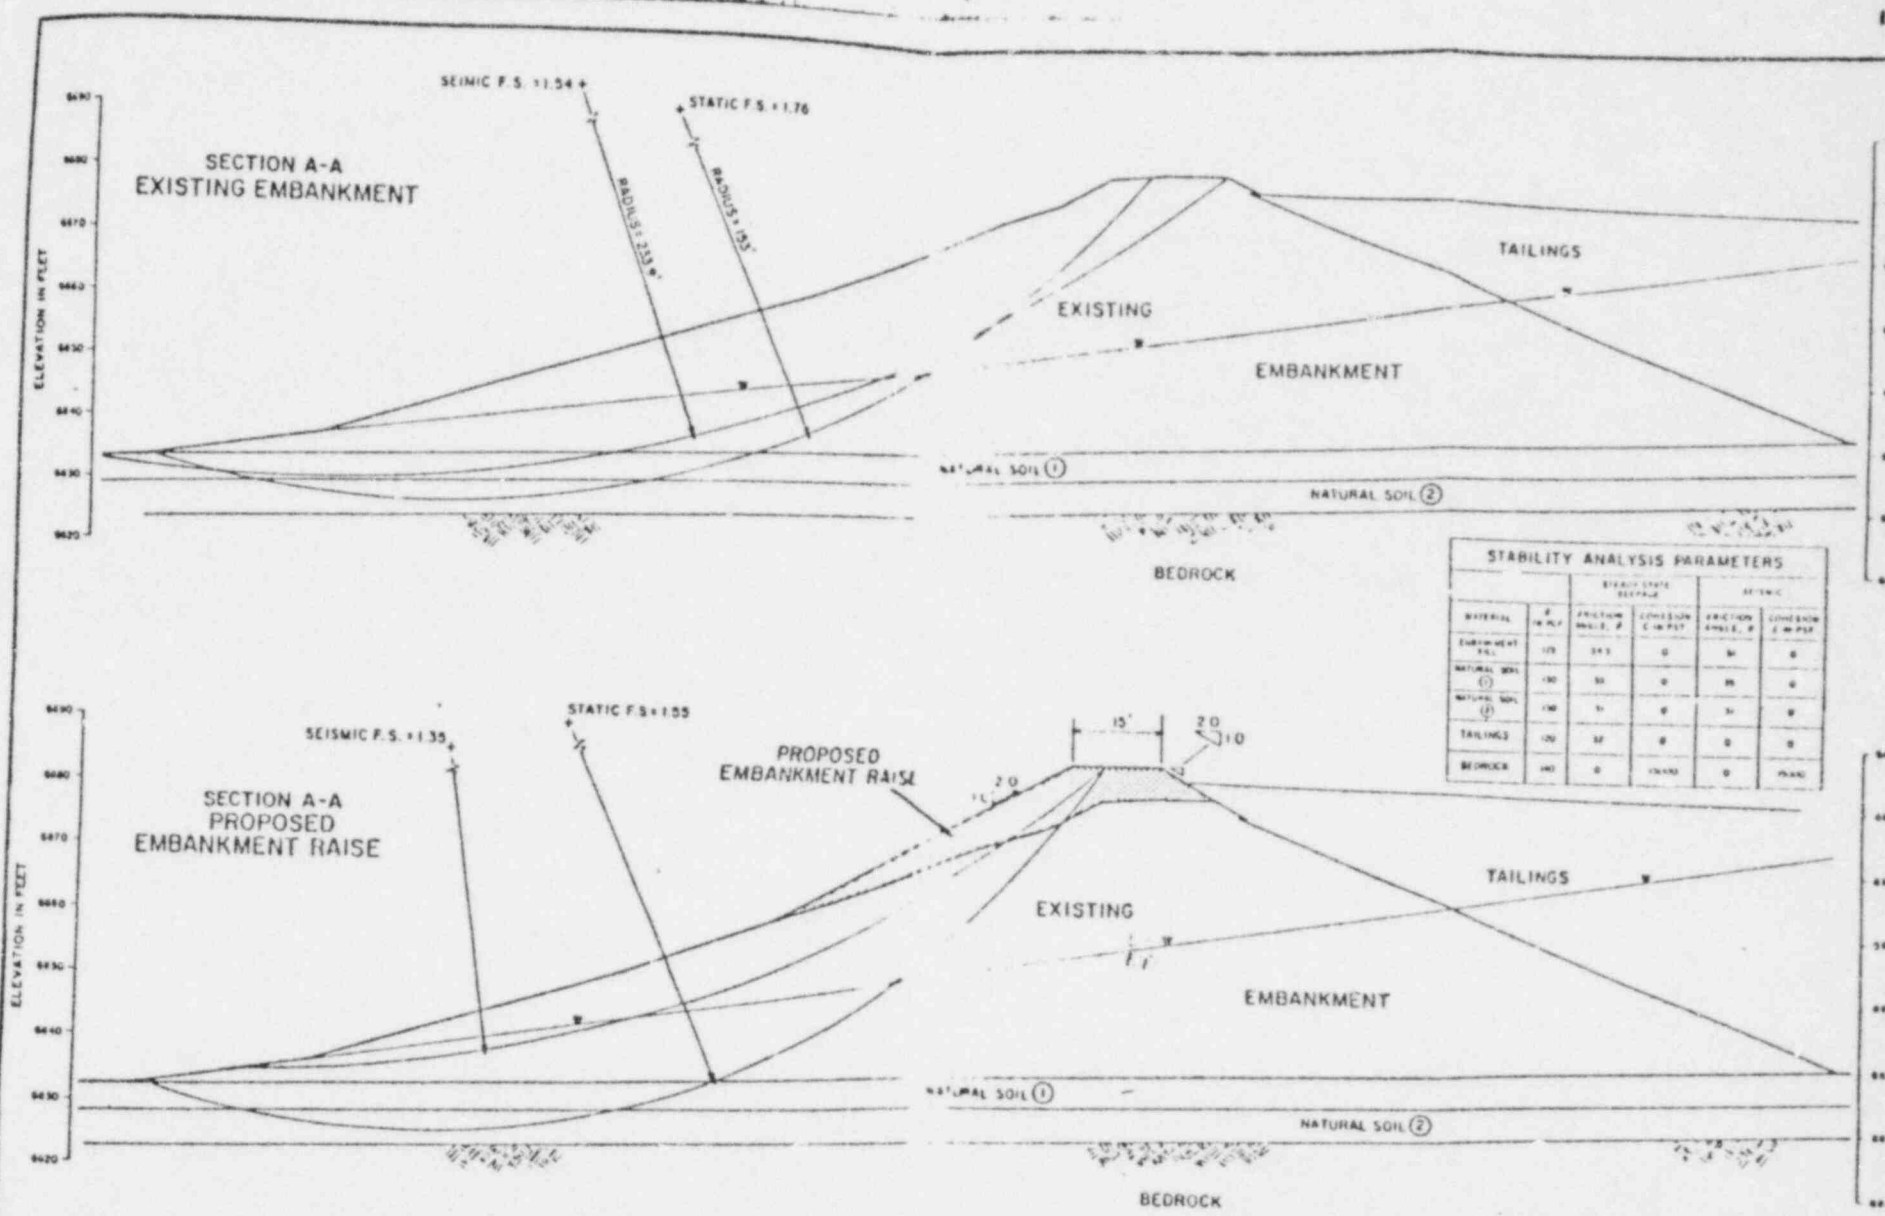
Fig. 2.2 Critical Embankment Section Analyzed (Source: ref. 3)

Stability analyses were conducted by Dames and Moore utilizing the shear strength parameters as shown in Fig. 2.2. The results indicated that the minimum factor of safety for static steady state seepage conditions would be 1.55. For seismic conditions, the minimum factor of safety would be 1.35. For static analyses, effective stress shear strength parameters were utilized whereas for seismic analyses total stress shear strength parameters were used.

Shear strength values for the natural foundation soils as shown in Figure 2.2 were not substantiated with laboratory data. Furthermore, laboratory test data presented in the Dames and Moore report dated October 2, 1973 (ref. 1) indicate that shear strength values considerably lower than those that were assumed for the stability analyses may exist in the foundation soils. The reviewers, therefore, conclude that inadequate shear strength data for the natural foundation soil has been presented.

The boring logs that were presented in reference 3 indicated that bedrock had not been encountered in the borings. A subsequent letter from James R. Boddy of Dames and Moore dated September 11, 1980 to Rio Algom (ref. 5) indicates that bedrock was, in fact, encountered. Furthermore, in reference 3 the critical embankment section (as shown in Figure 2.2 of this report) indicates two strata of natural soils. The basis for representing the natural soil in two distinct strata with different shear strengths is not presented and the boring logs do not indicate any basis for doing so. Also, on page 7 of reference 3 it is stated that a cutoff barrier was extended to competent bedrock. This cutoff barrier is not indicated in the critical embankment for stability analyses. It is concluded, therefore, that the critical embankment section as shown in reference 3 (Figure 2.2 of this report) does not represent the actual existing conditions with regard to geometry and shear strength of the foundation soils.

The phreatic surface within the embankment that was assumed for purposes of stability analyses is shown in Figure 2.2. However, the boring logs indicate that to the entire depth of soil overlying the bedrock, no groundwater was encountered. Furthermore, piezometers placed at depths of 31.5 feet in boring 1 and 28.5 feet in boring 2 indicated no water at the time reference 3 was prepared. The two piezometers, however, were located near the top of the location of the phreatic surface as shown in Figure 2.2. Consequently, they are not capable of locating a phreatic surface even slightly lower than that. It

Stability analyses were conducted by Dames and Moore utilizing their in-house computer program. The critical failure surfaces that were determined are shown in Figure 2.2 of this report. The static factor of safety of 1.55 and the seismic factor of safety of 1.35 were indicated.

The factors of safety that were computed appear to be adequate. Although the Bishop's method of analysis indicated a factor of safety slightly lower than 1.5 the assumed phreatic surface is believed to be higher than what actually exists, and therefore, would generate factors of safety lower than what actually exists. Some question, however, exists as to the adequacy with which the conditions that were analyzed represent the actual conditions.

4.3 Page 7 of reference 3 indicates that a cutoff trench was excavated and recompacted beneath the embankment. However, the critical embankment section that was analyzed and is reproduced as Figure 2.2 in this report does not indicate that cutoff wall. The effect of that cutoff on the stability analyses should be discussed. Plate 4 in reference 3 (reproduced as Figure 2.2 herein) should be revised to indicate that such a cutoff does exist if it does, or else the text should be revised. Because the inspection report as presented in Appendix B of reference 3 indicates that a cutoff trench was excavated, the reviewers believe that Plate 4 (ref. 3) is incorrect and that the stability analyses should be revised.

4.4 The boring logs and the piezometers indicate that the phreatic surface shown in Plate 4 of ref. 3 (see Fig. 2.2) is incorrect. It is not uncommon for the phreatic surface within an embankment to be lowered by a highly permeable natural foundation soil or through highly permeable bedrock. It was indicated in reference 3 that the upper layers of the sandstone bedrock are weathered and it is possible that the seepage is occurring therein. However, it is also possible that seepage could be occurring through a layer in the natural foundation soils causing a zone of high water content with low strength. It is recommended that adequate sampling in the natural foundation soils should be accomplished to show that such a zone of high moisture content does not exist that

4.2 The basis on which the shear strength of the natural soils was assumed was not presented. The applicant should show by means of laboratory data or field tests that the assumed values of shear strength are in fact accurate. If this can not be demonstrated, revised slope stability analyses should be conducted.

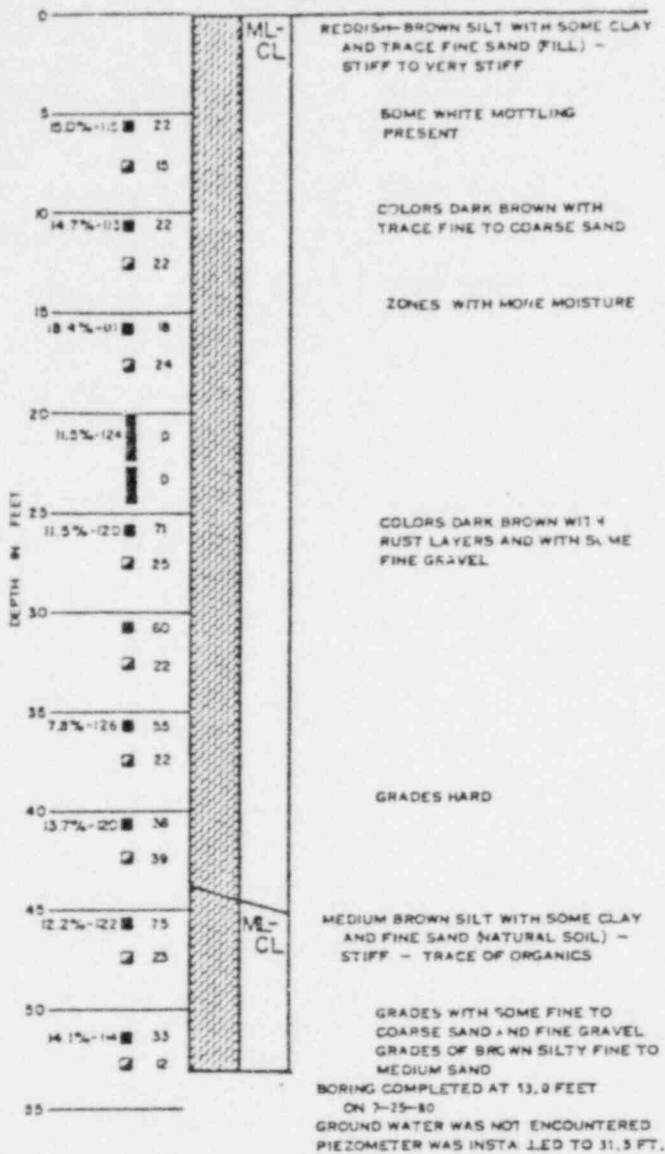
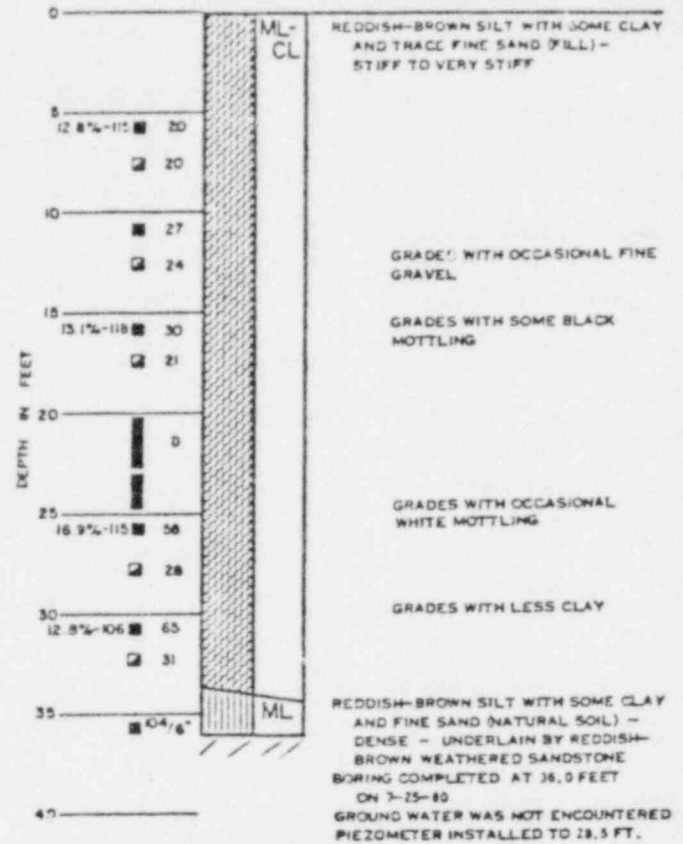
Fig. 2.3 Boring Logs
(Source: ref. 3)

The logs of those borings as presented by Dames and Moore are shown in Figure 2.3. Samples were taken from depths of 22.5 feet in each boring for laboratory testing and determination of shear strength. Multiple stage triaxial tests were performed on each of those samples. Stress paths and strength envelopes as presented by Dames and Moore (ref. 3) are shown in Figures 2.4 and 2.5. The triaxial tests indicated that for the embankment soil, the angle of internal friction was 34.5° and 38.5° in terms of effective stresses, and 31.0° and 40.0° in terms of total stresses. For one test, a cohesion of 800 psf was indicated whereas for all others the cohesion was zero.

4.1 It is recommended that a revised Appendix A to reference 3 be submitted. This Appendix should include corrected boring logs indicating any variations between the two strata of foundation soils. They should also indicate the depth to bedrock. In addition, this Appendix should include water content and dry density data for the second triaxial test sample.

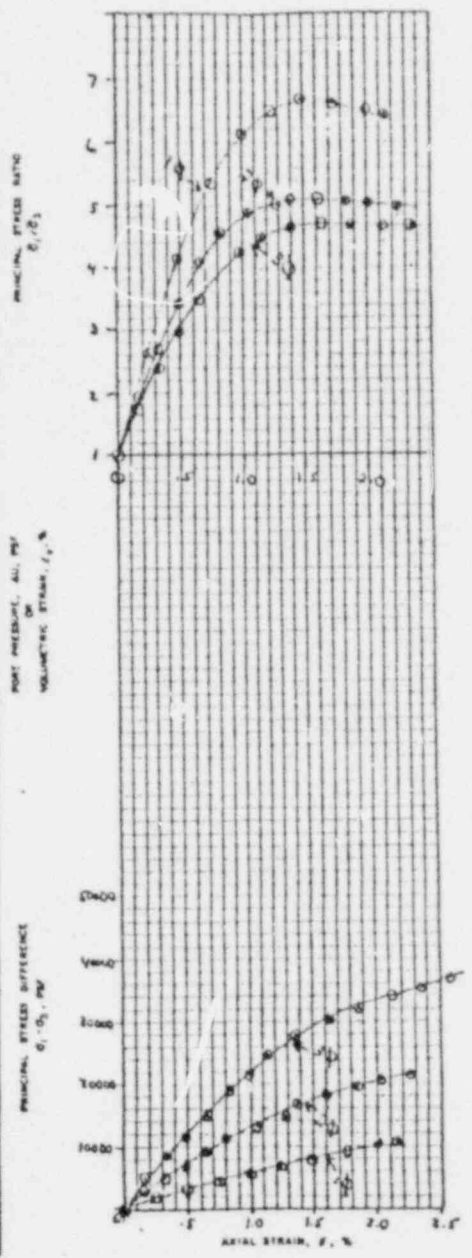
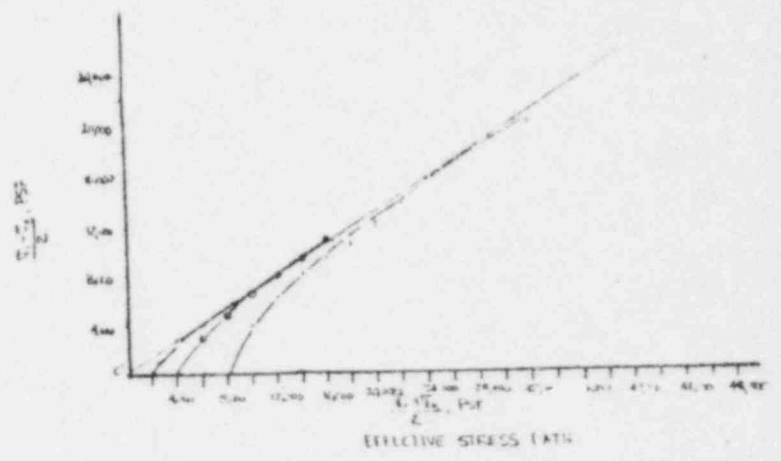
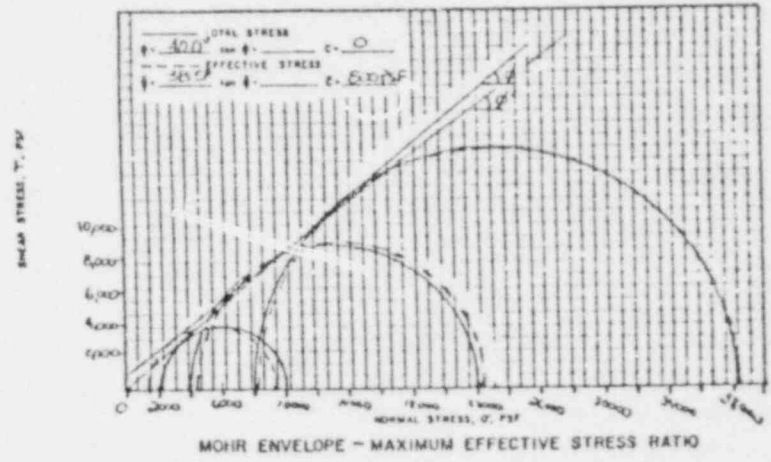
Fig. 2.4 Triaxial Test Results (Source: ref. 3)

Multiple stage triaxial tests were performed on two samples taken from the embankment. The test results indicated reasonable magnitude of shear strengths in terms of effective stresses. The shear strength parameters in terms of total stress, do not differ greatly from those for effective stresses. This is due to the development of low negative pore water pressures. This is reflected in the shapes of the stress paths and indicate the overconsolidated nature of the compacted embankment material. It is believed, therefore, that the total stress shear strength parameters that are reported, adequately describe the shear strength of the embankment.
