PACIFIC GAS AND ELECTRIC COMPANY

Re: Docket No. 50-133

On November 27, 1974 the Company submitted Abnormal Occurrence Report No. DPR-7/74-4 covering the failure of some of the reactor feedwater sparger hold-down U-bolts. At the time of the report, two broken U-bolts were undergoing laboratory examination and the feedwater sparger repairs were in progress. The purpose of this report is to describe the U-bolt failure mechanism determined from this examination and the corrective feedwater sparger repairs.

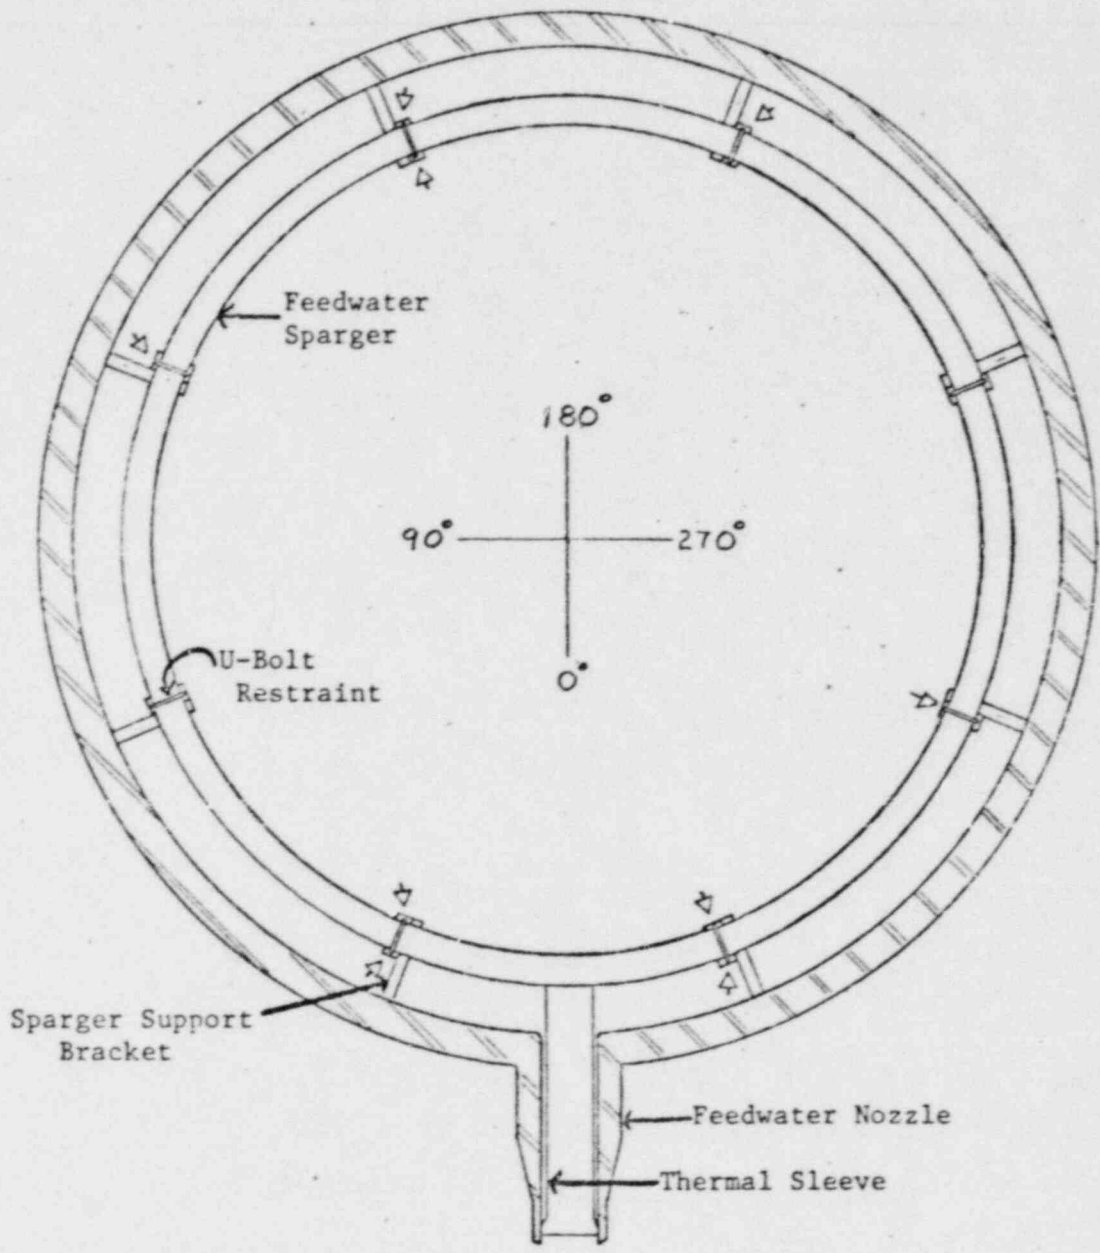
Figure No. 1 - Feedwater Sparger Plan  
 View Showing Location of Failed U-Bolts  
 (Illustrative Only)  
 PACIFIC GAS AND ELECTRIC COMPANY  
 SAN FRANCISCO, CALIFORNIA

On November 17, 1974, while the reactor was shut down for a regularly scheduled refueling outage, it was noted that the sparger had moved 1½ to 2 inches away from the nozzle and that some of the U-bolts were broken. A close examination showed that six of the U-bolts had broken through on one or both legs (refer to Figure No. 1). The bolts from the 22° and 157° positions, considering the feedwater nozzle as the 0° position, were sent to the Vallecitos Nuclear Center for metallographic examination to identify the failure mechanism. These bolts were broken through on both legs just above the nut on the top of the support bracket.

Examination procedures consisted of visual, visible dye penetrant, scanning electron microscopy, metallography and hardness. The examination showed that the U-bolt failure was caused by high cycle fatigue. The basis for this conclusion is as follows:

It is postulated that the U-bolts vibrated in resonance with input from a source such as the feedwater pump or recirculation flow. It is further postulated that the sparger itself was not vibrating or that the vibration amplitude was very low. This is based on the following findings:

Arrow (↗) indicates broken U-Bolt

Corrective repairs were performed under water using specially designed tools. All of the U-bolts and associated nuts were removed from the sparger support brackets. There are no lost or unaccounted for parts in the reactor vessel. The basic tools used in this phase of the repair were a commercial hydraulic bolt cutter and nut cracker modified by the plant staff for this particular application.

The sparger was then recentered using a commercial hydraulic jack with special fixtures built at the plant so that the sparger could be jacked against two of the sparger support brackets. The force required to move the sparger back in place was calculated to be less than 2000 pounds.
