Attachment to LER-79-018-01T-0
Consumers Power Co
Big Rock Point Plant
Docket 50-155

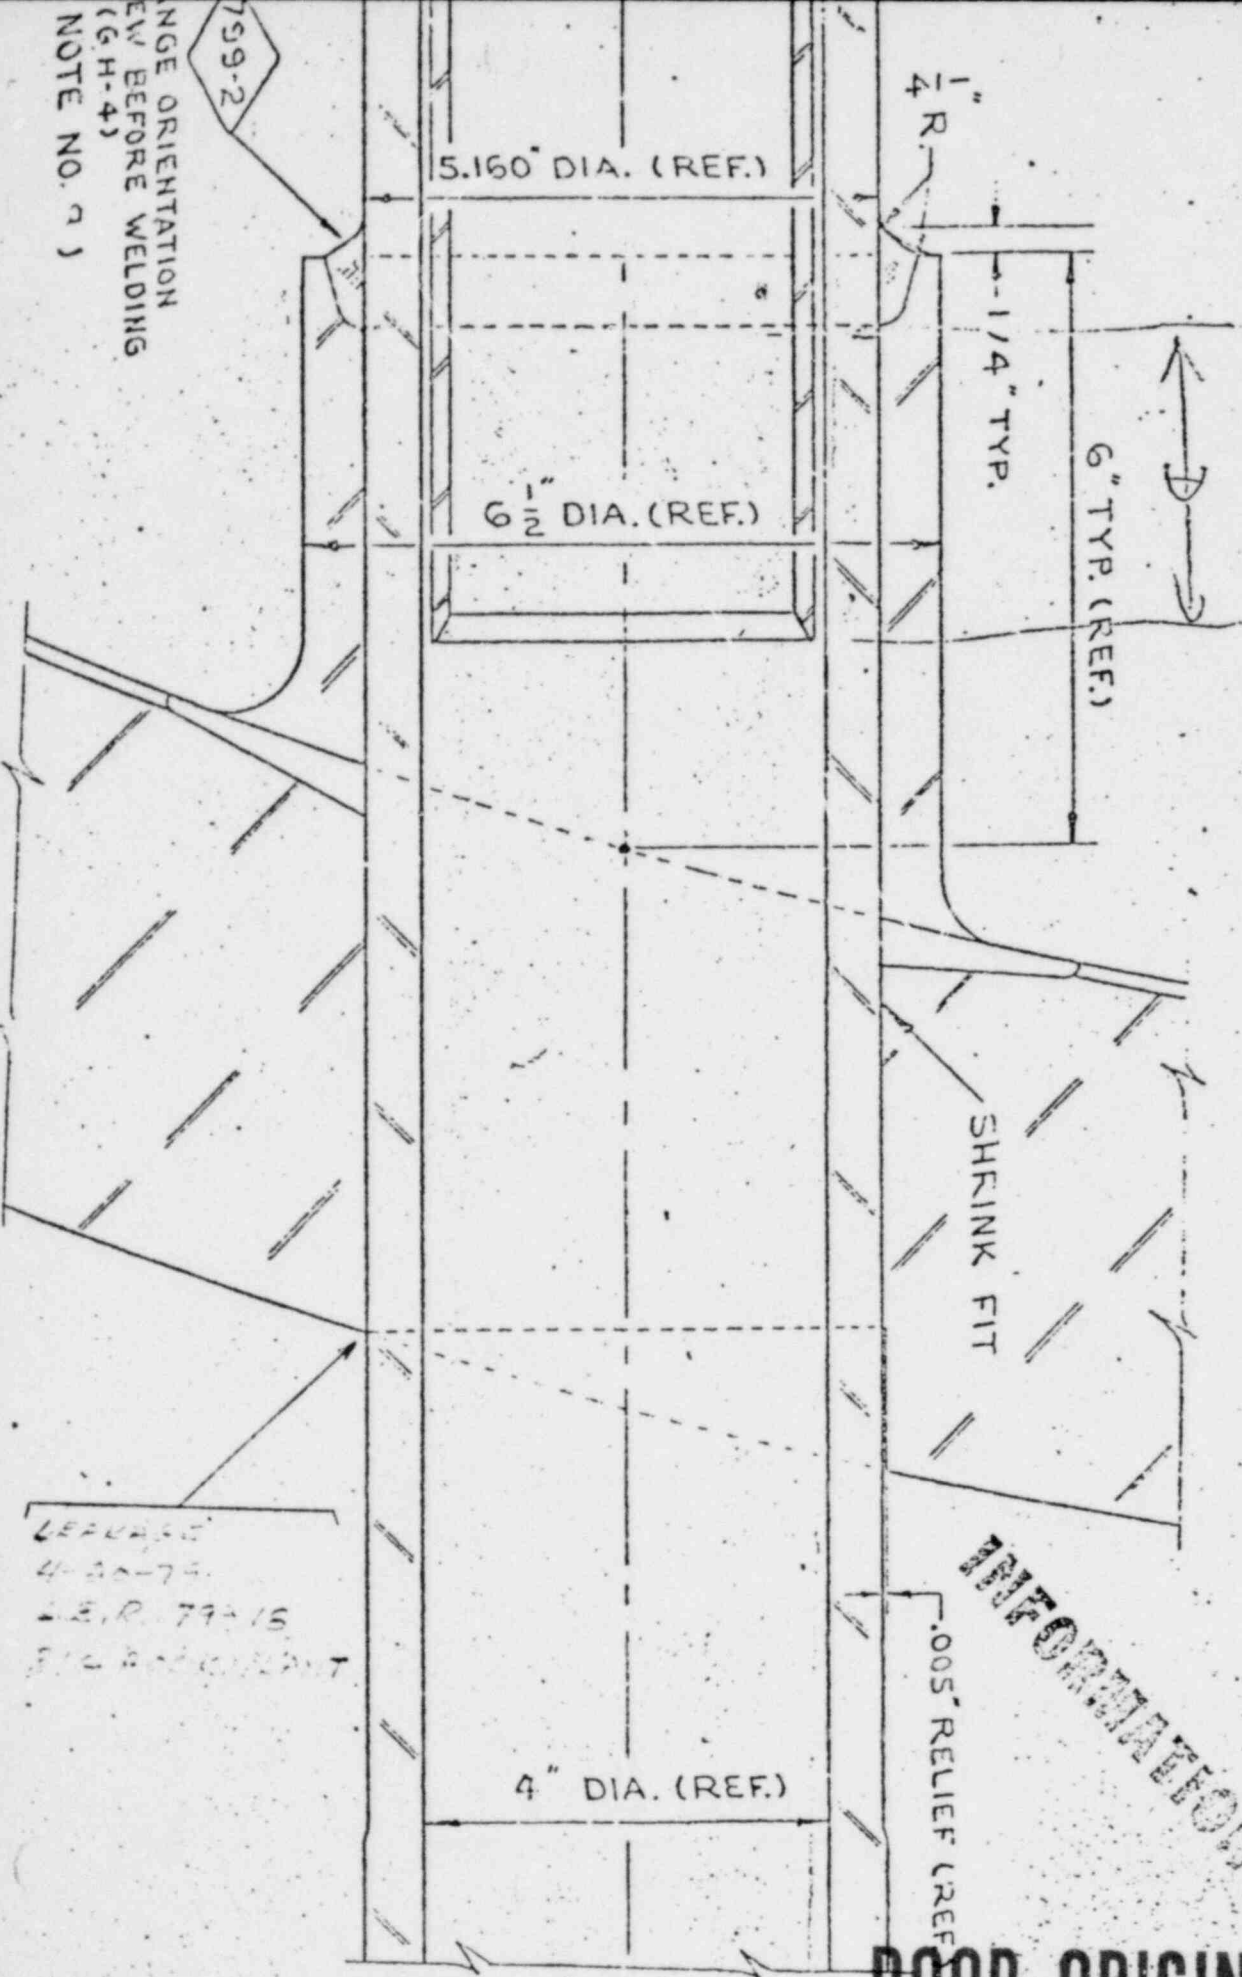
STEP 1 WELDING

Following replacement of "o ring" seals on four control rod drive flanges, an inspection with primary system pressure at 900 psig and the reactor subcritical revealed water on the outside of the drive housing at F-2 at 0406 hours on 4-20-79. Since this could not positively be attributed to condensation, reactor vessel thermal insulation was removed and water was observed to be coming from the shrink fit interface between the reactor vessel and the F-2 drive housing with the primary system pressure at 500 psig at 1500 hours on 4-20-79. The leak rate average over a four hour period at about 900 psig was 8.7 milliliters per minute. When reactor pressure was reduced to atmospheric conditions, the leakage stopped.
