SEOUOYAH NUCLEAR PLANT
ERCW CONDUIT SETTLEMENT MONITORING

Updated Results - December 1980

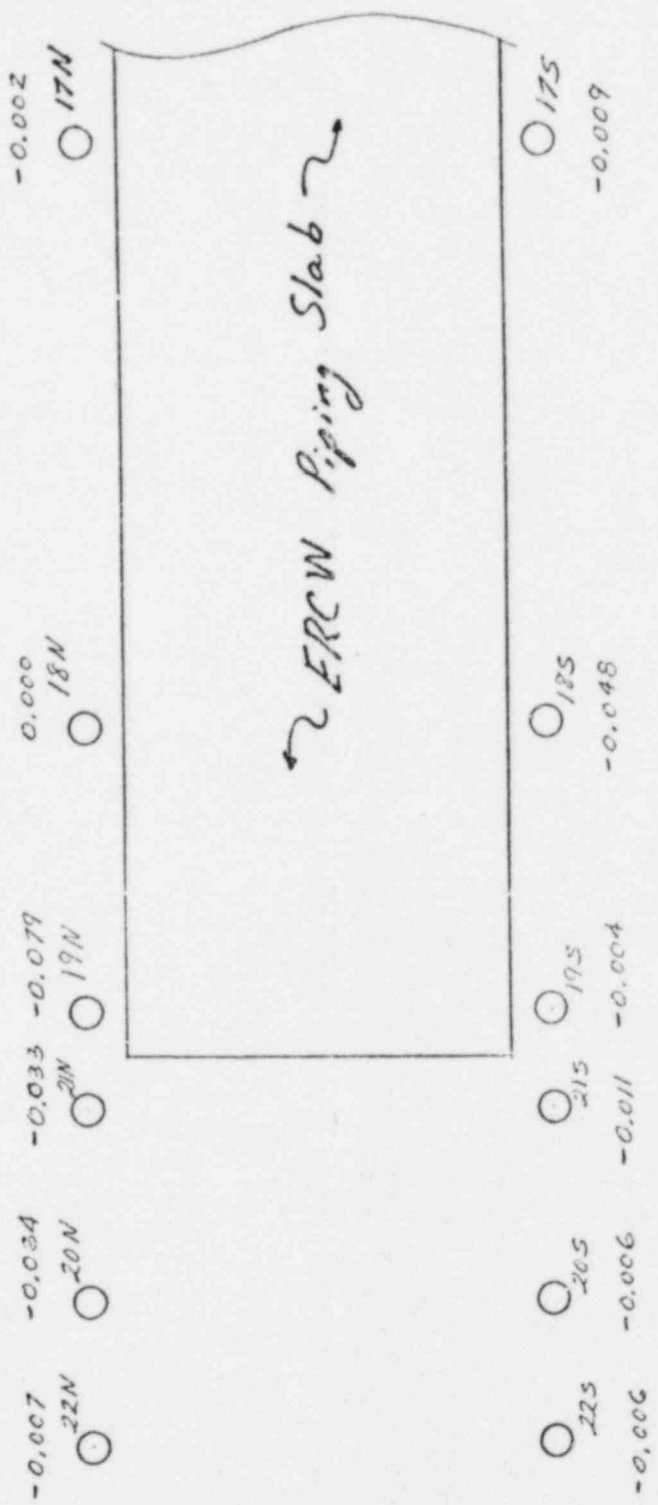
Figure Q2.86-6

As discussed in our response to Q2.86, several settlement markers were hit during construction. This is documented in the survey notes. The surveyors reported markers as either "monument hit" or "monument possibly hit." These data are included in Table Q2.86-1. During the site visit October 27, 1980, the NRC representative, Raman Pichumani, viewed these markers. The distress to the markers, which are just rebars in a pipe sleeve, was visually very apparent. The procedure used to correct the actual survey data to account for marker disturbance is thus justified.

The apparent movement of the disturbed markers is not logically explained as just consolidation settlement. For example, the markers were reported as hit on the December 19, 1979, survey. No settlement trend existed based on the previous data. Variations are only a few thousandths of a foot on monthly reading for four months. In fact some of the readings show an upward not downward movement (19N & 20N). The markers were reported hit with the December 19, 1979, reading. "Movements" of up to - 0.079 feet (down) are reported. However, movement from December 19, 1979, to present show no settlement trend. Variations are again a few thousandths on monthly readings for four months. Such a sudden jump in settlement with no pre- or post- activity is not logically explained by any consolidation theory.

Also, the reported "movements" are not logical when viewed in plan. Markers are present on each side of the road (road width is 20 feet, approximate marker separation is 25 feet) and at 30-foot intervals along the road. Figure Q2.84-6 shows an enlargement of the area between markers 17 and 22, the area of interest. The data shown are for the December 19, 1979, the reported hit date. The largest "movement" is reported for #19N (-0.079 ft.). However, #18N (30 feet east) reports 0.0 ft., #19S (25 feet south) reports -0.004 feet, #20N (30 feet west) reports -0.034 (also reported as hit), and #21N (10 feet west) reports -0.033 (also reported as hit). The second largest "movement" is reported for #18S (-0.048 feet). Adjacent markers #17S (30 feet east) reports -0.009 feet, #19S (30 feet west) reports -0.004 feet, #18N (25 feet north) reports 0.0 feet. In addition, the road and curbing show no signs of distress in the vicinity of these markers. Such local pockets of settlement might be explained by consolidation. However, consolidation cannot explain that they appear in one month with no pre- or post- activity and cannot explain the lack of impact on the road.

Enlargement of Area 17-22
 Showing "Movement" of Markers
 on Hit Date of 12-19-79
