LICENSEE EVENT REPORT

ATTACHMENT TO LICENSEE EVENT REPORT NO. 81-002/01L-0

Wisconsin Electric Power Company
Point Beach Nuclear Plant Unit 2
Docket No. 50-301

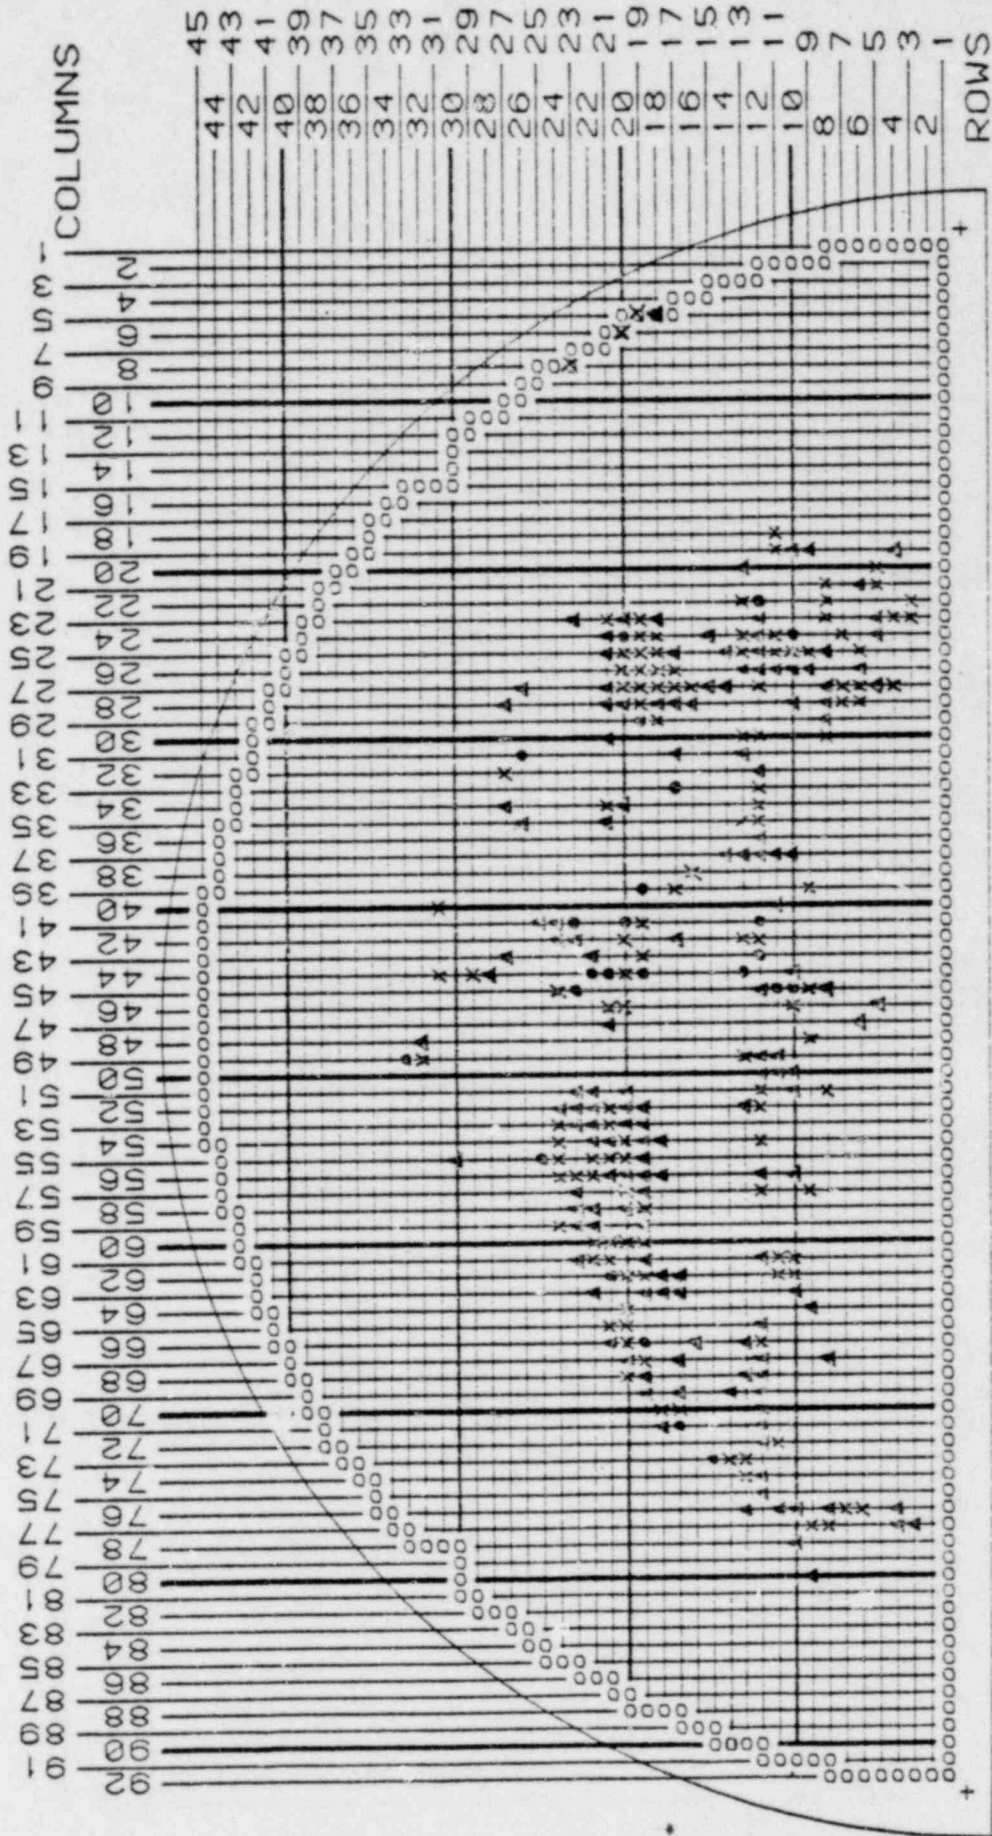
FIGURE 1

The initial eddy current inspection programs for the "A" and "B" steam generators consisted of inspection through the U-bend of 1% of the tubes in each steam generator plus all previously degraded tubes, in accordance with Technical Specification requirements. Additionally, the "A" steam generator program included a full length inspection for a previous indication in the cold leg and inspections through the U-bend of about 190 tubes in connection with tube degradation at contact with anti-vibration bars (AVB) reported by other plants. The program for the "B" steam generator inlet included inspecting 33 previously degraded tubes through the U-bend and 172 randomly located tubes to meet Technical Specification requirements and for AVB tube degradation. The program for the "B" steam generator outlet consisted of inspection through the first support plate of all previously degraded tubes, inspection through the first support plate of about 200 tubes in problem areas determined by previous inspections, and inspection through the third support plate of about 170 tubes around the periphery, in connection with tube degradation in these areas reported at Prairie Island. The programs in the inlets of both steam generators were later expanded in accordance with Technical Specifications resulting in inspection of essentially all tubes in the "A" steam generator through the first support plate and approximately 75% of the tubes in the "B" steam generator through the first support. A summary of the extent of the inspection and the results are given in Table 1. A summary of eddy current indications by size and location is given in Table 2 and illustrated in Figures 1, 2, and 3.

SERIES 44
UNIT 2
'A' INLET

← --- MANWAY EDDY CURRENT INDICATIONS - REFUELING 7, APRIL, 1981 NOZZLE --- →

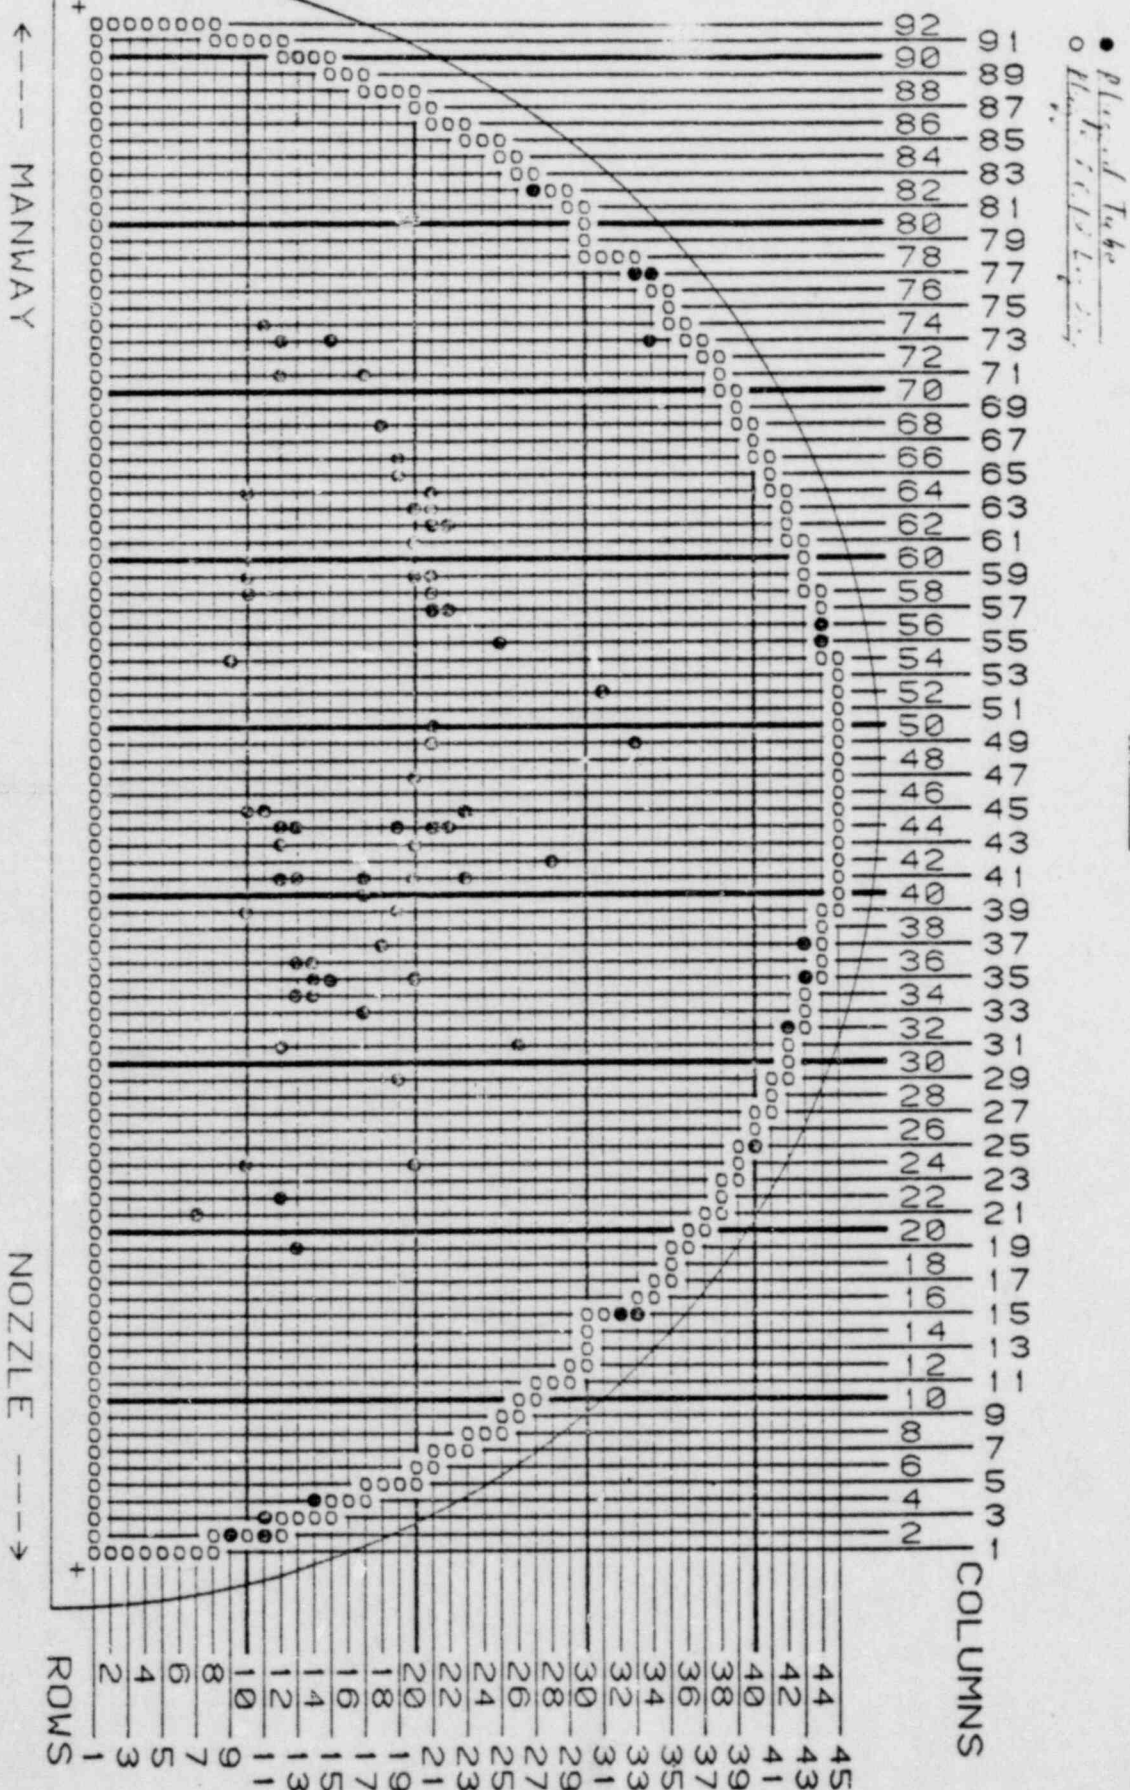
FIGURE 4

"A" Steam Generator

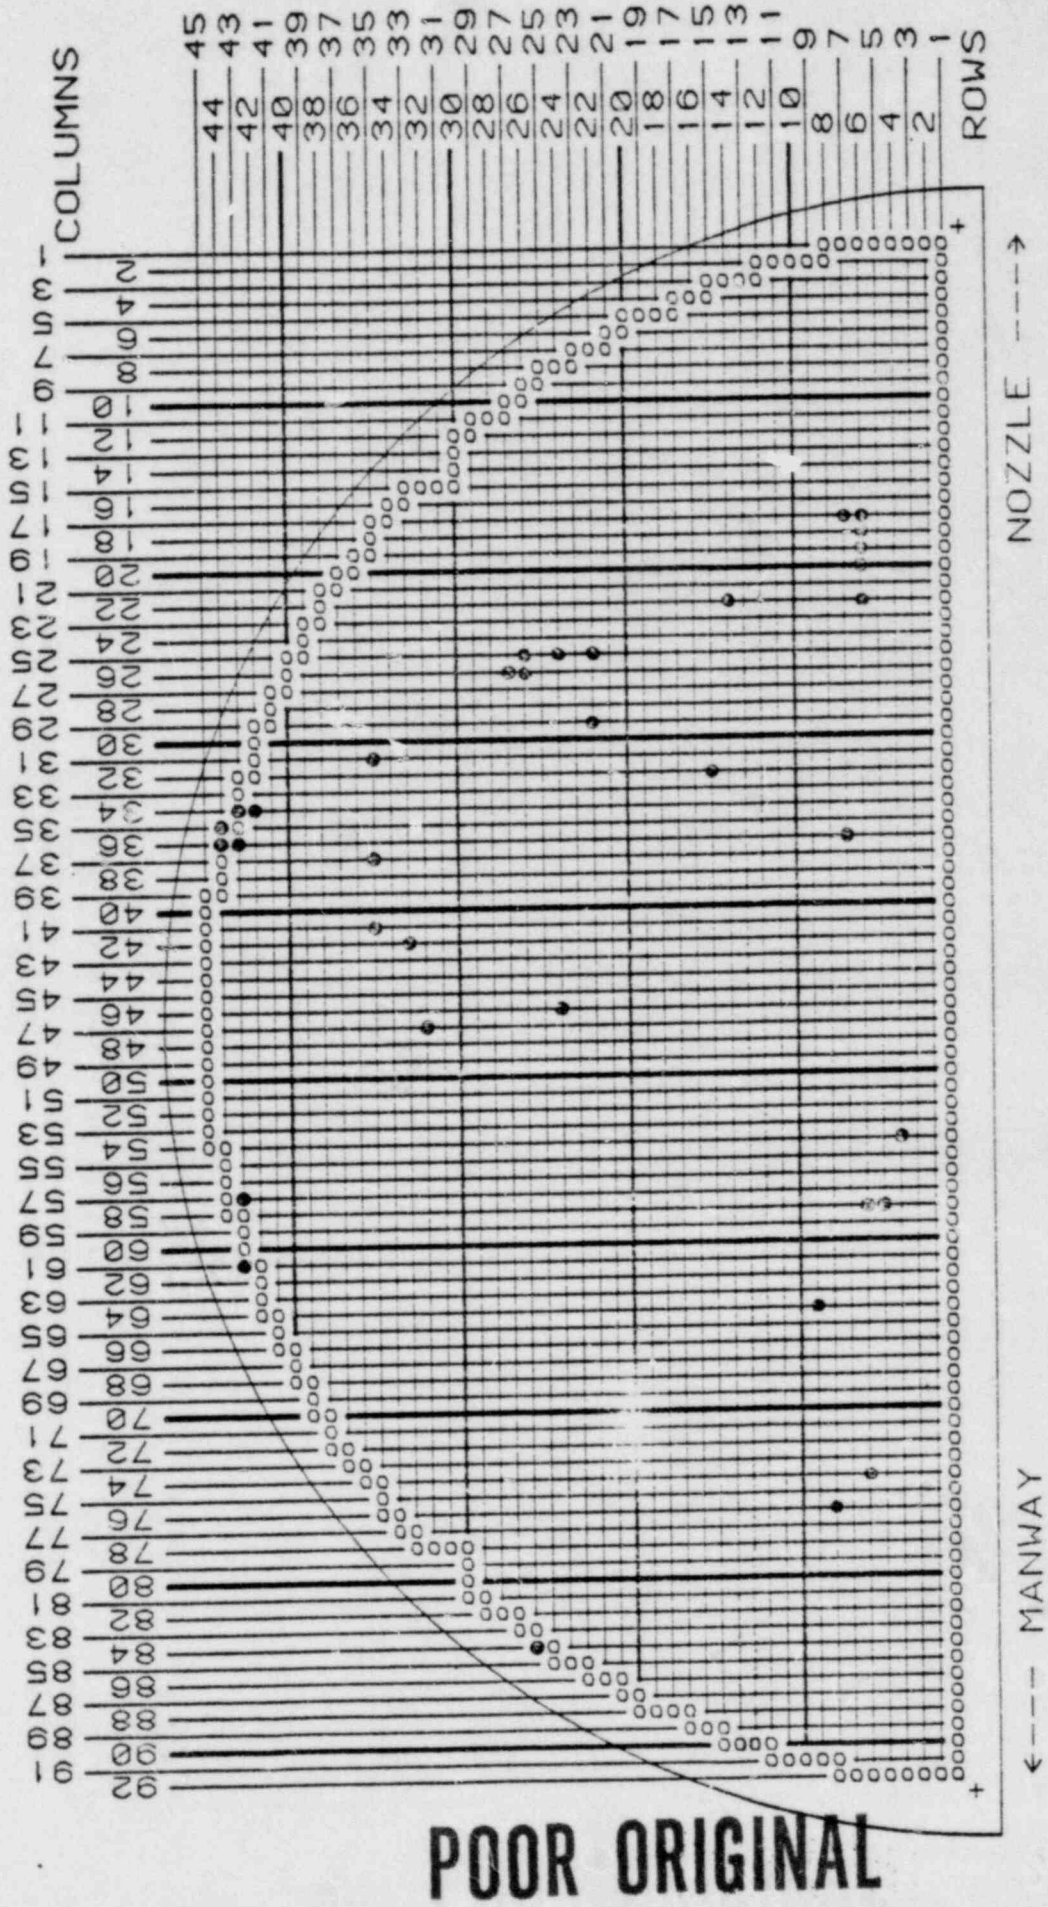
FIGURE 5

"B" Steam Generator
Unit 2
4/81
