Docket Nos. 50-445
50-446

IE Information Notice No. 81-04
February 27, 1981
Page 1 of 2

CRACKING IN MAIN STEAM LINES

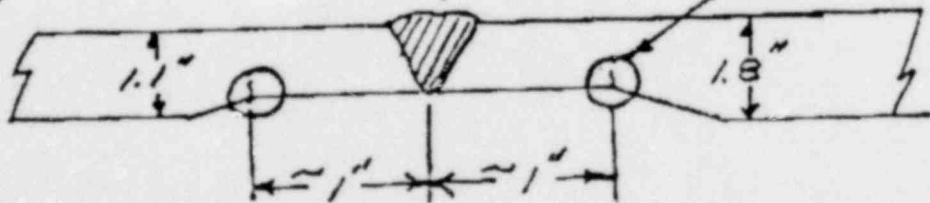
Attachment:
Sketch

The Virginia Electric Power Company promptly notified the NRC on February 23, 1981 that a radiography examination, during the ongoing steam generator replacement outage at Surry Unit 1, had revealed a lengthy crack indication in the I.D. counterbore area of a weldment on the in-line "T" fitting which connects the vertical run of 30-inch piping to the safety relief valve header and 30-inch main steam line of Steam Generator "A." This piping connection is located outside the containment penetration immediately upstream of the main steam isolation valve as shown in the attached sketch.

A visual and dye penetrant examination on the pipe I D. surface of the weldment nearest the containment penetration established that the cracking extended about 120° around the fitting counterbore between the 4 o'clock to 8 o'clock position. Cracking was also observed in the weld counterbore at the opposite end of the T-fitting during visual examination of the piping interior. Radiographic examination of "B" and "C" main steam line T-fitting welds disclosed crack indications at similar locations.

Metallurgical specimens of the cracking were trepanned from the T-fitting of the "A" main steam line for analysis. Controlled excavation and depth measurements of the crack at its mid-length indicated a crack depth of about 0.090" in this location. The cause of cracking has not yet been established.

ZONE OF CRACKING

This information is provided as an early notification of a significant safety matter that is still under review by the NRC staff. It is expected that recipients will review the information for possible applicability to their plants. For those plants having similar main steam line configurations which are currently in a refueling or extended repair outage, it is recommended that a ultrasonic and/or radiographic examination of the three welds and counterbore areas of the T-fittings be performed before resumption of operations, unless some current basis for assurance of piping integrity is available.
