UNITED STATES
NUCLEAR REGULATORY COMMISSION
OFFICE OF INSPECTION AND ENFORCEMENT
WASHINGTON, D.C. 20555

IE Information Notice No. 81-04
February 27, 1981
Page 1 of 2

CRACKING IN MAIN STEAM LINES

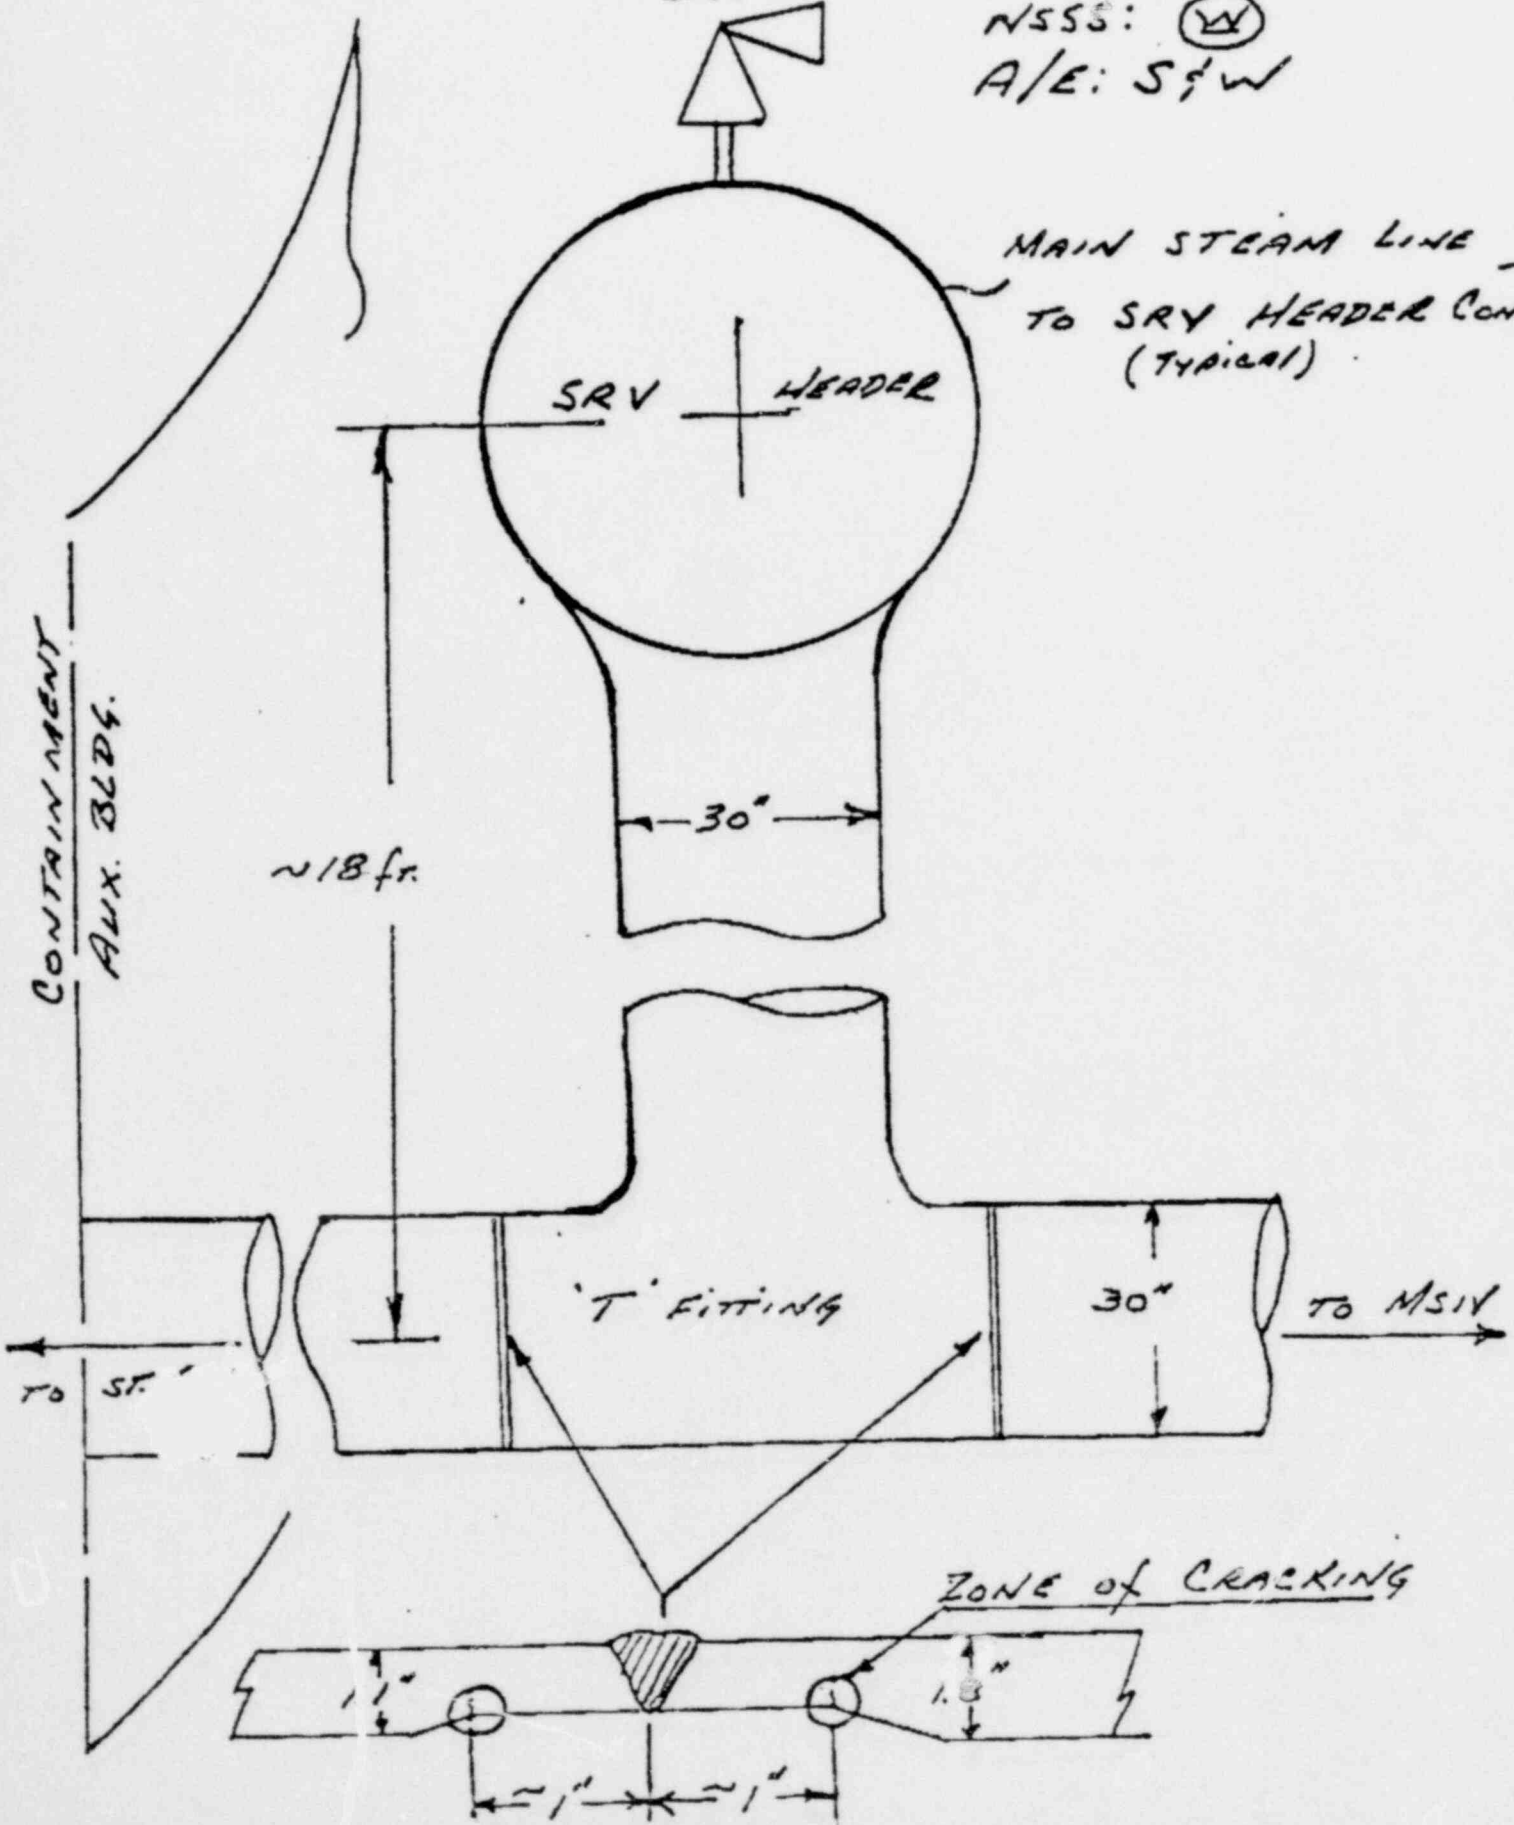
Attachment:
Sketch

The Virginia Electric Power Company promptly notified the NRC on February 23, 1981 that a radiography examination, during the ongoing steam generator replacement outage at Surry Unit 1, had revealed a lengthy crack indication in the I.D. counterbore area of a weldment on the in-line "T" fitting which connects the vertical run of 30-inch piping to the safety relief valve header and 30-inch main steam line of Steam Generator "A." This piping connection is located outside the containment penetration immediately upstream of the main steam isolation valve as shown in the attached sketch.

A visual and dye penetrant examination on the pipe I.D. surface of the weldment nearest the containment penetration established that the cracking extended about 120° around the fitting counterbore between the 4 o'clock to 8 o'clock position. Cracking was also observed in the weld counterbore at the opposite end of the T-fitting during visual examination of the piping interior. Radiographic examination of "B" and "C" main steam line T-fitting welds disclosed crack indications at similar locations.

Metallurgical specimens of the cracking were trepanned from the T-fitting of the "A" main steam line for analysis. Controlled excavation and depth measurements of the crack at its mid-length indicated a crack depth of about 0.090" in this location. The cause of cracking has not yet been established.

ZONE OF CRACKING

This information is provided as an early notification of a significant safety matter that is still under review by the NRC staff. It is expected that recipients will review the information for possible applicability to their plants. For those plants having similar main steam line configurations which are currently in a refueling or extended repair outage, it is recommended that a ultrasonic and/or radiographic examination of the three welds and counterbore areas of the T-fittings be performed before resumption of operations, unless some current basis for assurance of piping integrity is available.
