UNITED STATES
NUCLEAR REGULATORY COMMISSION
OFFICE OF INSPECTION AND ENFORCEMENT
WASHINGTON, D.C. 20555

February 27, 1981

IE Information Notice No. 81-04: CRACKING IN MAIN STEAM LINES

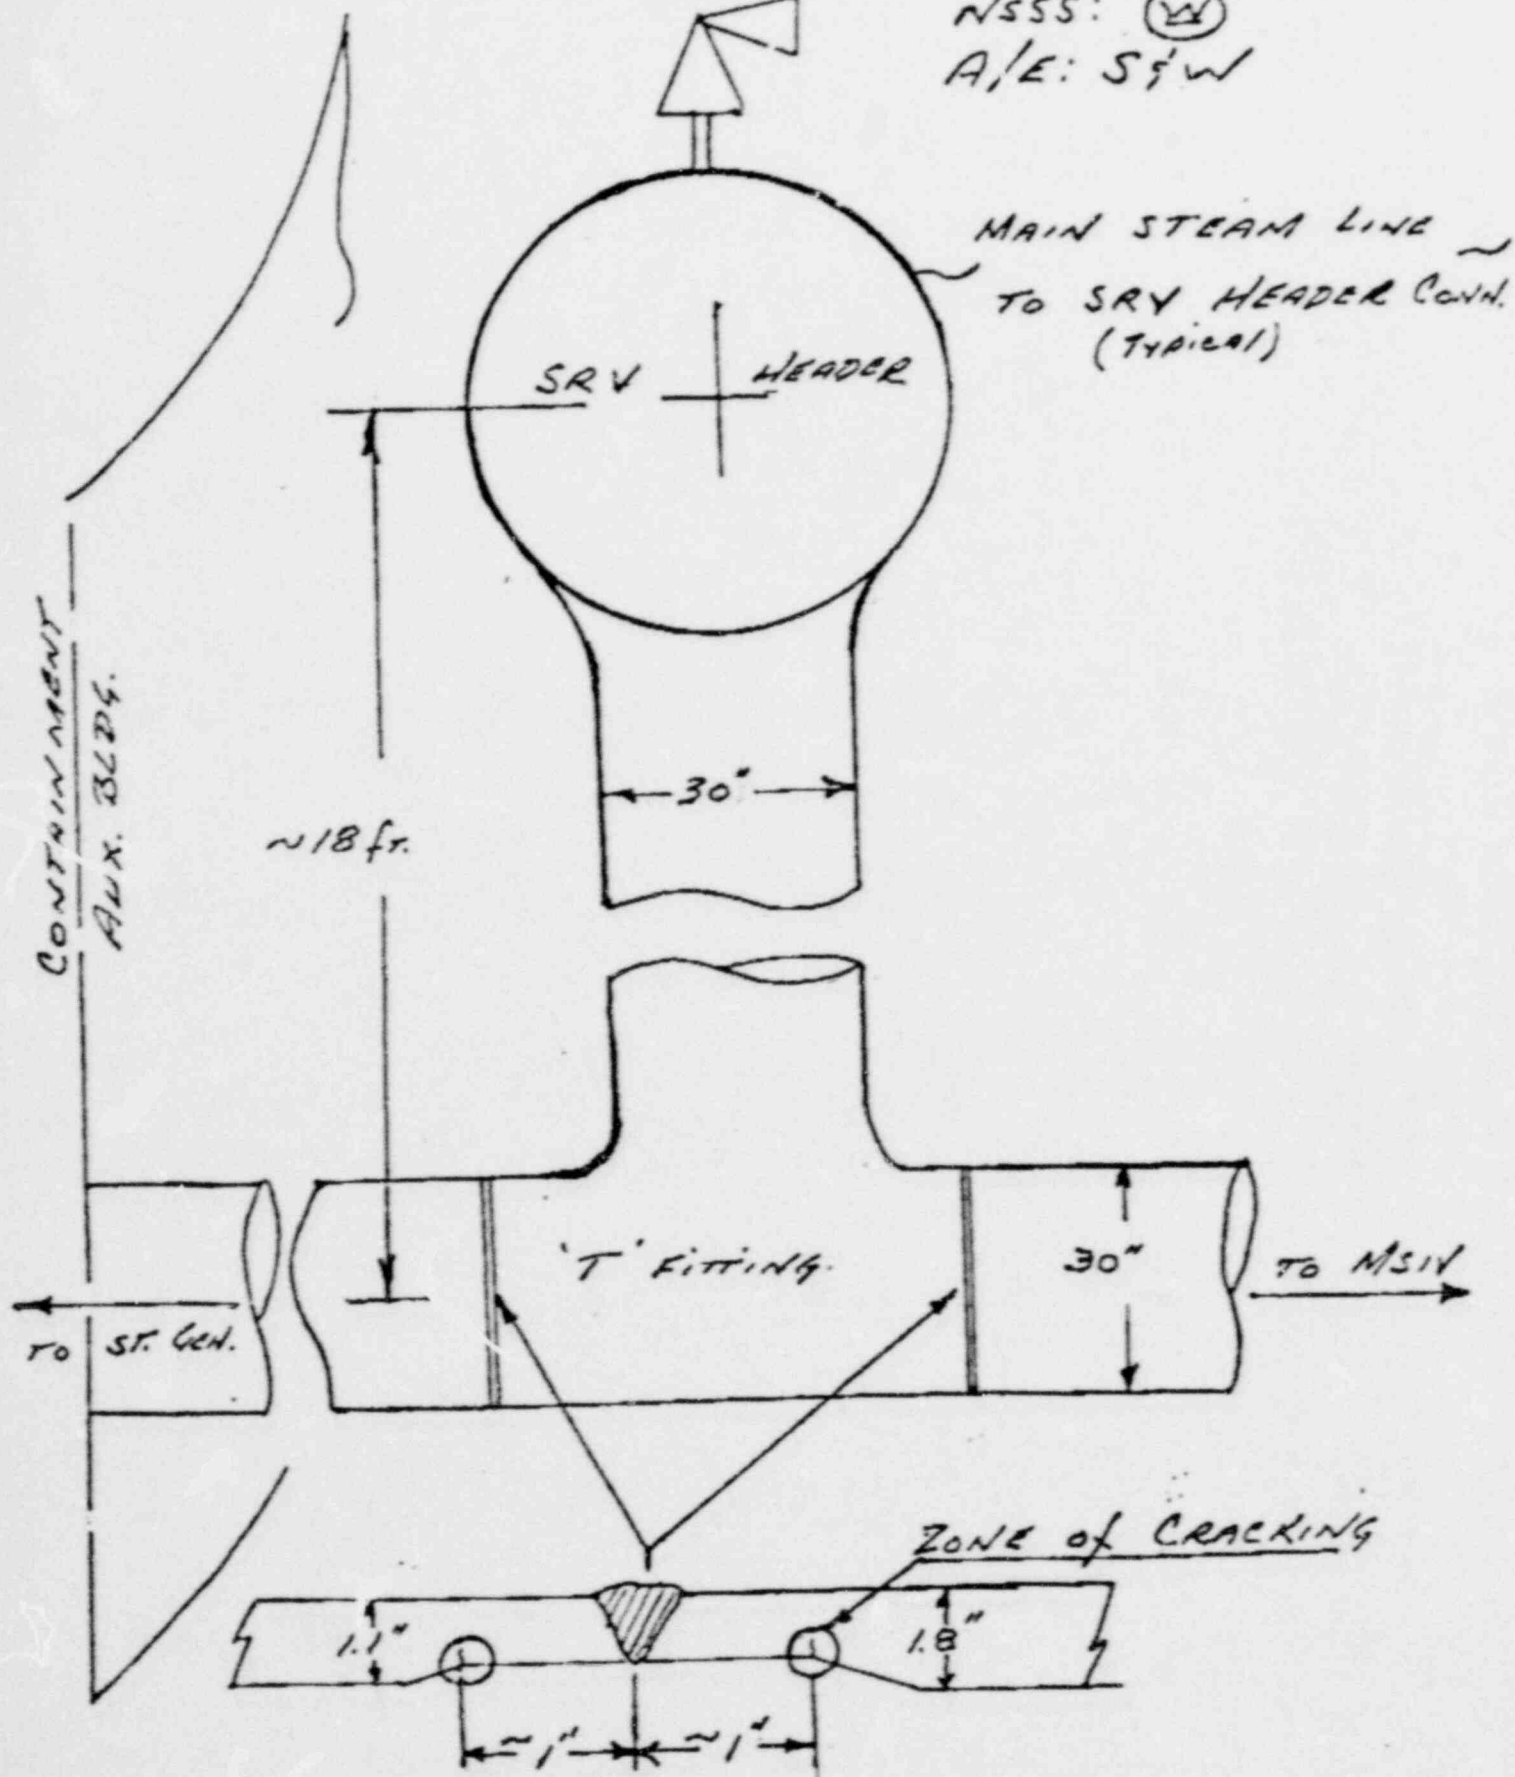
The Virginia Electric Power Company promptly notified the NRC on February 23, 1981 that a radiography examination, during the ongoing steam generator replacement outage at Surry Unit 1, had revealed a lengthy crack indication in the I.D. counterbore area of a weldment on the in-line "T" fitting which connects the vertical run of 30-inch piping to the safety relief valve header and 30-inch main steam line of Steam Generator "A". This piping connection is located outside the containment penetration immediately upstream of the main steam isolation valve as shown in the attached sketch.

A visual and dye penetrant examination on the pipe I.D. surface of the weldment nearest the containment penetration established that the cracking extended about 120° around the fitting counterbore between the 4 o'clock to 8 o'clock position. Cracking was also observed in the weld counterbore at the opposite end of the T-fitting during visual examination of the piping interior. Radiographic examination of "B" and "C" main steam line T-fitting welds disclosed crack indications at similar locations.

Metallurgical specimens of the cracking were trepanned from the T-fitting of the "A" main steam line for analysis. Controlled excavation and depth measurements of the crack at its mid-length indicated a crack depth of about 0.090" in this location. The cause of cracking has not yet been established.

ZONE OF CRACKING

This information is provided as an early notification of a significant safety matter that is still under review by the NRC staff. It is expected that recipients will review the information for possible applicability to their plants. For those plants having similar main steam line configurations which are currently in a refueling or extended repair outage, it is recommended that a ultrasonic and/or radiographic examination of the three welds and counterbore areas of the T-fittings be performed before resumption of operations, unless some current basis for assurance of piping integrity is available.
