UNITED STATES  
NUCLEAR REGULATORY COMMISSION  
REGION II  
101 MARIETTA ST., N.W., SUITE 3100  
ATLANTA, GEORGIA 30303  
FEB 27 1981

IE Information Notice No. 81-04: CRACKING IN MAIN STEAM LINES

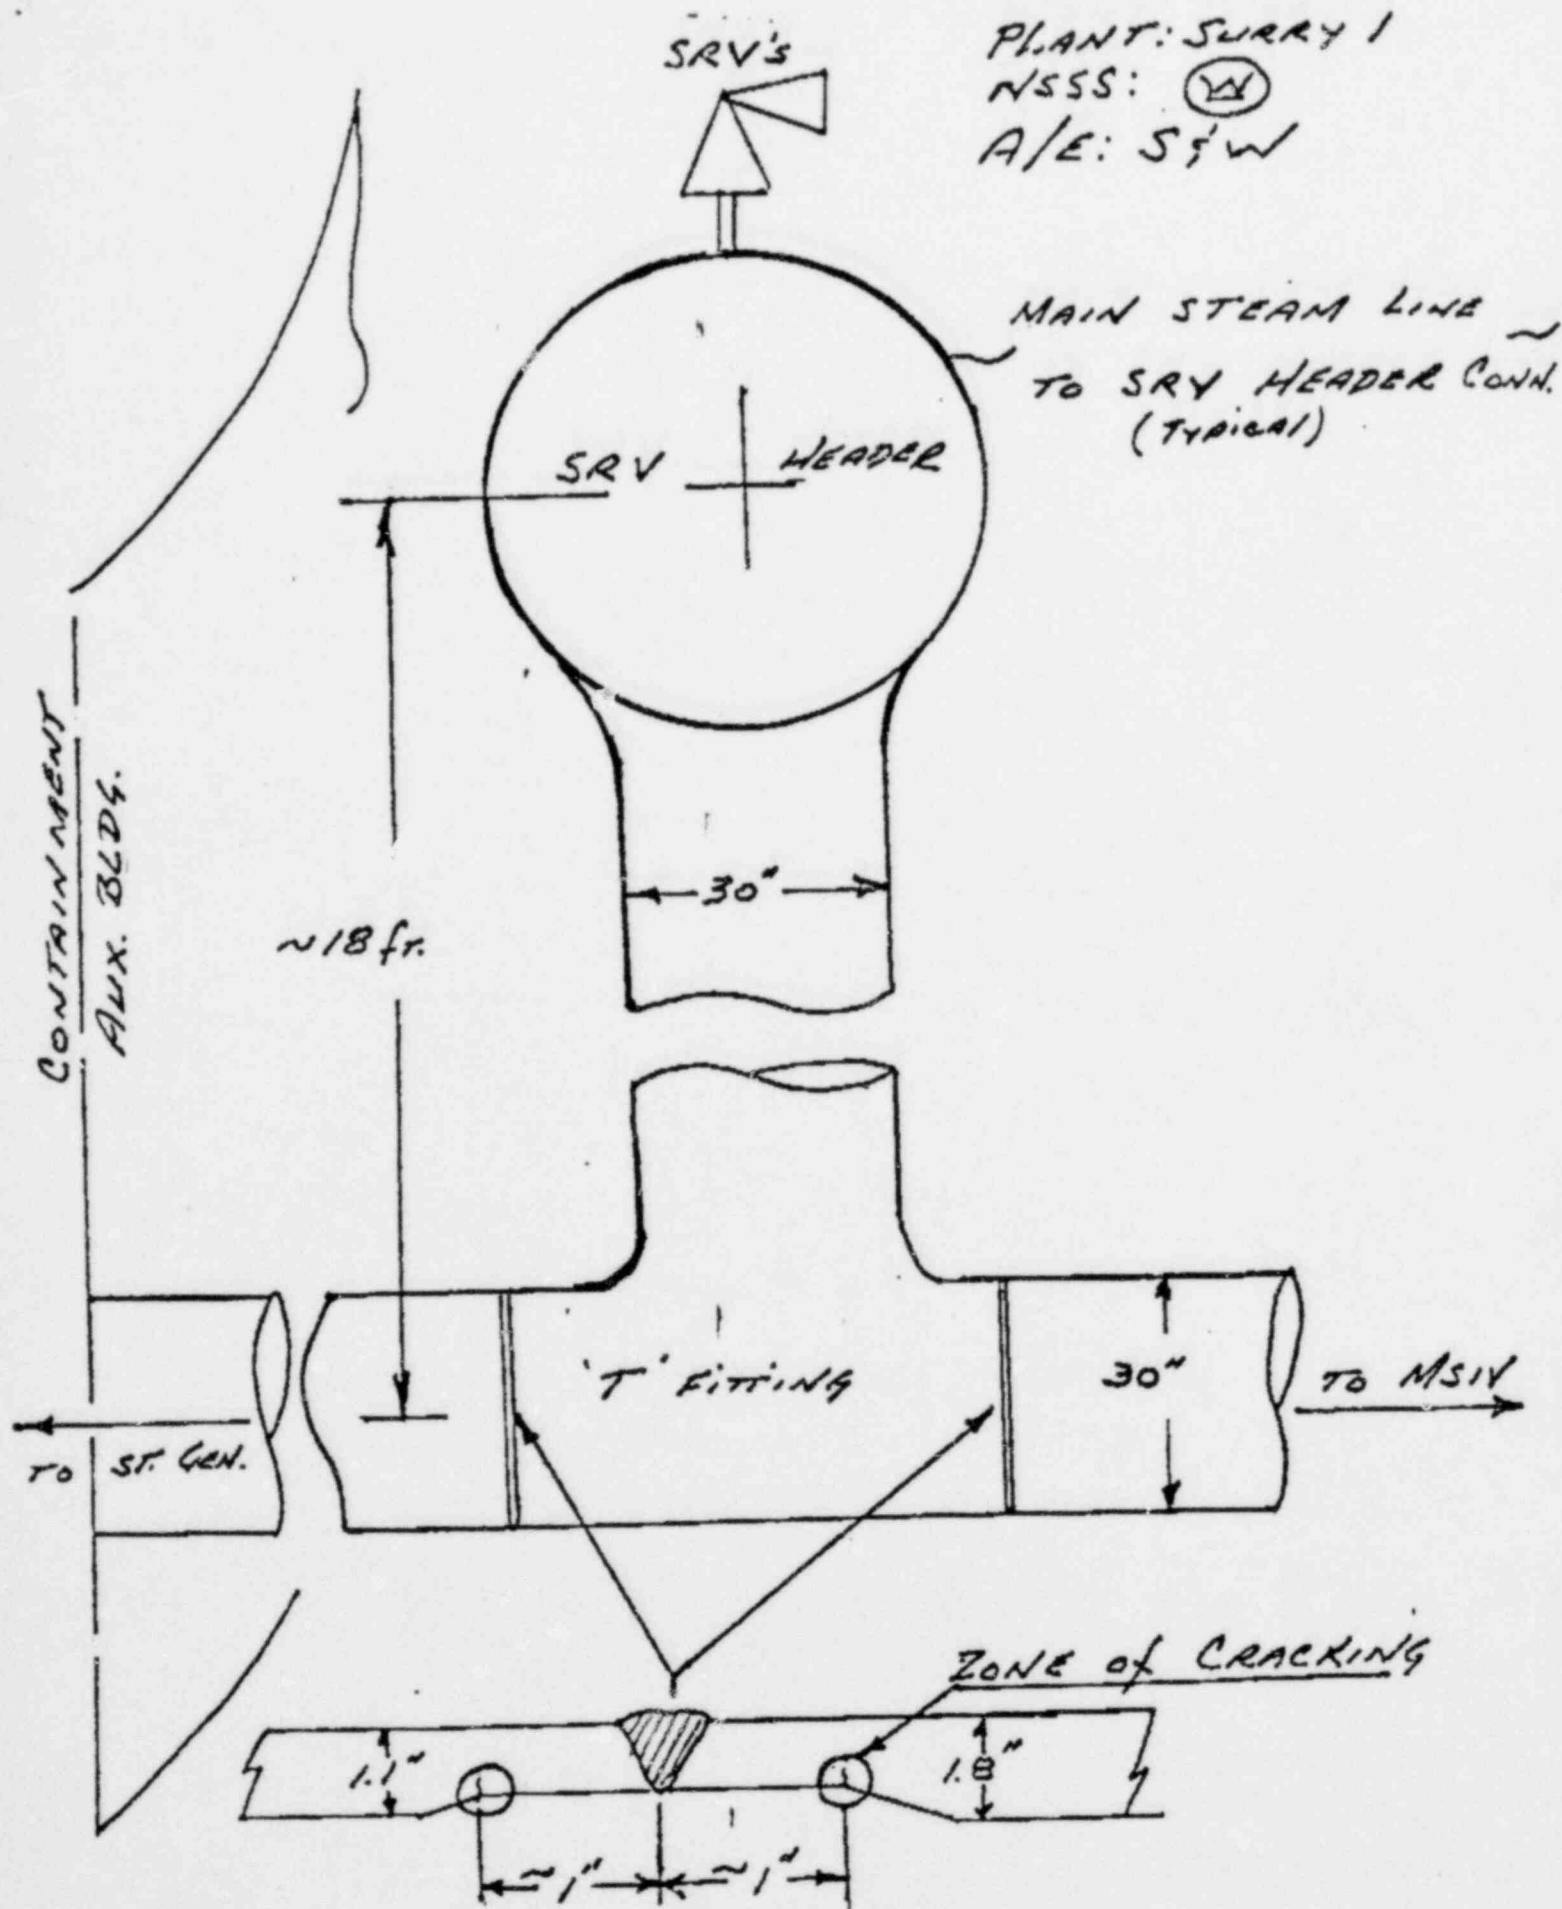
PLANT: SURRY 1  
NSSS:

The Virginia Electric Power Company promptly notified the NRC on February 23, 1981 that a radiography examination, during the ongoing steam generator replacement outage at Surry Unit 1, had revealed a lengthy crack indication in the I.D. counterbore area of a weldment on the in-line "T" fitting which connects the vertical run of 30-inch piping to the safety relief valve header and 30-inch main steam line of Steam Generator "A". This piping connection is located outside the containment penetration immediately upstream of the main steam isolation valve as shown in the attached sketch.

A visual and dye penetrant examination on the pipe I.D. surface of the weldment nearest the containment penetration established that the cracking extended about 120° around the fitting counterbore between the 4 o'clock to 8 o'clock position. Cracking was also observed in the weld counterbore at the opposite end of the T-fitting during visual examination of the piping interior. Radiographic examination of "B" and "C" main steam line T-fitting welds disclosed crack indications at similar locations.

Metallurgical specimens of the cracking were trepanned from the T-fitting of the "A" main steam line for analysis. Controlled excavation and depth measurements of the crack at its mid-length indicated a crack depth of about 0.090" in this location. The cause of cracking has not yet been established.

This information is provided as an early notification of a significant safety matter that is still under review by the NRC staff. It is expected that recipients will review the information for possible applicability to their plants. For those plants having similar main steam line configurations which are currently in a refueling or extended repair outage, it is recommended that a ultrasonic and/or radiographic examination of the three welds and counterbore areas of the T-fittings be performed before resumption of operations, unless some current basis for assurance of piping integrity is available.
