LICENSEE EVENT REPORT

LER ATTACHMENT - RO # 2-81-45

Facility: BSEP Unit No. 2

Event Date: 4-12-81

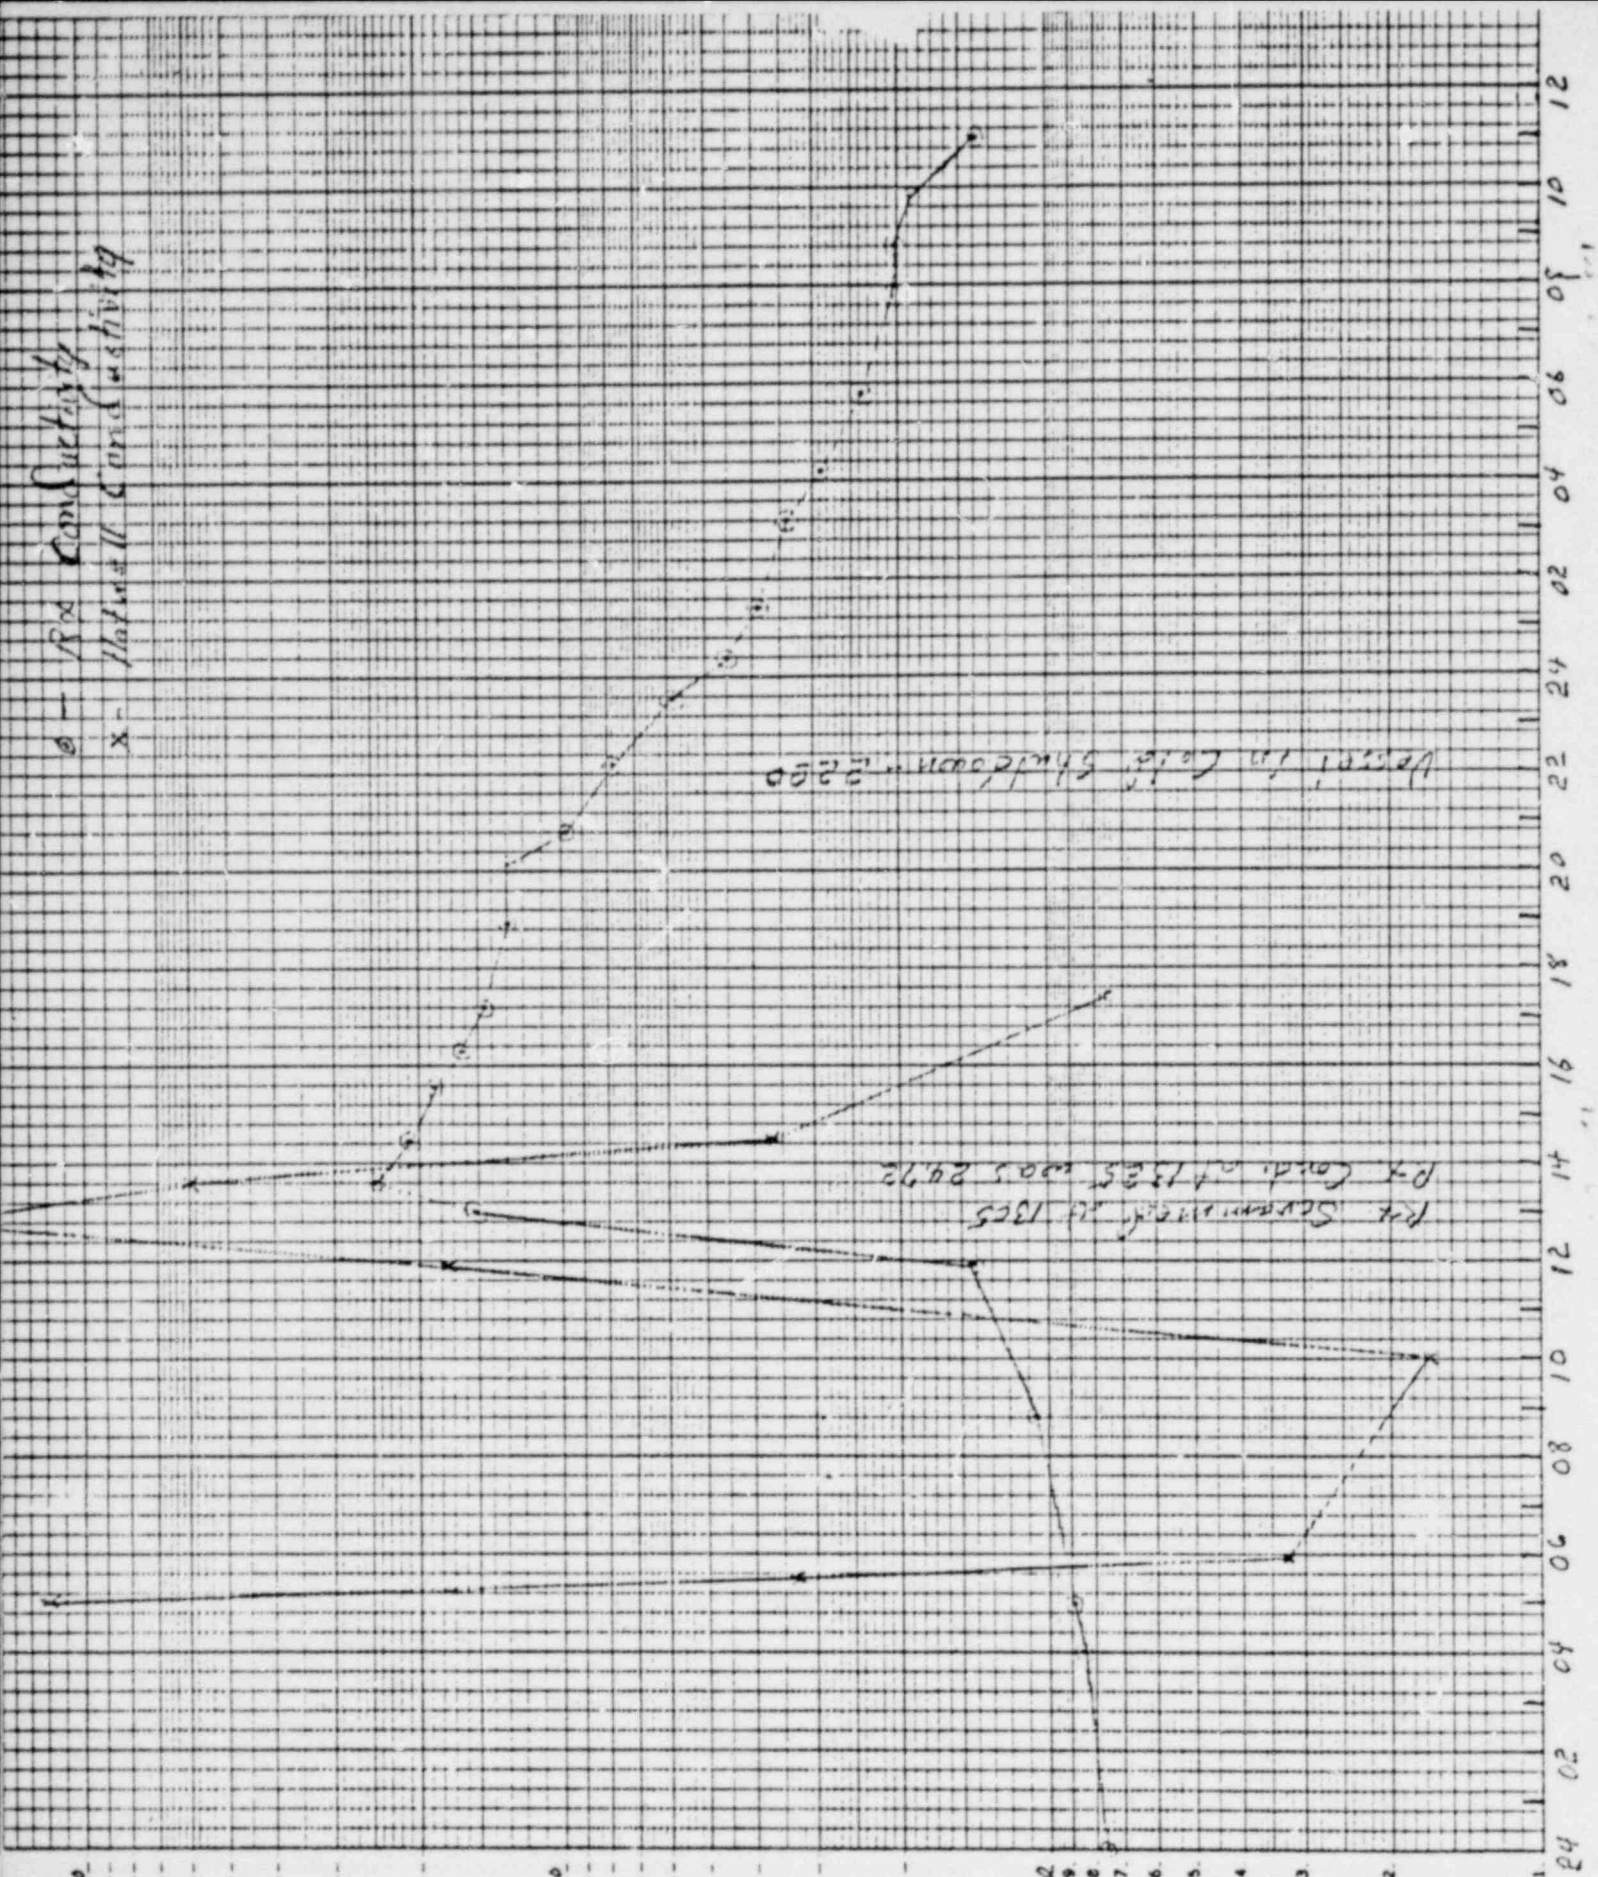
0 4 | conductivity > 10 μmho/cm². Vessel conductivity remained > 10 μmho/cm² for 8 hours

0 5 | with the highest recorded value at 24.8 μmho/cm². Following the discovery that vessel

o - Rx Conductivity
 x - Natural Conductivity

Vessel in Cold Shutdown - 2200

Rx SURVEYED AT 1305
 Rx Cond. at 1305 was 24.72
