February 13, 1981  
Fort St. Vrain  
Unit No. 1  
P-81051

REPORTABLE OCCURRENCE 80-49

FORT ST. VRAIN NUCLEAR GENERATING STATION  
PUBLIC SERVICE COMPANY OF COLORADO  
16805 WELD COUNTY ROAD 19 1/2  
PLATTEVILLE, COLORADO 80651

REPORT NO. 50-267/80-49/03-X-1

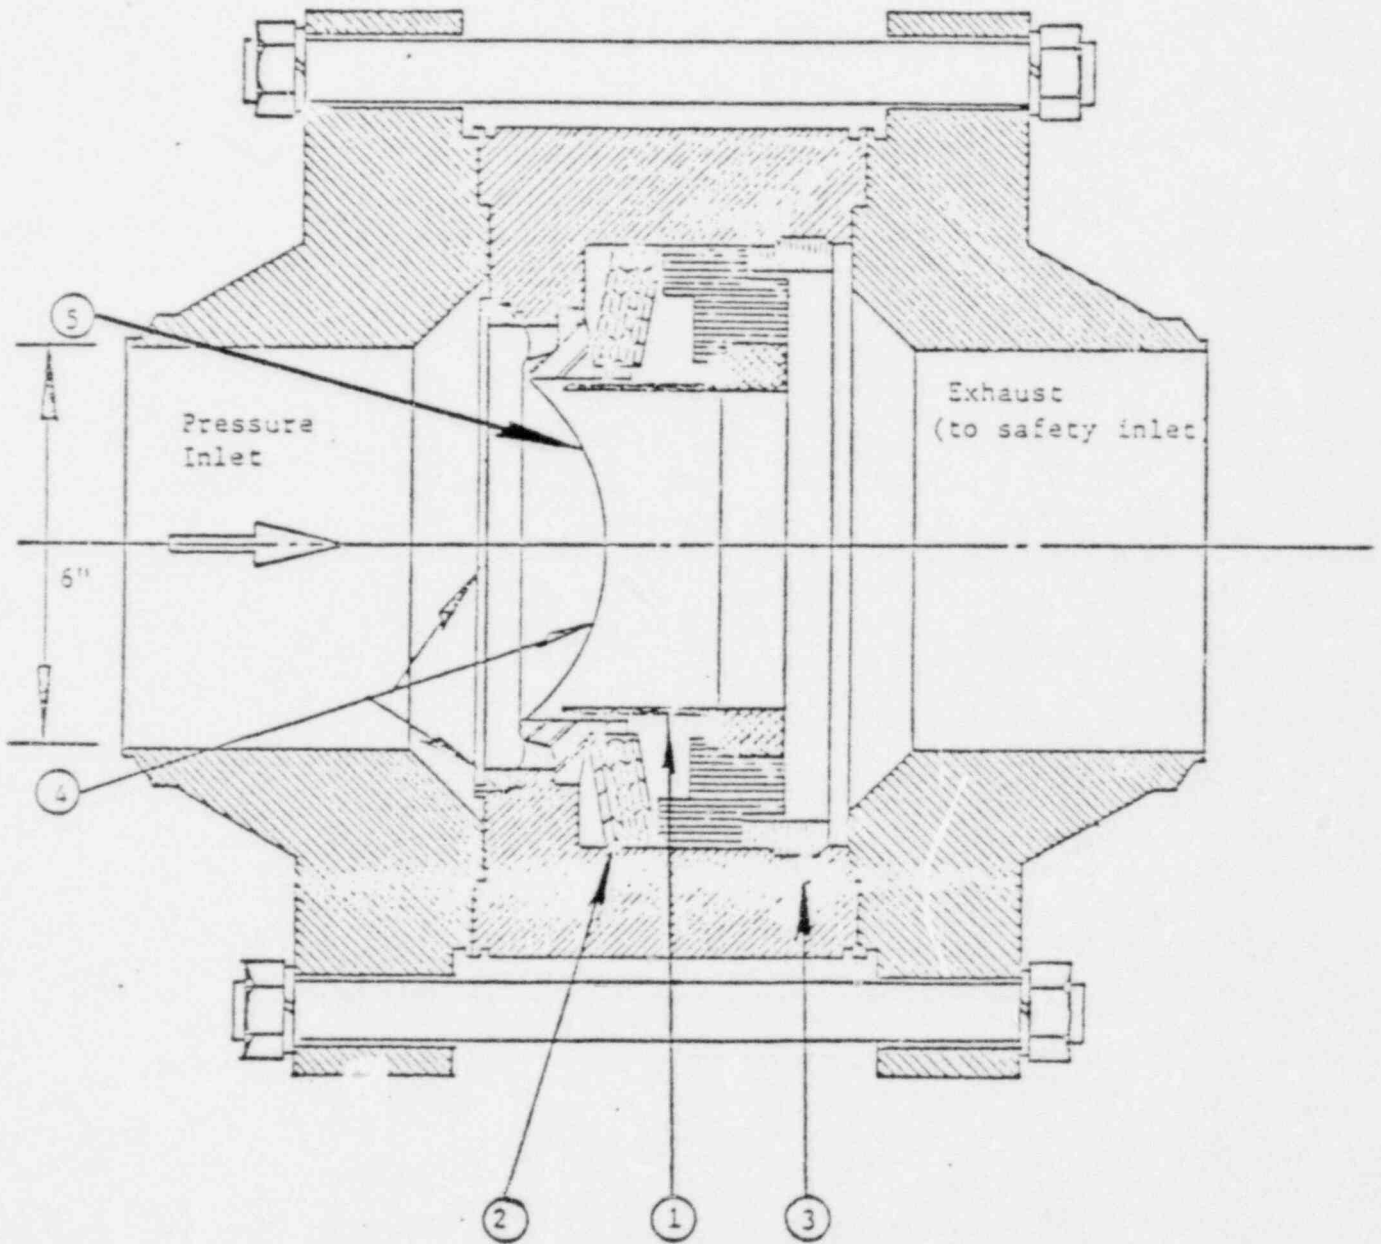
FIGURE 1

During a routine surveillance calibration check, the setpoint of the PCRV rupture disc assembly, M-11702, was found to be 826 psig. Since this setpoint is higher than the 812 psig  $\pm$  1% allowable by Fort St. Vrain Technical Specification LSSS 3.3.2(c), it is being reported per Fort St. Vrain Technical Specification AC 7.5.2(b)1.

With the reactor shutdown and depressurized for a maintenance shutdown period, low set rupture disc, M-11702, was removed from service for a schedule surveillance calibration bench test. The "as found" pressure setpoint was 826 psig. The acceptance criterion of LSSS 3.3.2(c) requires the set pressure to be 812 psig  $\pm$  1% (804 psig to 820 psig).

Refer to Figure 1. Before the test gas pressure is applied, the cutter, ①, is removed and a special ring is installed to limit the travel of the Belleville washers, ②. These washers snap over when the set pressure is reached. Adjustment of the set pressure is made by positioning of the threaded ring, ③. When the set pressure is reached, the diaphragm and washers travel a few thousandths of an inch, which produces an audible "thump."

The rupture disc movement setpoint being out of tolerance was caused by drift of the Belleville washer operating point over the period since its last calibration surveillance.

Further investigation of this occurrence revealed that the Belleville washers did not need adjustment. Two additional snap-over tests demonstrated that the rupture disc setpoint was in tolerance.

No further corrective action is anticipated or required.
