U. S. NUCLEAR REGULATORY COMMISSION
OFFICE OF INSPECTION AND ENFORCEMENT

Emergency Preparedness Appraisal

Report No. 50-272/81-07
50-311/81-08
Docket No. 50-272
50-311
License No. DPR-70 Priority - Category C
DPR-75 B-2
Licensee: Public Service Electric and Gas Company
80 Park Place
Newark, New Jersey 07101

Facility Name: Salem Nuclear Generating Station (SNGS), Units 1 & 2

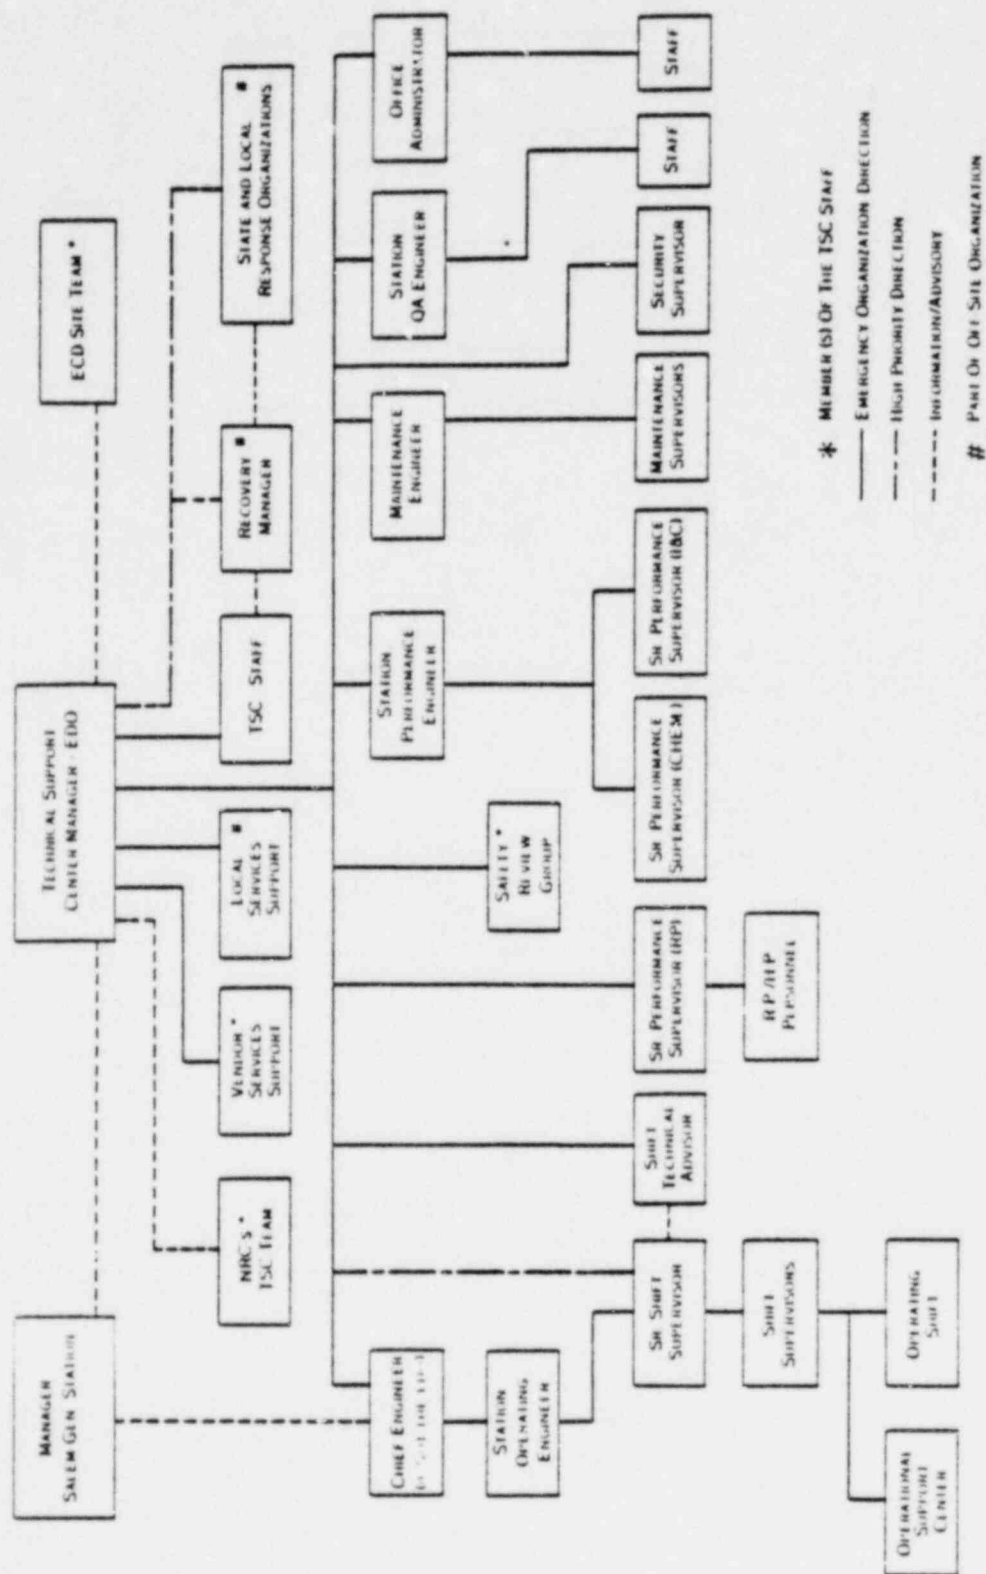
FIGURE 2

organization from Section 2.1 and 3.1 and Table III-1 of the Emergency Plan with the onsite emergency organization chart (Figure III-1 of the Emergency Plan). This organization chart is included as Figure 2 of Annex B to this report. The auditors noted that the emergency organization chart and written description of the emergency organization more closely resembled the normal organization and did not identify the relationships of the functional areas of emergency activity contained in Table III-1 of the Emergency Plan.

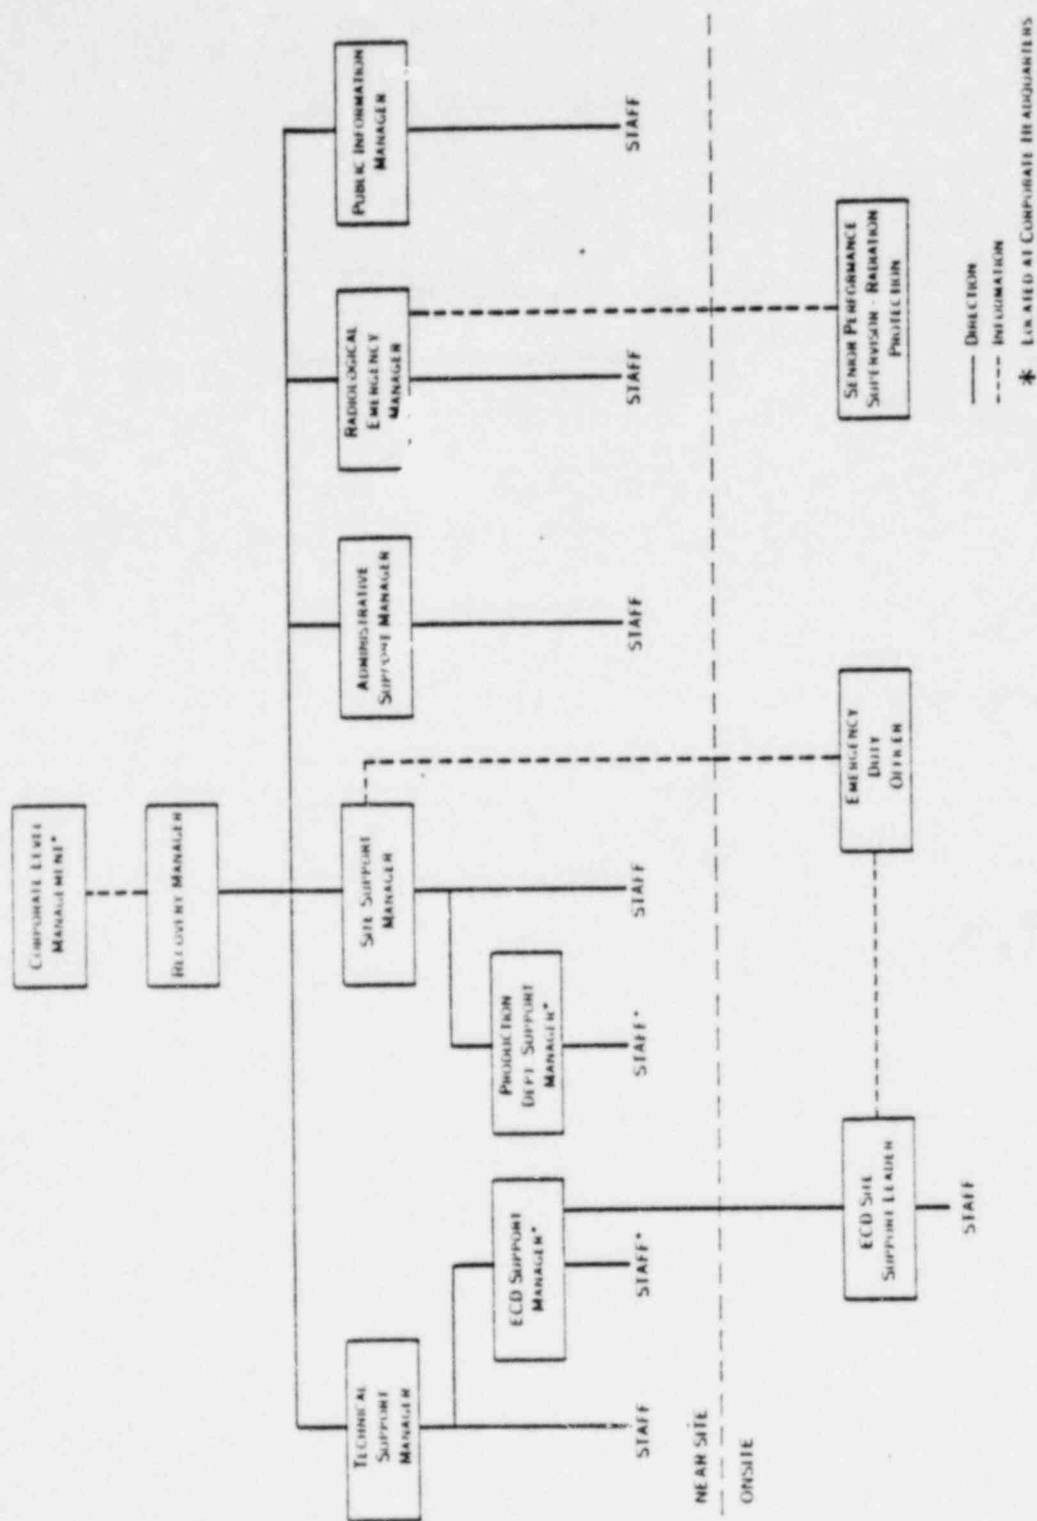
FIGURE XIV-2 Emergency Management Plan Emergency Organization

The corporate organization depicted in Figure 14-2 of the Emergency Plan and described in Section 14.0, included the positions shown in Figure 6 of Annex B to this report. The auditors noted that the description of the corporate PSE&G emergency organization in the Emergency Plan and procedures only identified the management positions that "are to act in a support and advisory capacity to the EDO."
