RBG-47985

Subject: Licensee Event Report 50-458 / 2019-004, "Potential Loss of Safety Function for all ADS (Automatic Depressurization System) Valves".
River Bend Station, Unit 1
NRC Docket No. 50-458
Renewed License No. NPF-47

4. Title
Potential Loss of Safety Function for all ADS (Automatic Depressurization System) Valves.

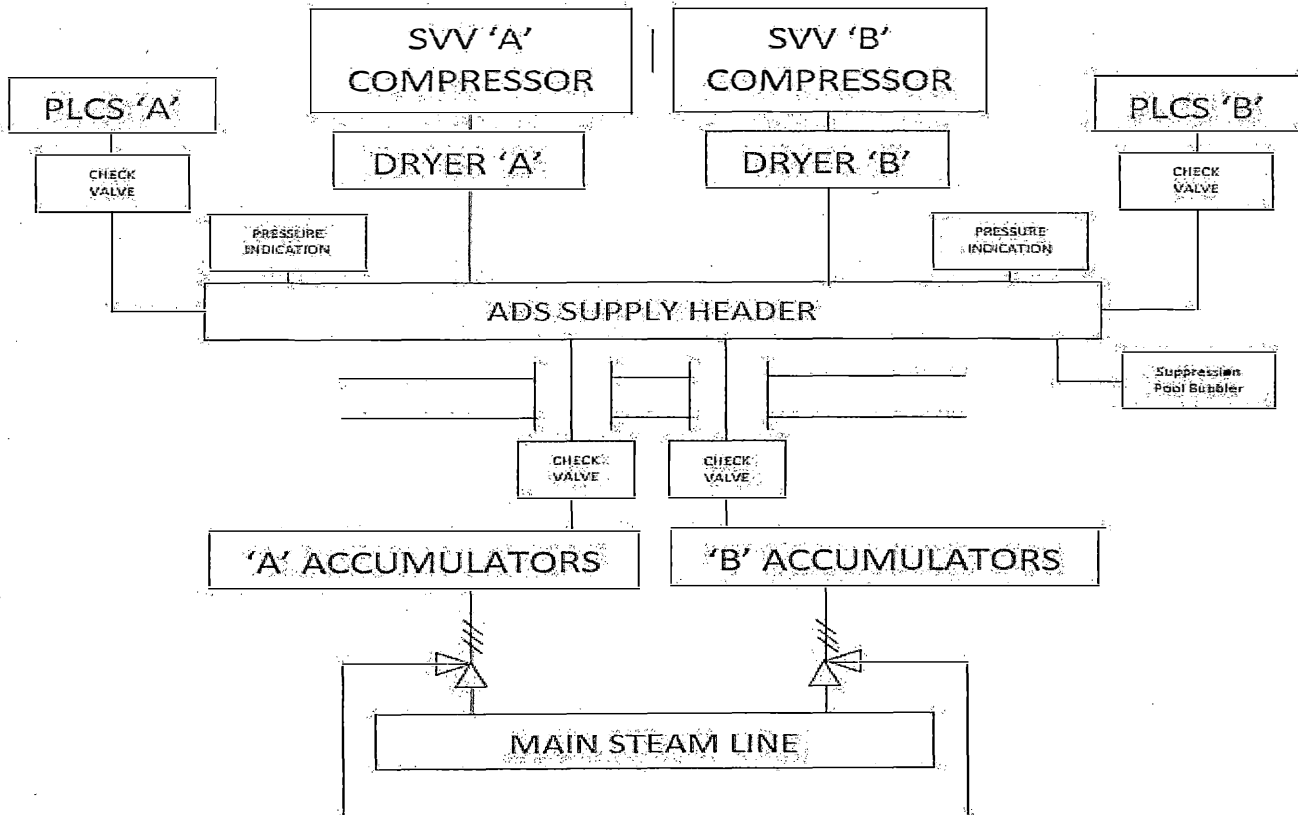
This illustration provided for basic understanding of ADS.

In addition, the portion of the ADS supply header where pressure is sensed is bounded by check valves which isolate the ADS Supply Header and the ADS accumulators. As header pressure began to lower, air pressure was contained within the piping and accumulators bounded by these check valves. ADS Supply Header pressure lowered due to the identified leaks in the 'B' Train ADS and as a result of air supplied to the Suppression Pool Level Transmitter Bubbler as seen in illustration provided.
