UNIVERSITY *of* MISSOURI

RESEARCH REACTOR CENTER

SUBJECT: Written communication as required by University of Missouri Research Reactor
Technical Specification 6.6.c(3) regarding a deviation from Technical Specifications
3.2.a and 3.2.f.8.

Licensee Event Report No. 19-07 – December 19, 2019
University of Missouri Research Reactor

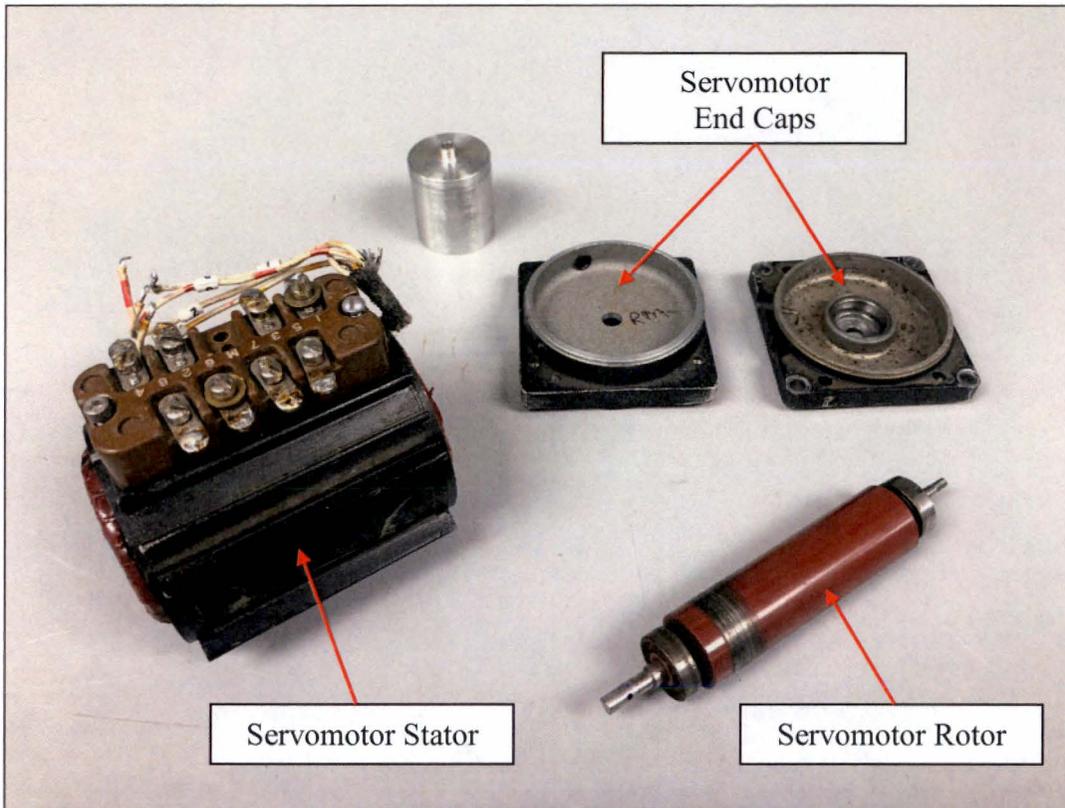
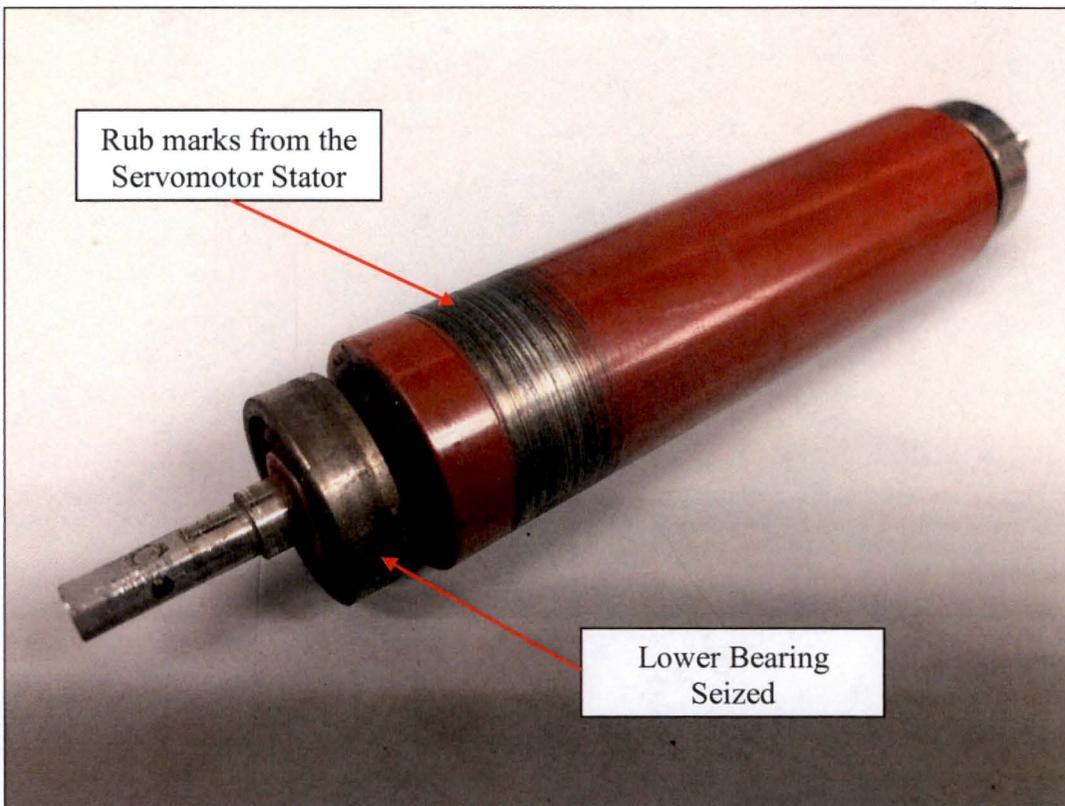
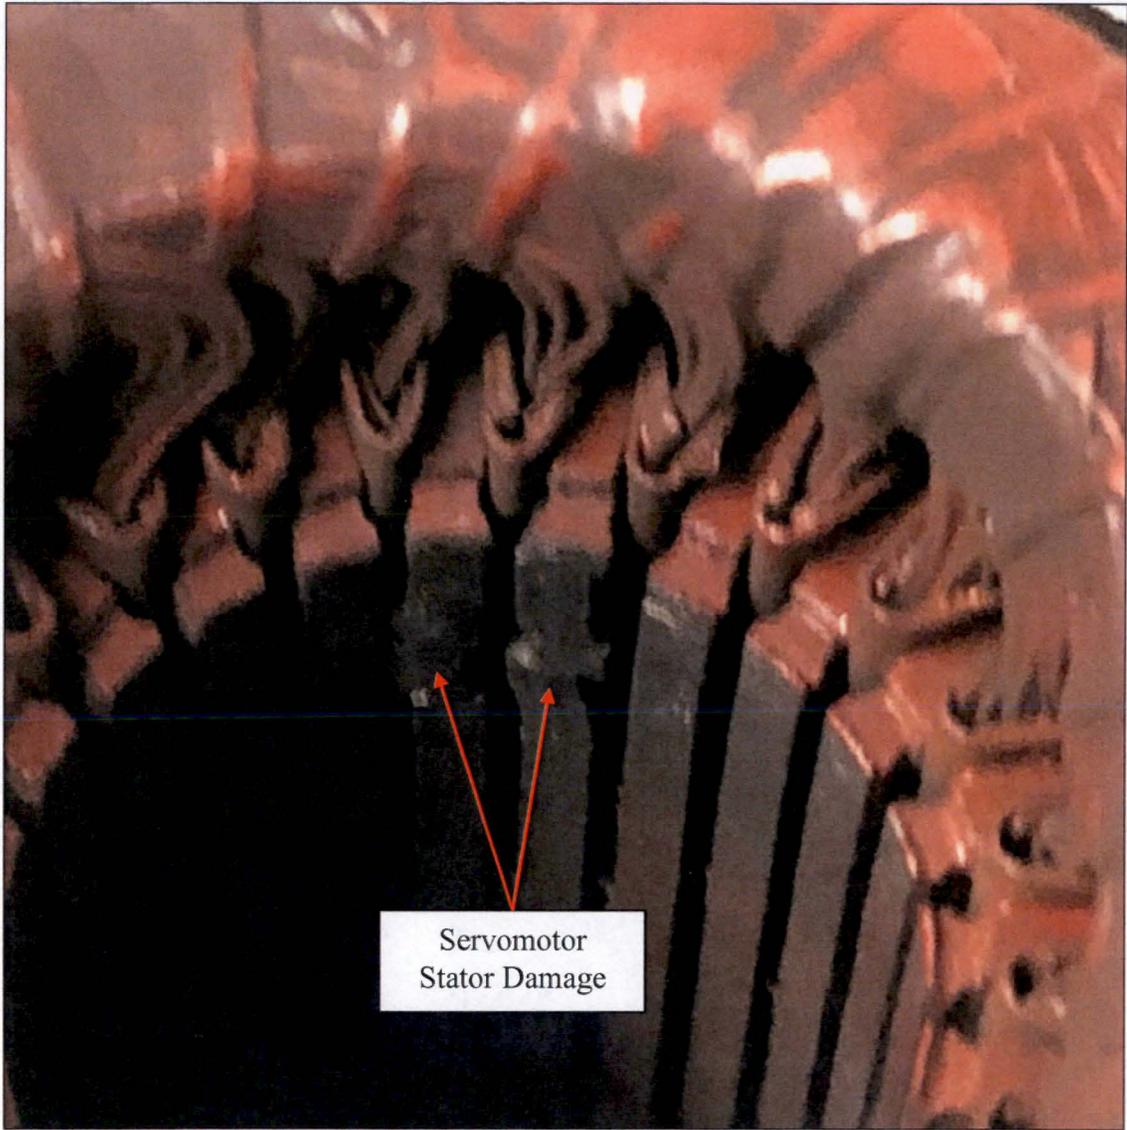
After the manual scram was initiated, a reactor operator was then directed to the reactor bridge to inspect the regulating blade drive mechanism. Visual inspection revealed no abnormalities – the rod position indication (RPI) encoder and rotatory limit switch drive chains were still properly attached. The regulating blade drive mechanism was removed and transferred to the Instrumentation Support shop for inspection and troubleshooting. It was determined that the regulating blade drive mechanism servomotor had seized.

The reactor was shut down by manual scram when it was determined that the regulating blade was inoperable. The regulating blade drive mechanism was removed and transferred to the Instrumentation Support shop for inspection and troubleshooting. It was determined that the regulating blade drive mechanism servomotor had seized – see photos on pages 6 and 7. The lower rotor bearing would not rotate and there were circular rub marks on the lower 1/3rd of the rotor which were caused by the stator as the bearing failed. The last photo shows damage to the servomotor stator from the rotor. The current servomotor is a Diehl Manufacturing Company Model No. F 12004, 115V, 60 Hz, 25 Watts.

Failed Regulating Blade Drive Mechanism Servomotor Disassembled

The servomotor for the regulating blade drive mechanism was replaced with a brand new one and the drive mechanism was cycled across its full range 10 times in a test stand prior to re-installation. The regulating blade drive mechanism was then reinstalled and connected to the regulating blade. The regulating blade was cycled across its full range two (2) times prior to pre-startup checks. No visual or audible abnormalities with the chain, sprockets, shafts, RPI, or rotary switch assembly operation were noted during these cycle tests.

It should be noted that in over 53 years of operation, this is the first failure of the regulating blade drive mechanism servomotor during reactor operation. As discussed in LER No. 19-06, significant progress has been made in the long-term corrective action of designing and fabricating a new regulating blade drive mechanism. The design has been finalized, the new drive mechanism has been fabricated and initial testing was satisfactorily completed. The new regulating blade drive mechanism was then disassembled so certain components could be anodized and powder coated for final assembly. Reassembly should occur within a week after the anodized and powder coated parts are received with final testing completed approximately two (2) months afterwards. Installation is tentatively scheduled for late March/early April. The new servomotor is a Groschopp Model No. A C8040FC-RA2605T, 115V, 60 Hz, 74 Watts. It is a much more robust motor than the current servomotor.
