REVIEW OF PROPOSED 5 FOOT DAM RAISE
UPPER TAILINGS POND EMBANKMENT SYSTEM
LISBON VALLEY OPERATIONS
RIO ALGOM CORPORATION

U.S. Nuclear Regulatory Commission
NMSS

John D. Nelson and Steven R. Abt
Geotechnical Engineering Program
Civil Engineering Department
Colorado State University
Fort Collins, Colorado 80523

October 1, 1980

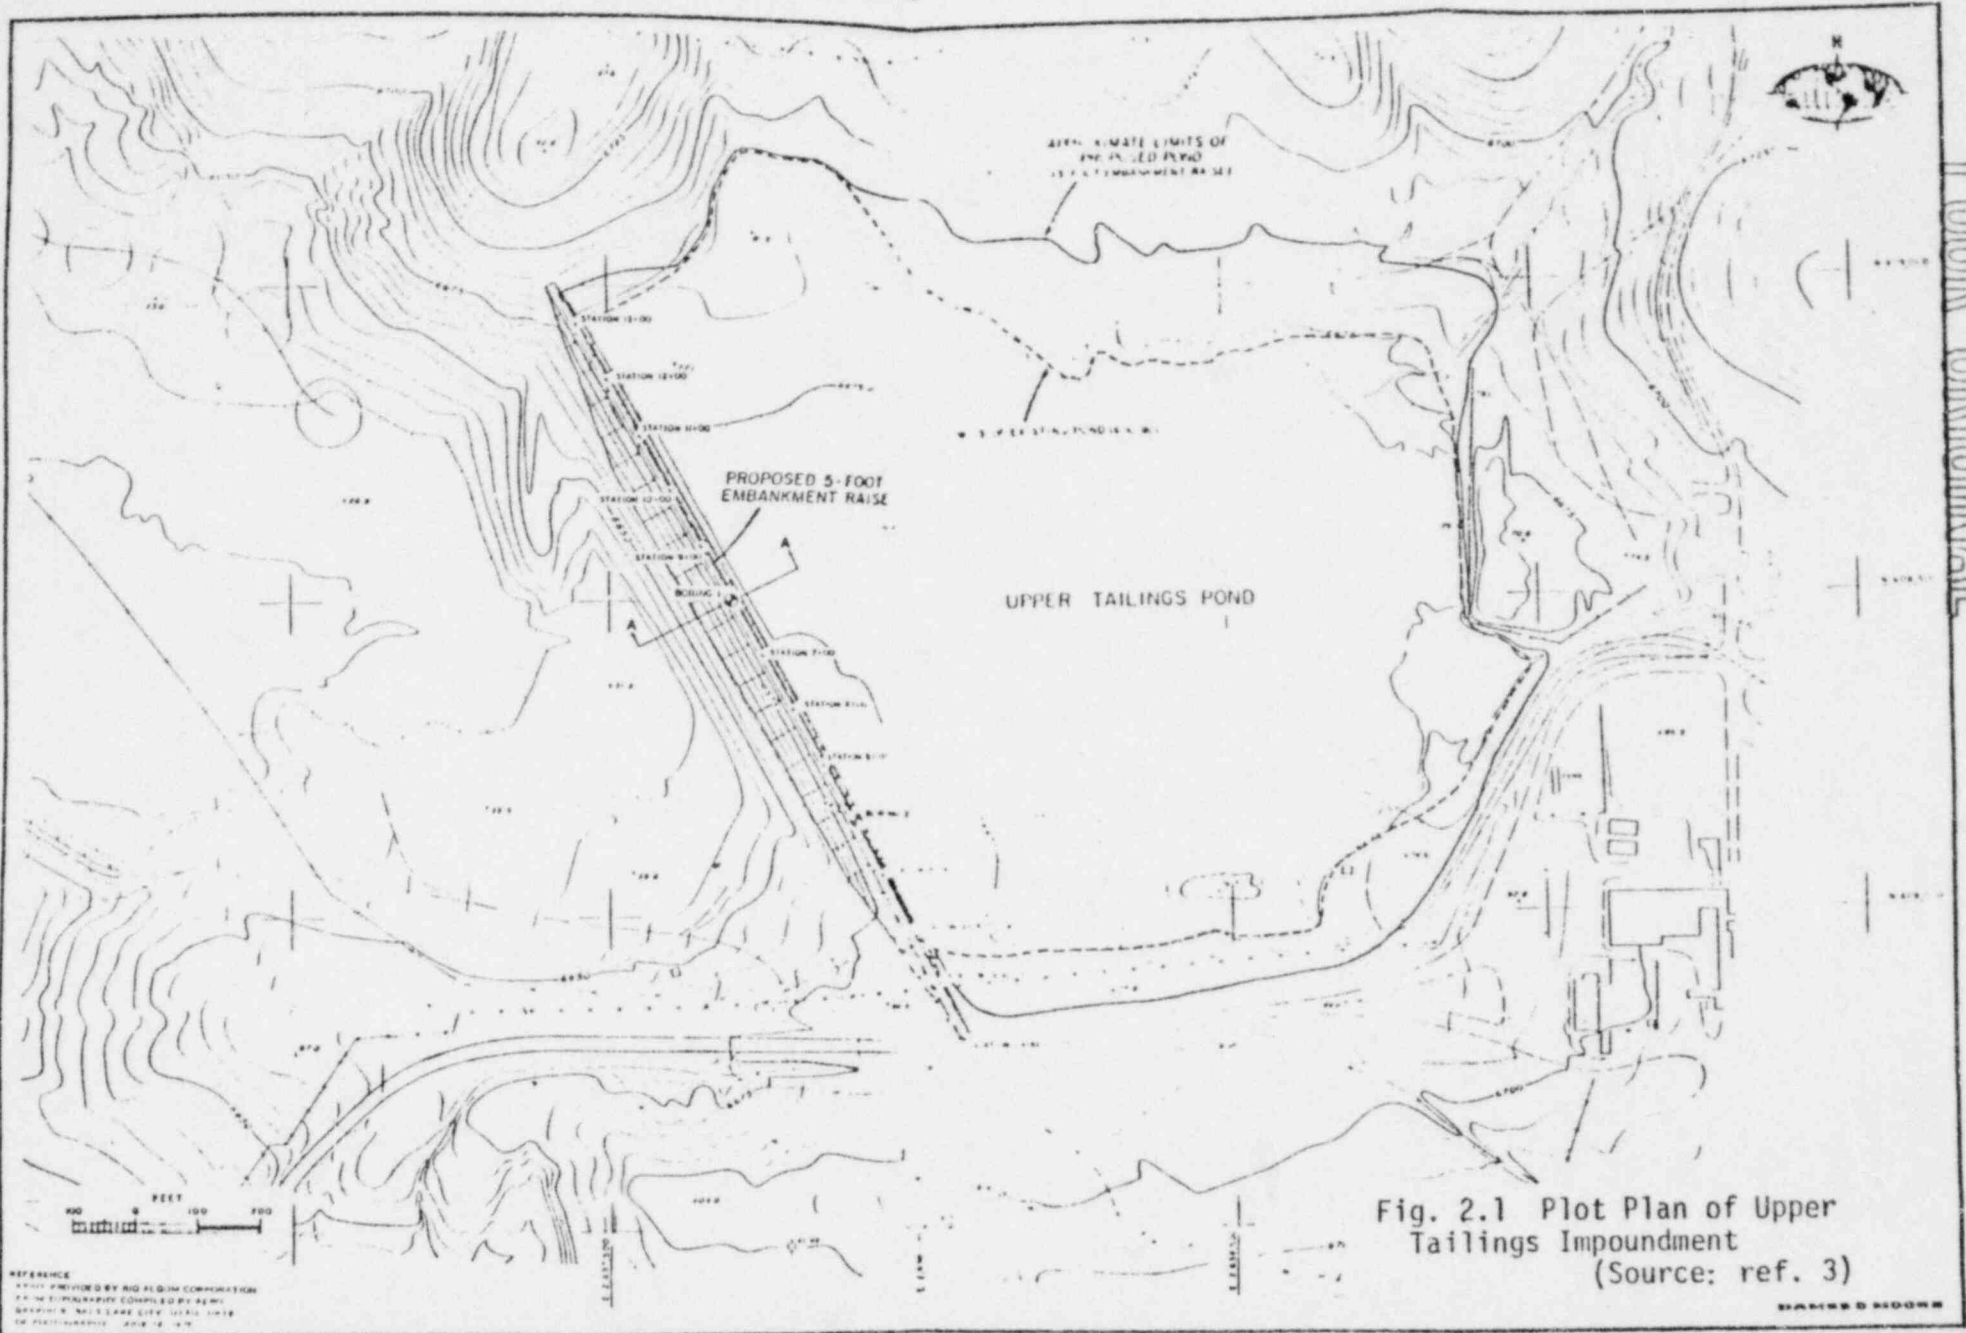
Fig. 2.1 Plot Plan of Upper Tailings Impoundment (Source: ref. 3)

The existing embankment and soil properties are described in the report by Dames and Moore dated August 22, 1980 (ref. 3). Figure 2.1 shows a plan view of the existing embankment and the proposed five-foot embankment raise. Figure 2.2 shows the critical embankment section through the existing embankment and the proposed five-foot embankment raise.

Borings were advanced at locations 1 and 2 as shown in Figure 2.1.

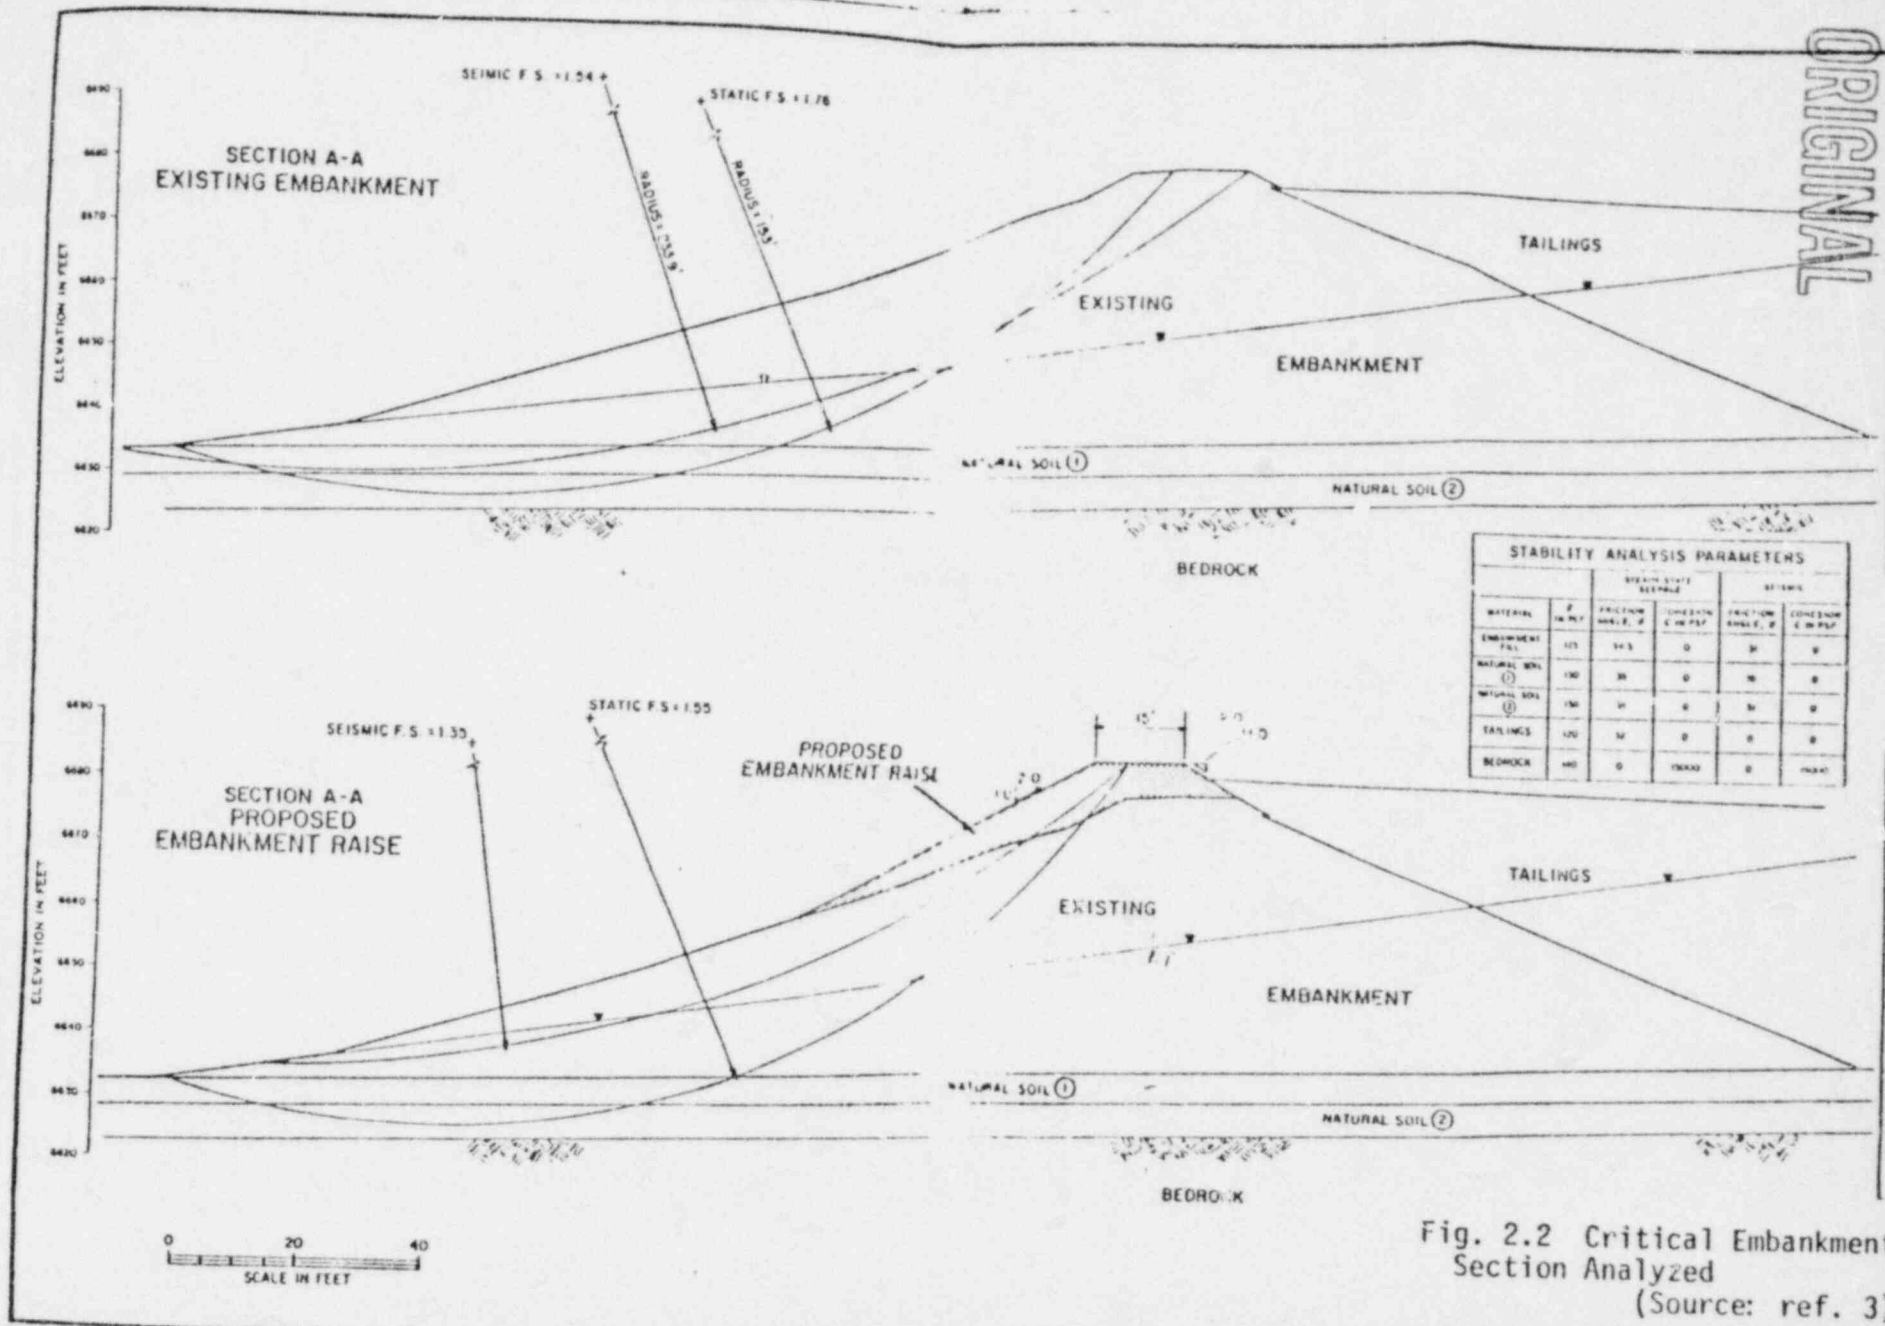
Fig. 2.2 Critical Embankment Section Analyzed
 (Source: ref. 3)

Stability analyses were conducted by Dames and Moore utilizing the shear strength parameters as shown in Fig. 2.2. The results indicated that the minimum factor of safety for static steady state seepage conditions would be 1.55. For seismic conditions, the minimum factor of safety would be 1.35. For static analyses, effective stress shear strength parameters were utilized whereas for seismic analyses total stress shear strength parameters were used.

Shear strength values for the natural foundation soils as shown in Figure 2.2 were not substantiated with laboratory data. Furthermore, laboratory test data presented in the Dames and Moore report dated October 2, 1973 (ref. 1) indicate that shear strength values considerably lower than those that were assumed for the stability analyses may exist in the foundation soils. The reviewers, therefore, conclude that inadequate shear strength data for the natural foundation soil has been presented.

The phreatic surface within the embankment that was assumed for purposes of stability analyses is shown in Figure 2.2. However, the boring logs indicate that to the entire depth of soil overlying the bedrock, no groundwater was encountered. Furthermore, piezometers placed at depths of 31.5 feet in boring 1 and 28.5 feet in boring 2 indicated no water at the time reference 3 was prepared. The two piezometers, however, were located near the top of the location of the phreatic surface as shown in Figure 2.2. Consequently, they are not capable of locating a phreatic surface even slightly lower than that. It

Stability analyses were conducted by Dames and Moore utilizing their in-house computer program. The critical failure surfaces that were determined are shown in Figure 2.2 of this report. The static factor of safety of 1.55 and the seismic factor of safety of 1.35 were indicated.

Stability analyses were checked at Colorado State University using the Computer Program STABL2. The program utilizes a modified Bishop's method similar to that utilized by Dames and Moore. This program computed a factor of safety of only 1.4 for the static condition shown in ref. 3. The STABL2 program generates conservative values and for that reason the actual factor of safety was checked by means of a hand calculation. This resulted in a factor of safety for the static critical section of 1.45. For the seismic analyses, the STABL2 program indicated a factor of safety of 1.14. This value is somewhat lower than that indicated by Dames and Moore. Nevertheless, it is greater than the value required by Regulatory Guide 3.11. An additional analysis was conducted

4.4 The boring logs and the piezometers indicate that the phreatic surface shown in Plate 4 of ref. 3 (see Fig. 2.2) is incorrect. It is not uncommon for the phreatic surface within an embankment to be lowered by a highly permeable natural foundation soil or through highly permeable bedrock. It was indicated in reference 3 that the upper layers of the sandstone bedrock are weathered and it is possible that the seepage is occurring therein. However, it is also possible that seepage could be occurring through a layer in the natural foundation soils causing a zone of high water content with low strength. It is recommended that adequate sampling in the natural foundation soils should be accomplished to show that such a zone of high moisture content does not exist that

4.2 The basis on which the shear strength of the natural soils was assumed was not presented. The applicant should show by means of laboratory data or field tests that the assumed values of shear strength are in fact accurate. If this can not be demonstrated, revised slope stability analyses should be conducted.

4.3 Page 7 of reference 3 indicates that a cutoff trench was excavated and recompactd beneath the embankment. However, the critical embankment section that was analyzed and is reproduced as Figure 2.2 in this report does not indicate that cutoff wall. The effect of that cutoff on the stability analyses should be discussed. Plate 4 in reference 3 (reproduced as Figure 2.2 herein) should be revised to indicate that such a cutoff does exist if it does, or else the text should be revised. Because the inspection report as presented in Appendix B of reference 3 indicates that a cutoff trench was excavated, the reviewers believe that Plate 4 (ref. 3) is incorrect and that the stability analyses should be revised.

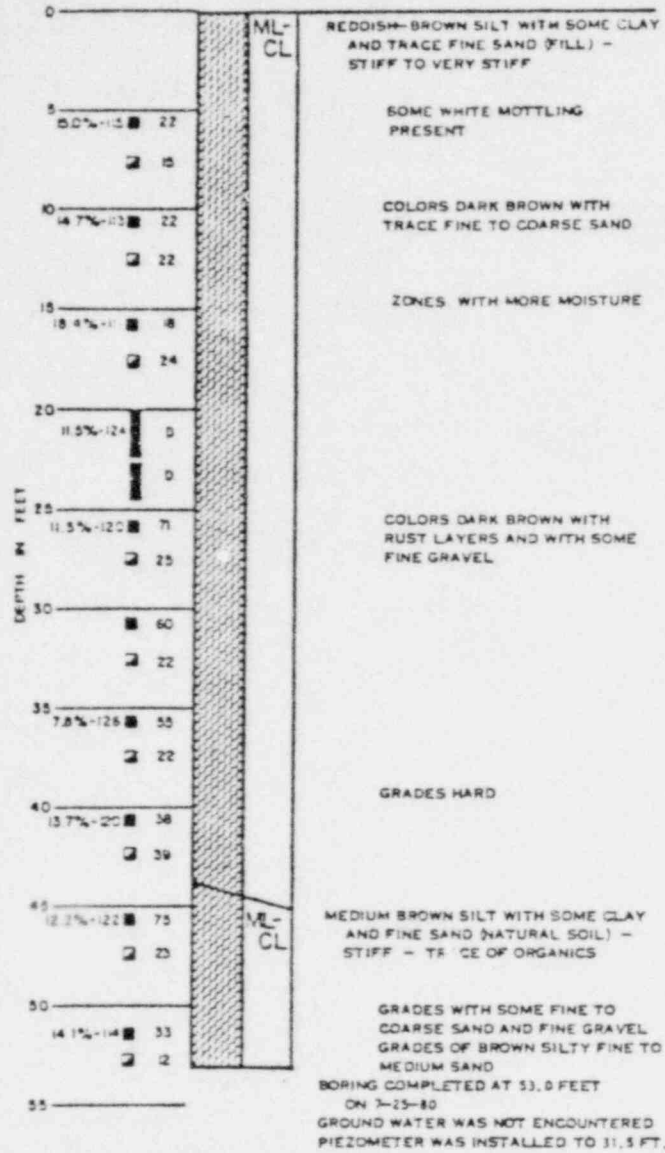
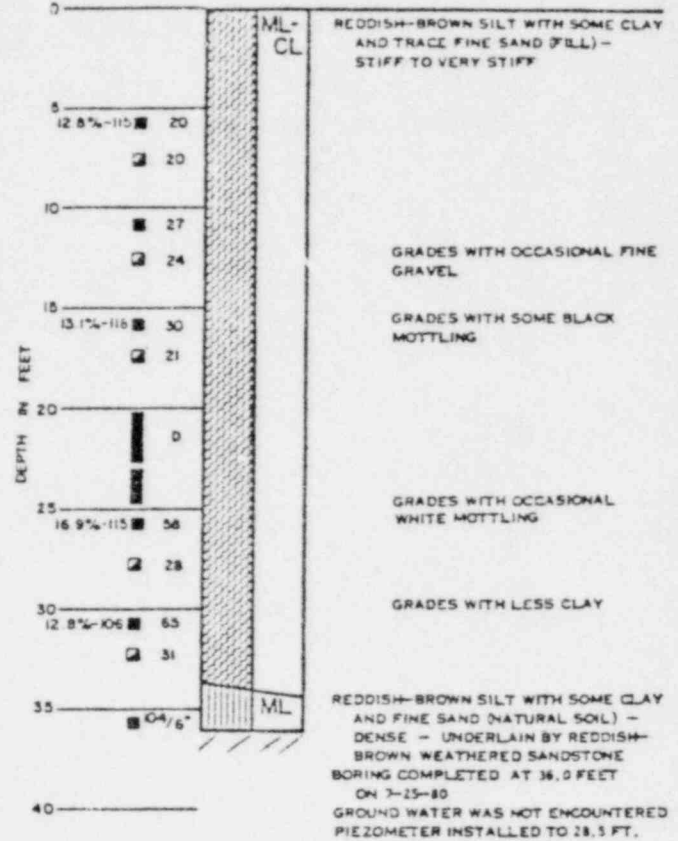
Fig. 2.3 Boring Logs
(Source: ref. 3)

The logs of those borings as presented by Dames and Moore are shown in Figure 2.3. Samples were taken from depths of 22.5 feet in each boring for laboratory testing and determination of shear strength. Multiple stage triaxial tests were performed on each of those samples. Stress paths and strength envelopes as presented by Dames and Moore (ref. 3) are shown in Figures 2.4 and 2.5. The triaxial tests indicated that for the embankment soil, the angle of internal friction was 34.5° and 38.5° in terms of effective stresses, and 31.0° and 40.0° in terms of total stresses. For one test, a cohesion of 800 psf was indicated whereas for all others the cohesion was zero.

The boring logs that were presented in reference 3 indicated that bedrock had not been encountered in the borings. A subsequent letter from James R. Boddy of Dames and Moore dated September 11, 1980 to Rio Algom (ref. 5) indicates that bedrock was, in fact, encountered. Furthermore, in reference 3 the critical embankment section (as shown in Figure 2.2 of this report) indicates two strata of natural soils. The basis for representing the natural soil in two distinct strata with different shear strengths is not presented and the boring logs do not indicate any basis for doing so. Also, on page 7 of reference 3 it is stated that a cutoff barrier was extended to competent bedrock. This cutoff barrier is not indicated in the critical embankment for stability analyses. It is concluded, therefore, that the critical embankment section as shown in reference 3 (Figure 2.2 of this report) does not represent the actual existing conditions with regard to geometry and shear strength of the foundation soils.

is concluded, therefore, that the locations of the peizometers are such that they would be unable to accurately describe the location of the phreatic surface unless it were relatively high.

4.1 It is recommended that a revised Appendix A to reference 3 be submitted. This Appendix should include corrected boring logs indicating any variations between the two strata of foundation soils. They should also indicate the depth to bedrock. In addition, this Appendix should include water content and dry density data for the second triaxial test sample.

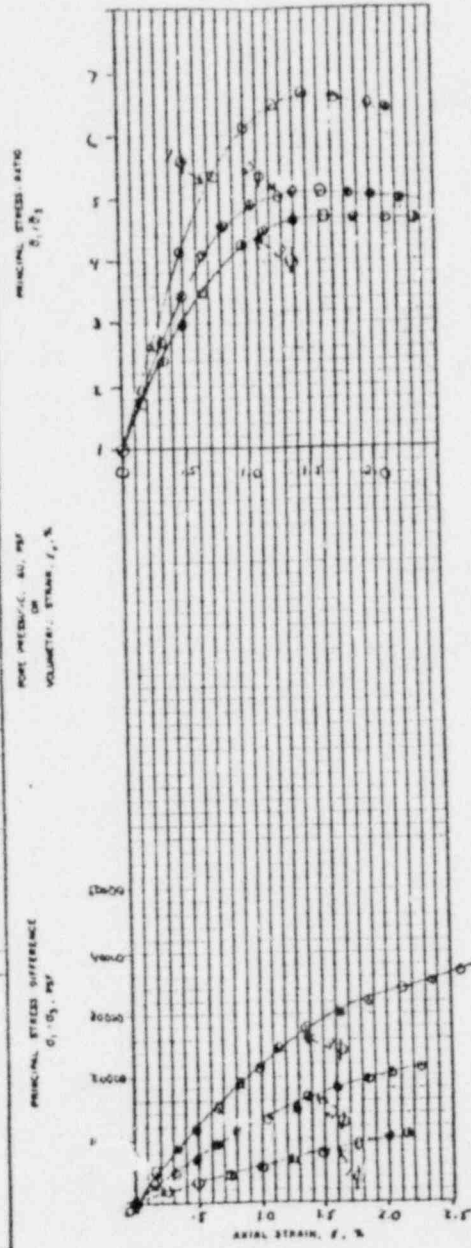
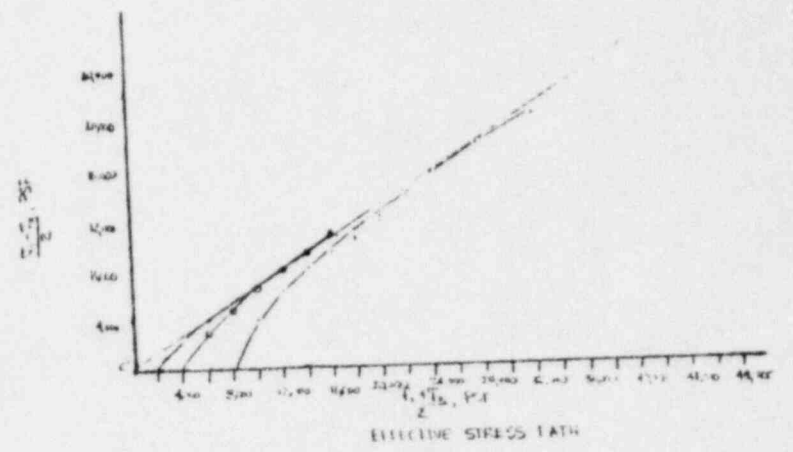
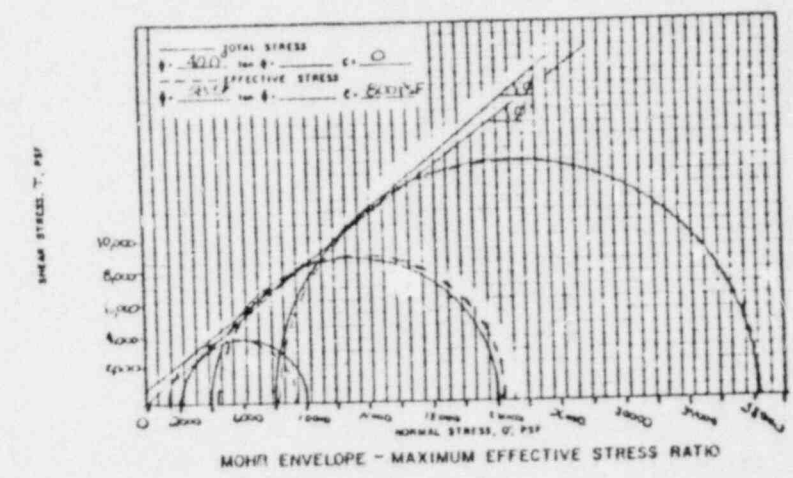
Fig. 2.4 Triaxial Test Results (Source: ref. 3)

Multiple stage triaxial tests were performed on two samples taken from the embankment. The test results indicated reasonable magnitude of shear strengths in terms of effective stresses. The shear strength parameters in terms of total stress, do not differ greatly from those for effective stresses. This is due to the development of low negative pore water pressures. This is reflected in the shapes of the stress paths and indicate the overconsolidated nature of the compacted embankment material. It is believed, therefore, that the total stress shear strength parameters that are reported, adequately describe the shear strength of the embankment.
