Consumers  
Power  
Company

March 3, 1972

Re: Docket 50-155  
DPR-6 (ZEK)

This is intended to apprise you of the loss of an off-site power incident which occurred at our Big Rock Point Nuclear Plant on January 25, 1972. During the outage caused by the loss of off-site power, a two-to-three-foot drop in the spent fuel pool water level was experienced and one of two d-c operated emergency condenser valve (MO-7063) failed after opening automatically as required by reactor pressure conditions.

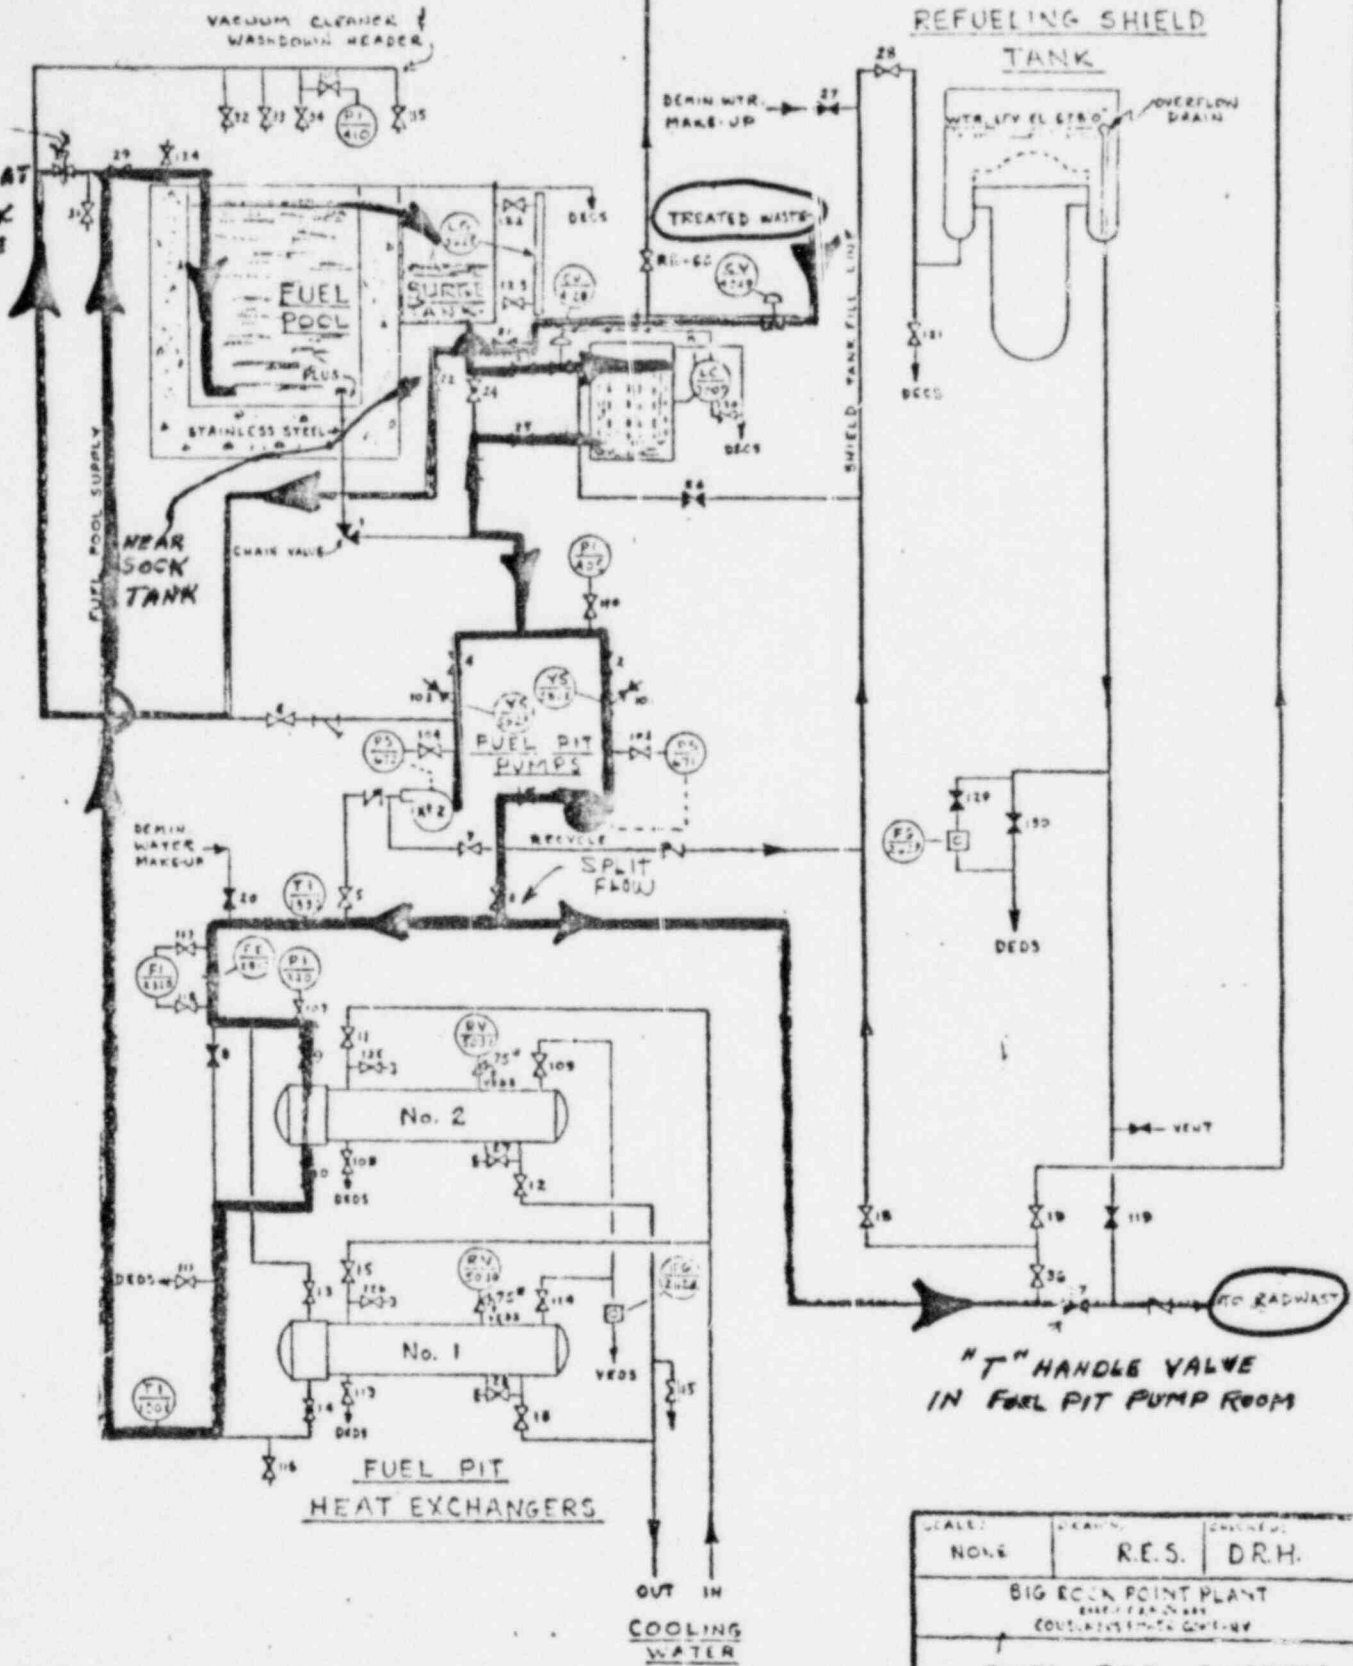
FUEL POOL RECYCLE TO RADWASTE **POOR ORIGINAL**

At the time the outage occurred, the fuel pool was valved for recycle through the radwaste system. However, upon loss of the normal station power, the fuel pit, radwaste and treated waste pumps ceased to operate and the fuel pit to radwaste isolation valves CV-4027 and CV-4117 closed automatically.

Thus, the hydraulic head was available to create a siphoning action (11'-6" head) from the fuel pool to the clean waste receiver tanks when the isolation valves were reopened. (See Attachments 2 and 3.)

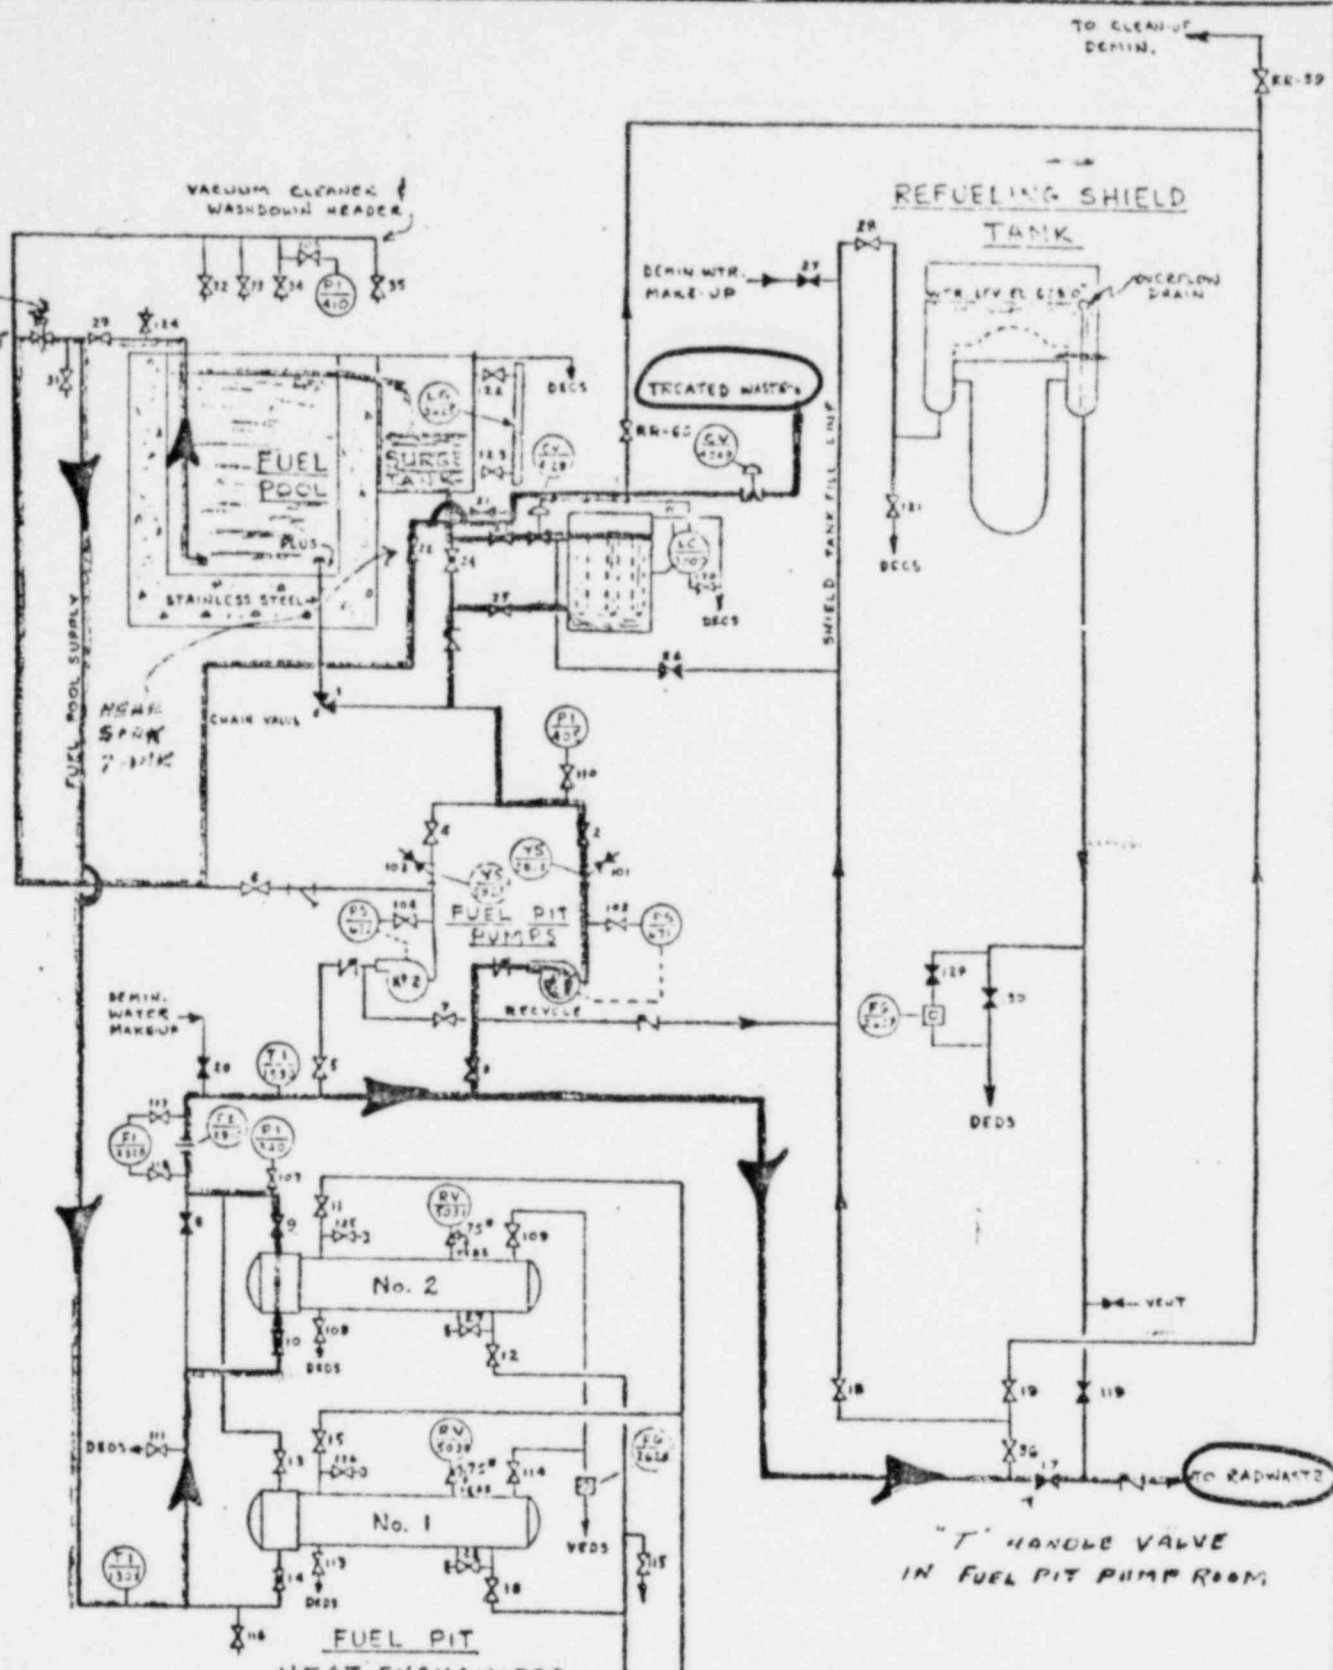
ABNORMAL SYPHONING FLOW TO RADWASTE

The first indication of an abnormal spent fuel pool water level was at 0100 on January 26, 1972 when the Control Room Operator observed a gradual increase in the fuel pool area monitor readings (approximately 12 mR). A visual inspection followed. The fuel pool water level was discovered to be two to three feet below the normal overflow to surge tank level. Detailed investigations of this decrease in fuel pool water level revealed the cause to be a siphoning action created by the piping configuration and valve alignment.

The critical elevations in the piping sequence are as follows:

1. Discharge Pipe at Bottom of Pool - 601'-6"
2. Highest Elevation of Pipe at Pool Surface - 630'-6"

3. Elevation of Sphere Isolation Valves - 593'-6"
4. Elevation of Pipe Where It Opens Into Clean Waste Receiver Tanks - 590'

With the loss of two to three feet of water, equipment hanging on the side of the pool such as flange protectors, sample specimen racks and vacuum hoses were exposed to some extent. A fuel bundle was located in the elevator which was at the top of its vertical travel. The elevator has a pneumatic stop at seven feet below normal water surface and a mechanical stop at six feet. The decrease in water shielding allowed an increase in radiation dose rate in the vicinity of the fuel pool.

After the discovery, the valve to radwaste ("T" handle valve in fuel pit pump room) was closed and the fuel pool level restored via the waste hold tanks.

To prevent any further reoccurrence of the problem, a siphon breaker has been added to the inlet piping of the spent fuel pool. Three 7/16" holes were drilled in a horizontal pattern on the vertical section of inlet piping about 2" below the normal fuel pool level. On February 2, a test of the siphon breaker was conducted under conditions similar to those of January 25 and the siphoning action ceased when the pool level reached the three holes.
