Consumers Power Company

June 17, 1971

Re: Docket 50-155
DPR 6 (ZEK)

Sketch of Removed Section of 3-inch Sch80 Piping

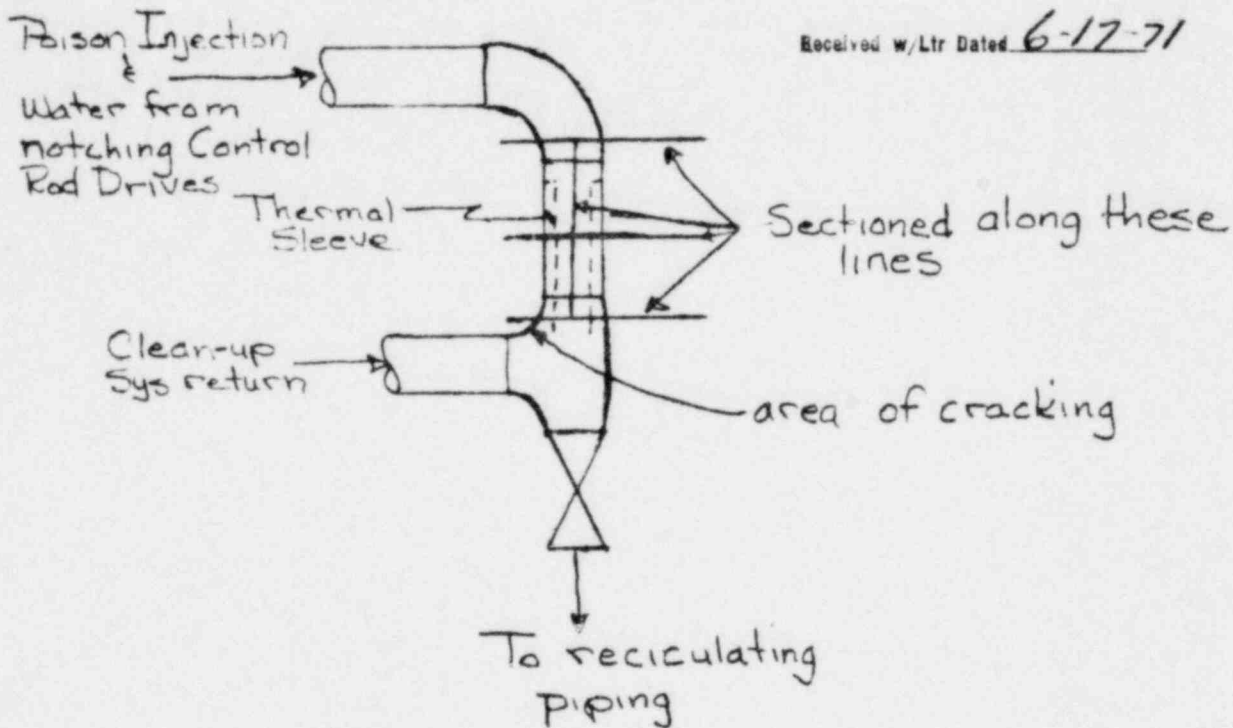
During the February-March 1971 refueling outage, a short section of three-inch 304 stainless steel clean-up system piping was replaced due to five welds of questionable quality located in this piping. The replaced piping was at the tee where the clean-up system return water mixes with poison system injection water and water displaced from control rod drives when they are notched. The intention to replace this piping and the welds was reported in the 13th Semiannual Report of Operations for the Big Rock Point Nuclear Plant. It was obvious after sectioning the removed piping that the welds did not meet Code standards. These welds showed what appeared to be incomplete fusion and "suckback" in the root pass.

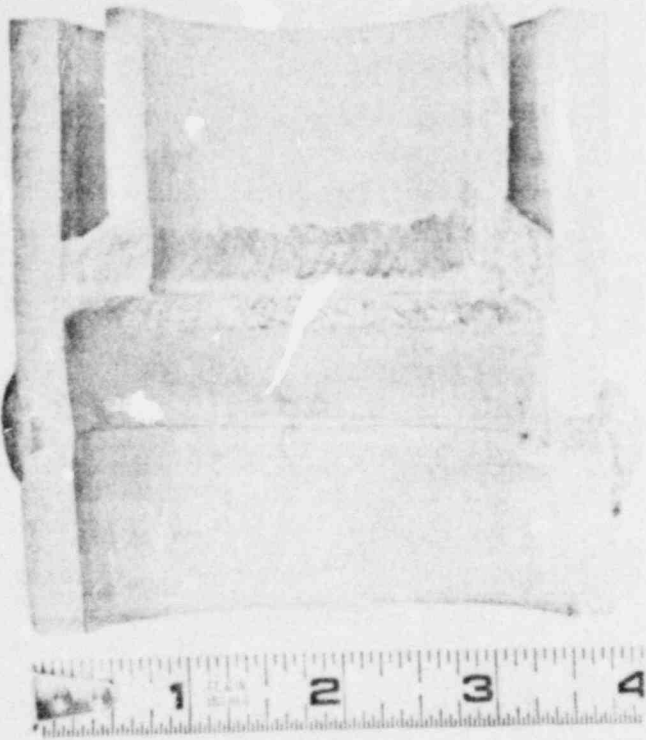
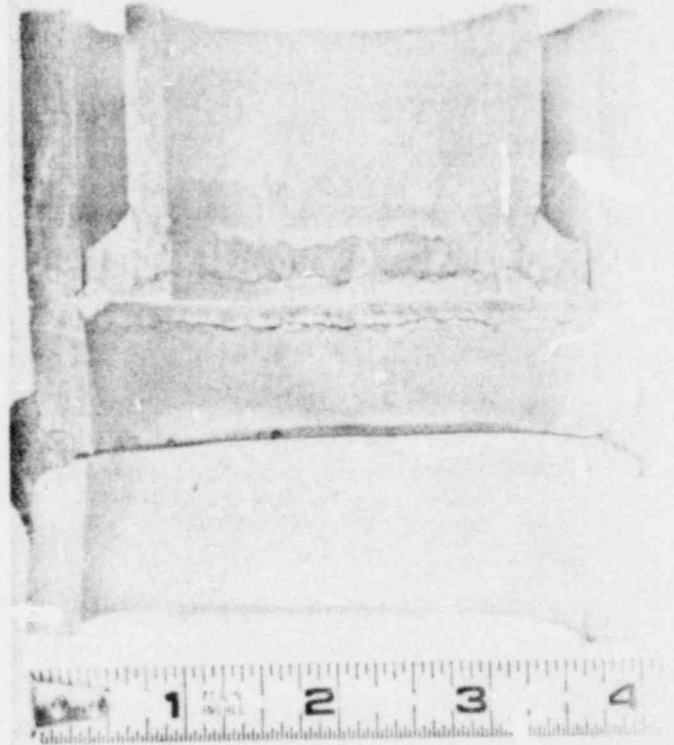
Inside of Sectioned Elbow

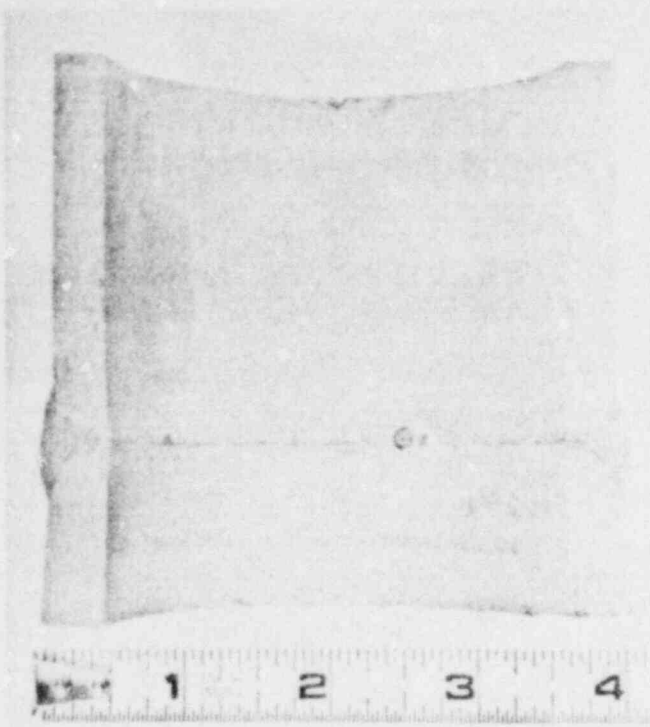
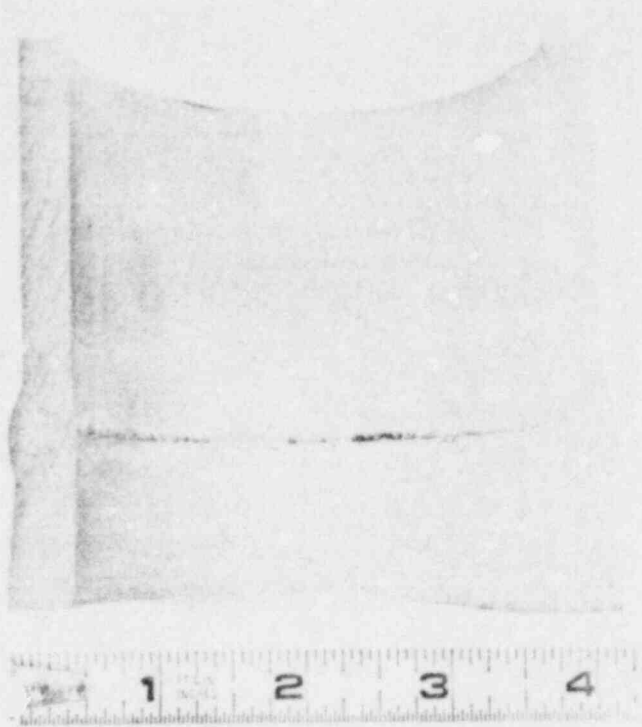
While the pieces of the welds were being prepared for shipment to the two vendors involved in the weld inspections, it was noted that the three-inch tee removed contained four slight cracks. These were on the ID of the tee and approximately one third to one half of the pipe wall thickness deep. They are not located in the heat-affected weld zone, but in the radius curvature as shown in the attached pictures and sketch. This is where the highest density of thermal cracks appeared on the previously failed tee reported in the 5th Semiannual Report of Operations dated December 20, 1966.

The cracking appears to be very similar but much less extensive than that observed in 1966. The 1966 failures were attributed to a thermal-induced fatigue failure. It is noted that the original tee had a service

Inside of Sectioned Tee
(Note cracks in upper right picture)

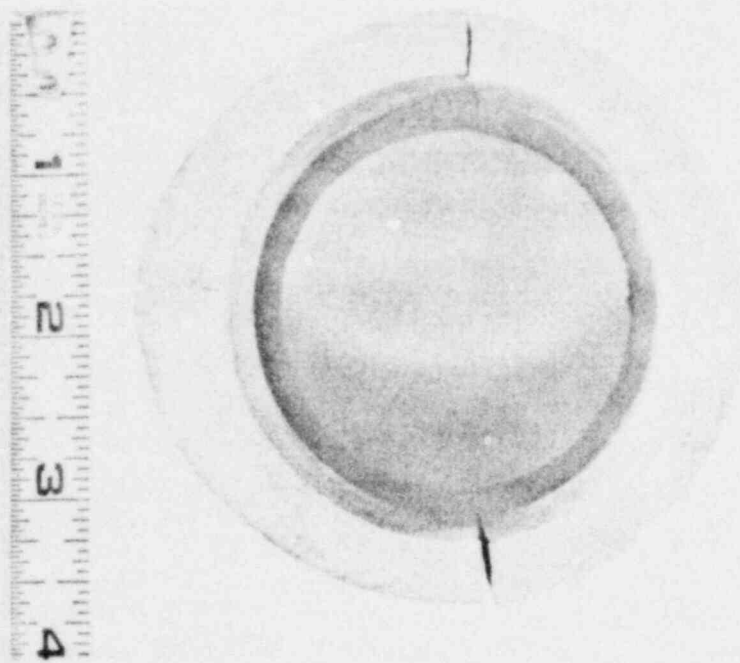
End View of Sectioned Tee
