SUBJECT: Beaver Valley Power Station - Unit No. 2
Docket No. 50-412
Linear Indications in Gib Gusset Welds in Reactor Vessel
Structural Support (Neutron Shield Tank) .
Significant Deficiency 80-03

Interim Report No. 2

Linear Indications In Gib Gusset Welds in Reactor Vessel

Beaver Valley Power Station - Unit No. 2

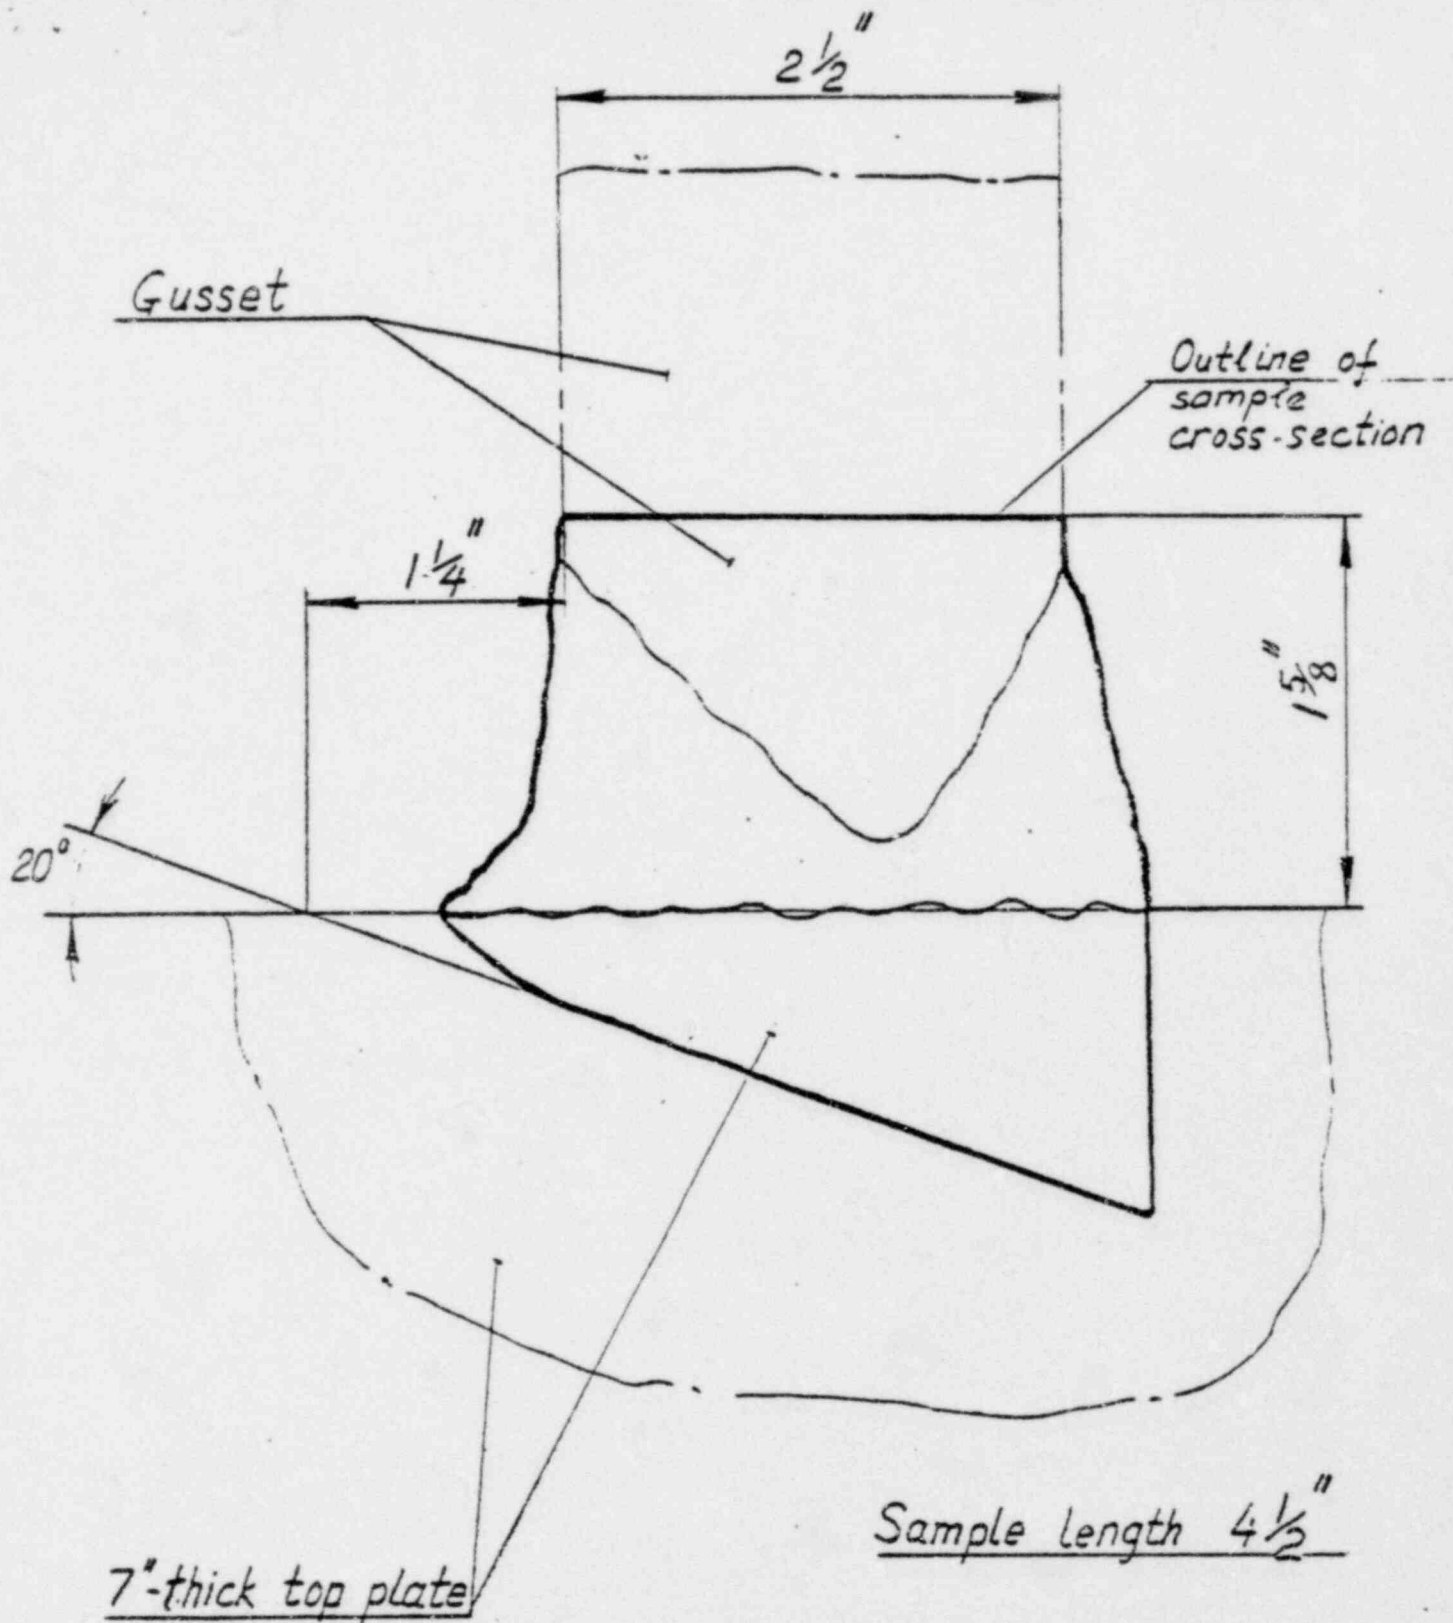
FIGURE 2

A weld sample (See Figure 2) was removed by drilling and cutting from the gib gusset that showed the most extensive ultrasonic indications. Material from the weld metal, gusset and top plate was taken from one of the sections for chemical analysis. The analysis showed no deviations from the specified chemistry or from normal trace elements.

POWER INDUSTRY GROUP		TITLE			SCALE:	
CHECKED		Sample for metallurgical examination			DATE:	
CORRECT					SKETCH NUMBER	
APPROVED						
REVISIONS	(2)	(3)	(4)	(5)

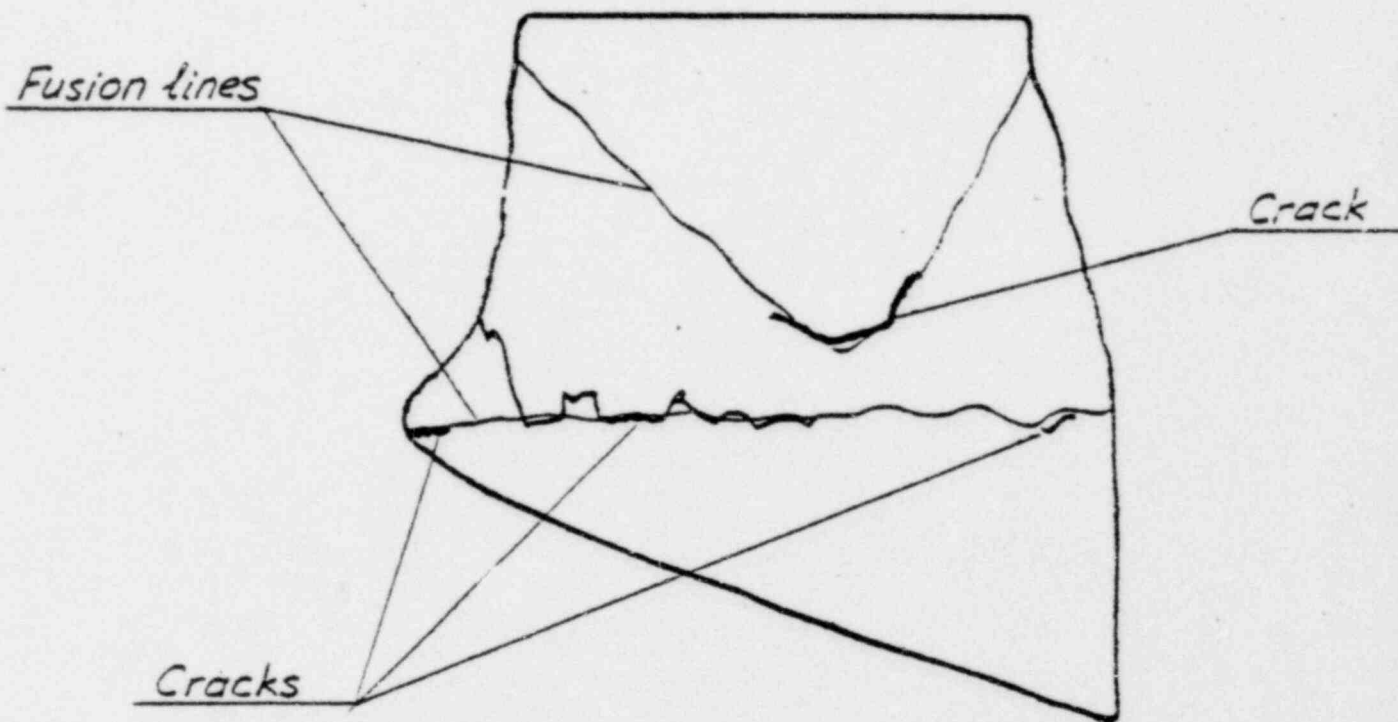
FIGURE 3

Macroscopic examination of polished and etched sections revealed various degrees of cracking, predominantly in the vicinity of the fusion zone of the top plate and along the weld-prep bevels of the gusset, the most severe as represented in Figure 3. The cracks in the top plate apparently initiated in the weld heat-affected zone, near the root of the weld, and propagated outward,

toward the weld surface, close to the fusion boundary, partially along the heat affected zone and partially through weld metal. It is now believed these cracks propagated during stress relief. The smaller cracks in the gusset and gib plates were located near the fusion boundary, close to the root of the weld, and have the appearance of delayed, cold, hydrogen-initiated cracks.

High temperature oxide on the fracture surface of both types of cracks indicates exposure to air above 800°F; clearly the cracks existed prior to, and/or developed during, stress relief. The cause of cracking is still being investigated. It is postulated at this time that the most probable cause of the defects was hydrogen delayed cracking aggravated by post weld heat treatment. There is no evidence of lamellar tearing in the top plate, which is fabricated from an electroslog remelted steel.

POWER INDUSTRY GROUP		TITLE <i>Representative cracks</i>		SCALE:	
CHECKED				DATE:	
CORRECT					
APPROVED					
REVISIONS	(2)	(3)	(4)	(5)	SKETCH NUMBER

Based on the reinspection performed to date, all the gibs (12 total) and all the gib gussets (48 total) will be removed and replaced, using a weld fabrication procedure/sequence (see Appendix I) that should eliminate the weld deficiencies that exist in this area of the support structure. An upgraded NDE program for the reworked gib and gib gusset welds has been established and is equivalent to the program for all the other welds on the structure, that were ultrasonically inspected by the vendor, and to acceptance criteria that would satisfy present code standards.
