REPORTABLE OCCURRENCE 81-008  
ISSUE 0  
Page 1 of 5

FORT ST. VRAIN NUCLEAR GENERATING STATION  
PUBLIC SERVICE COMPANY OF COLORADO  
16805 WELD COUNTY ROAD 19 1/2  
PLATTEVILLE, COLORADO 80651

REPORT NO. 50-267/81-008/03-L-0

IDENTIFICATION OF  
OCCURRENCE:

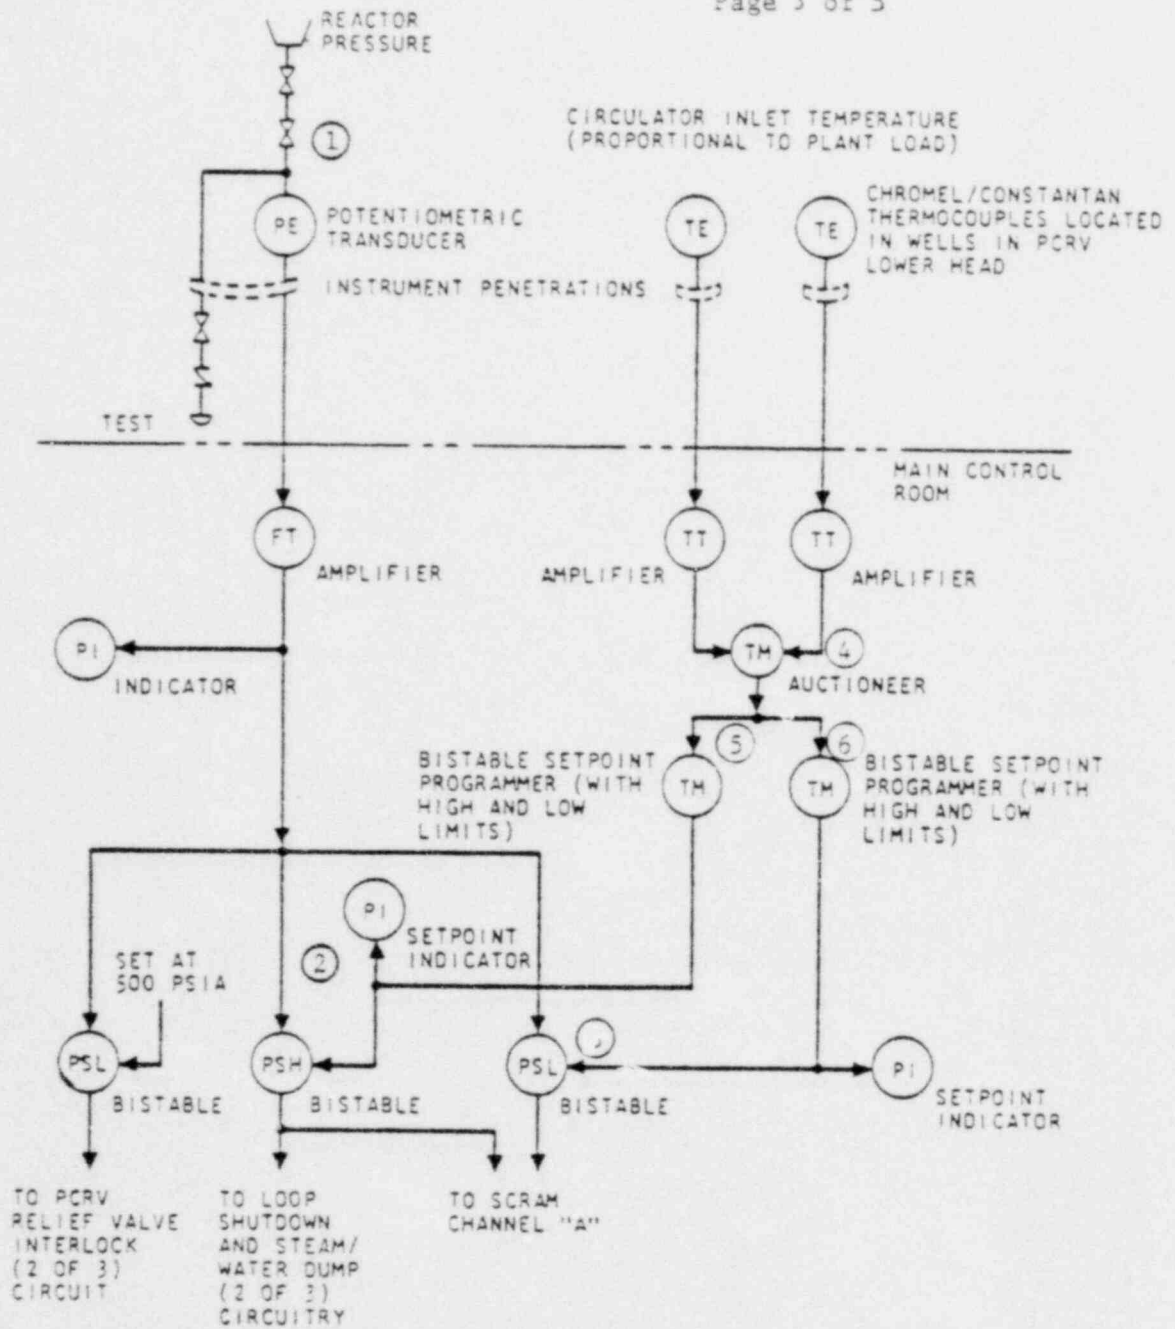
FIGURE 1

(See Figure 1) While performing the annual calibration of the primary coolant pressure scram channels, plant instrument personnel observed that three of the pressure transmitters (1) were out of calibration in the non-conservative direction and would have resulted in the pressure switch highs (2) tripping at a higher pressure than allowed by the LCO requirements. The low reading of the pressure transmitters (1) would have caused the pressure switch lows (3) to trip sooner at a higher, more conservative pressure than required.

The low pressure signals were due to instrument drift of the pressure transmitter.

The pressure transmitters were calibrated during the procedure, returned to service, and the surveillance test was successfully completed.

Once a month, on a temporary basis, the pressure transmitter voltage outputs will be checked against reactor pressure to determine if further instrument drift is occurring. The monthly test will be conducted until the next regularly scheduled surveillance calibration is required or until it is determined that instrument drift is not occurring.

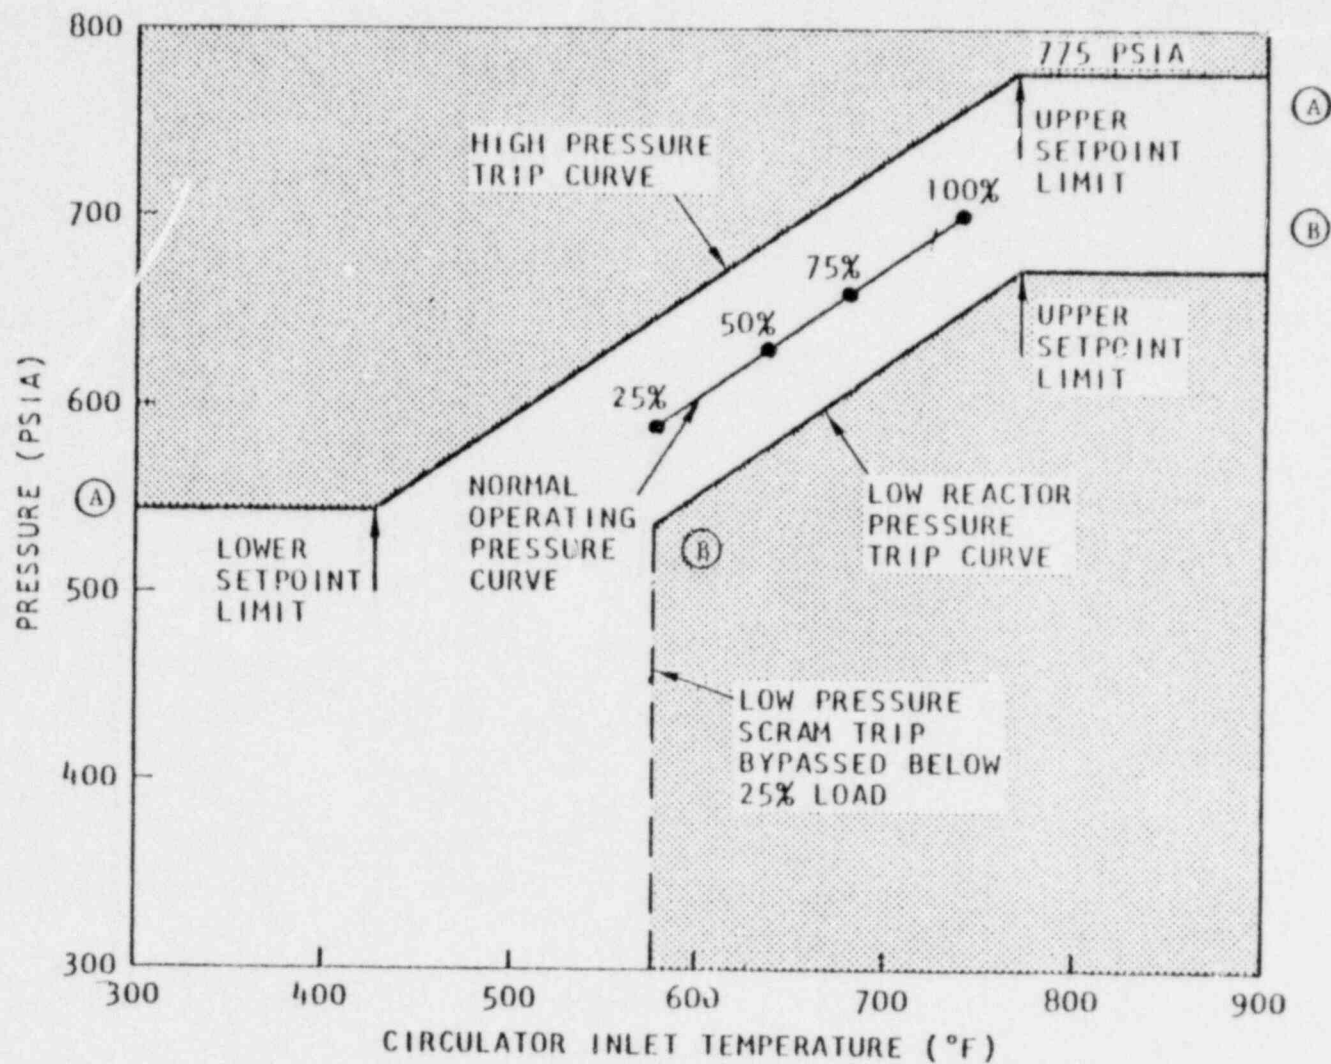
FIGURE 2

The high and low pressure trips (2) and (3) are programmed by circulator inlet temperature through an auctioneer circuit (4) and a bistable setpoint programmer (5) or (6). The programmed pressure temperature curve is shown in Figure 2. The low output signal from the pressure transmitter could have resulted in the high pressure trips occurring above the allowable high pressure curve (line A A). The low pressure trips would have occurred above low pressure trip curve (line B B) in a conservative direction.
