Observations and Comments on the Turbine Failure at Yankee Atomic Electric Company, Rowe, Massachusetts

Manuscript Completed: November 1980
Date Published: March 1981

Prepared by
A. Goldberg, R. D. Streit

Lawrence Livermore Laboratory
7000 East Avenue
Livermore, CA 94550

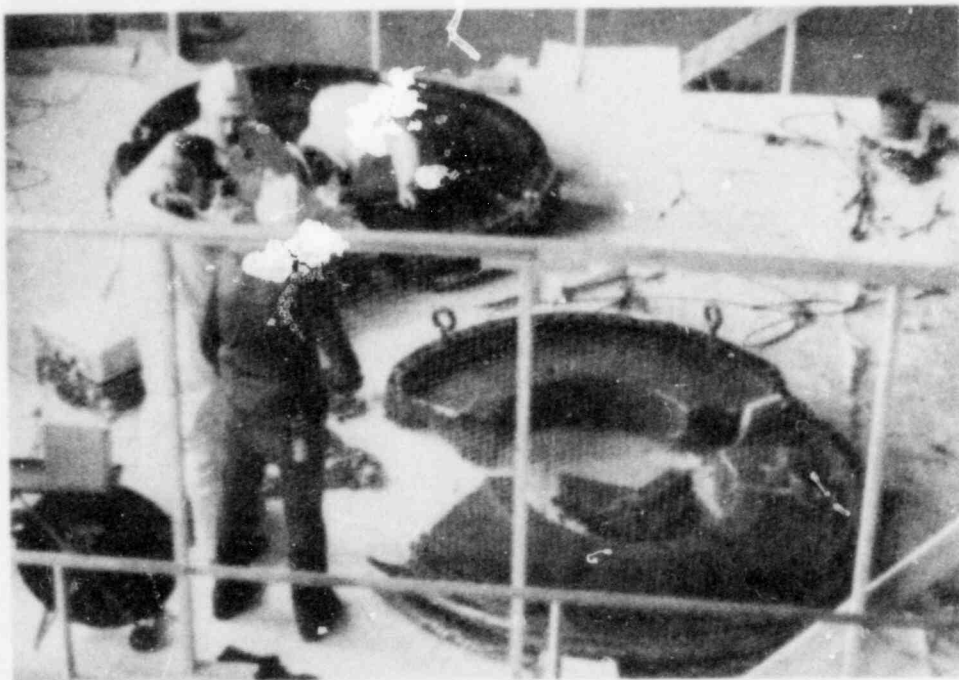
When we arrived at the site, the fractured sections were grouped according to their original location in the two respective discs (Fig. 2). The No. 1 governor-end disc (gov. disc) is close to the camera; the No. 1 generator-end disc (gen. disc) is away from the camera. The inlet faces of both discs are facing up. All of the blades from these two discs, as well as all the blades from the No. 2 discs and about half of the blades from the No. 3 discs, were

FIG. 2. Overall view of failed No. 1 turbine discs. Governor end is nearest the camera.

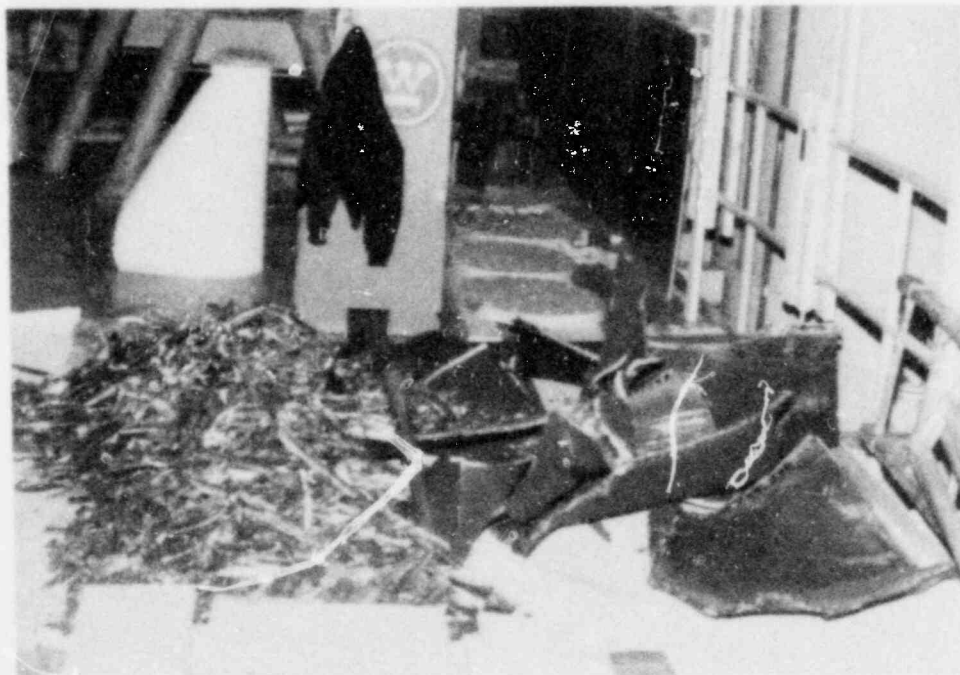
badly disintegrated (deformed and fractured). The blades that had separated from the discs were found piled together with the damaged turbine steam shroud (Fig. 3). The remaining blades were still intact; however, many showed considerable damage (Figs. 4, 5, and 6). Erosion/corrosion could be seen on the leading edge of numerous blades on the remaining discs.

FIG. 3. Pile of miscellaneous parts from inside the turbine cavity; broken turbine blades and shroud.

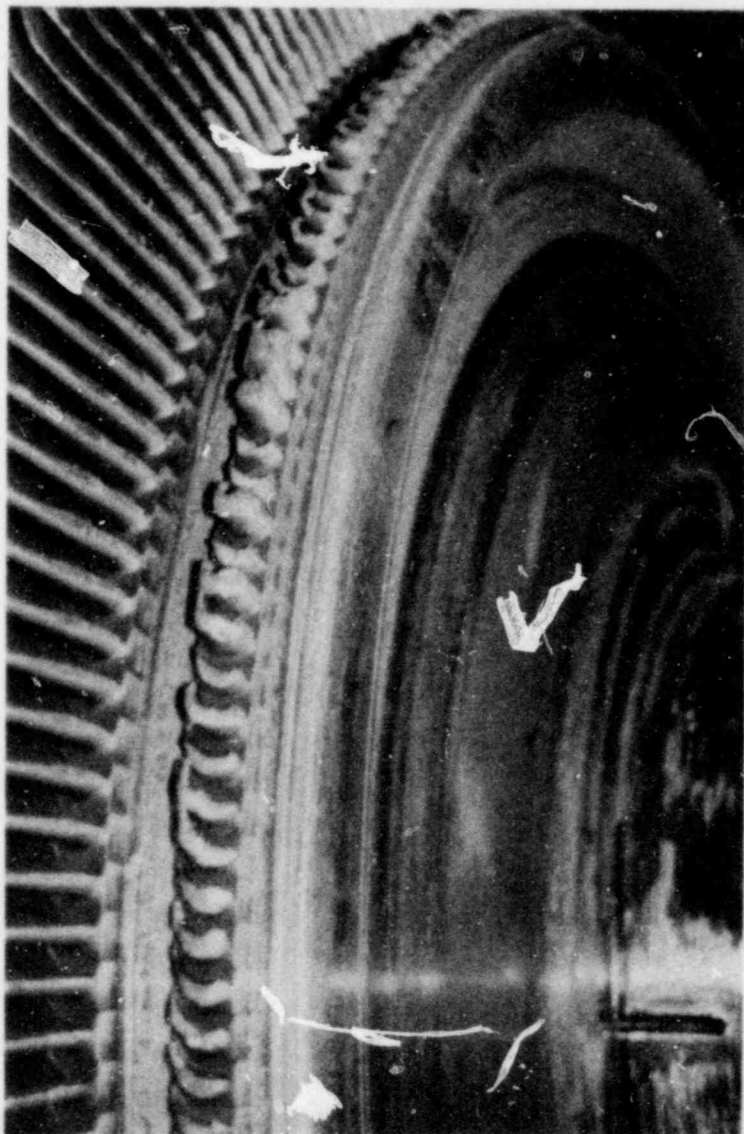
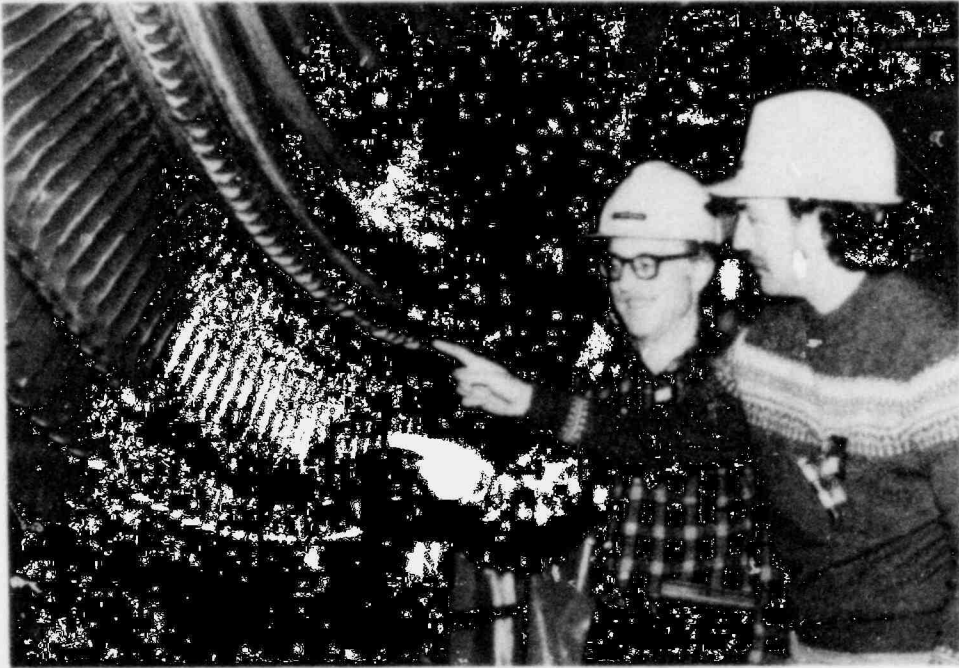
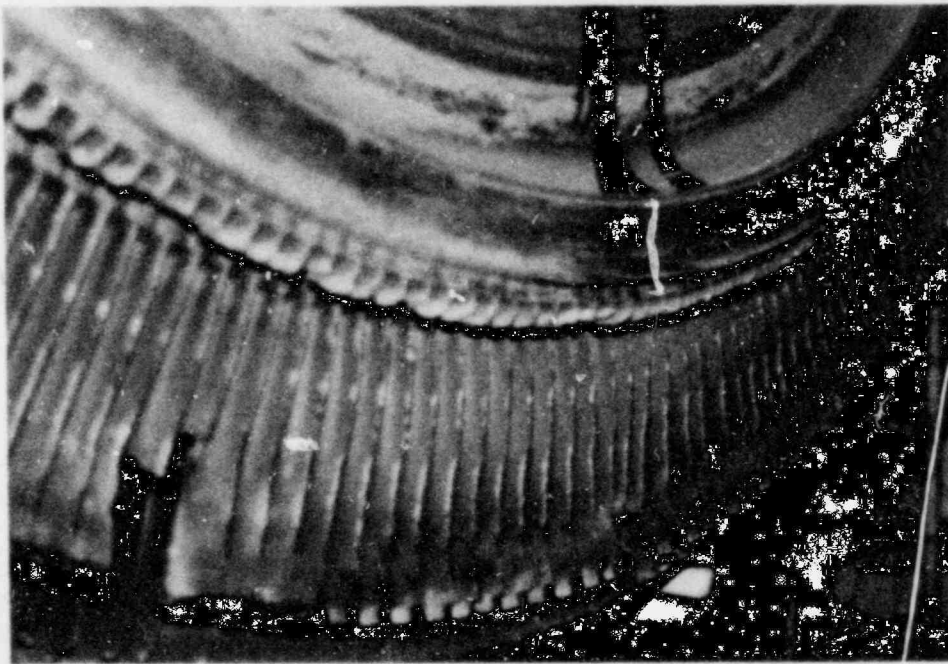
FIGS. 4-6. Views of the LP turbine assembly, showing blades, discs, and shaft after failure. The inside disc is the No. 2 disc.

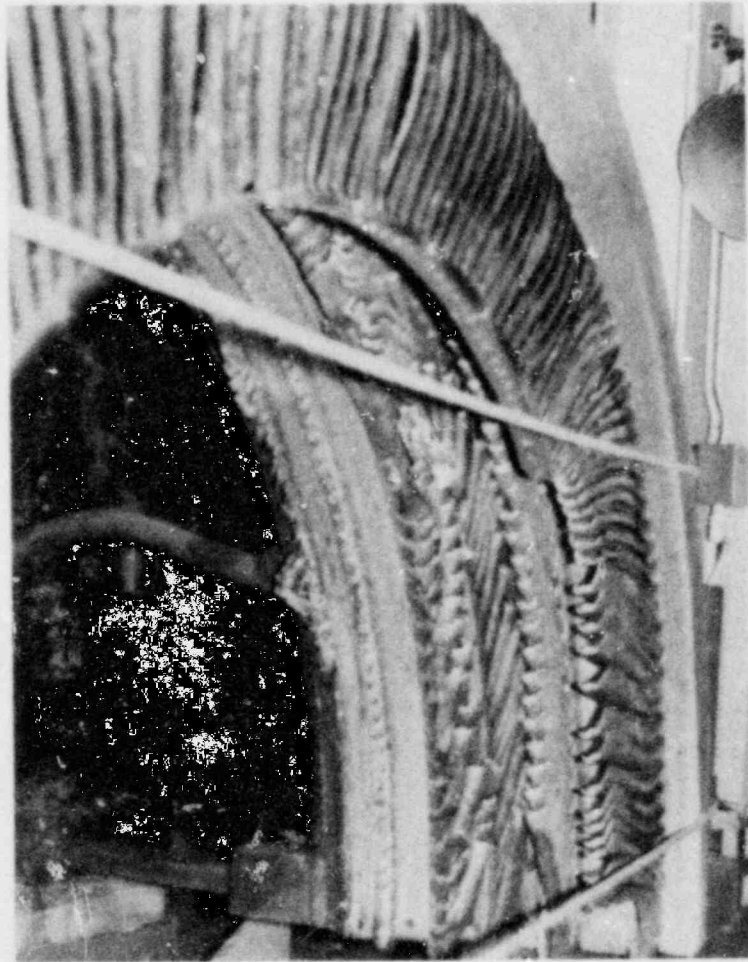
None of the broken pieces had penetrated the turbine containment. However, there appeared to be considerable damage to the inner covers (Figs. 7 and 8); and further, large cracks were observed at the alignment pin hole in the outer cover (Figs. 9 and 10).

FIG. 7. Inner cover of the LP turbine.
Note damage to the reinforcement bars and
stator blades.

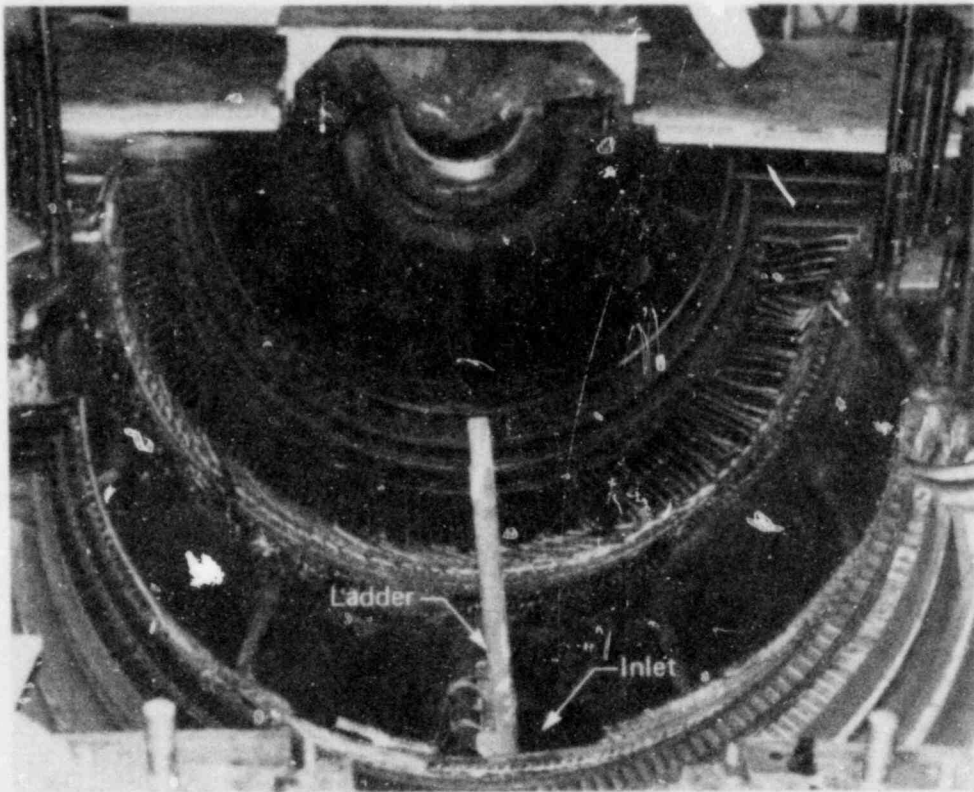
FIG. 8. Turbine cavity with steam inlet at the bottom (ladder). Note bending of reinforcement bars.

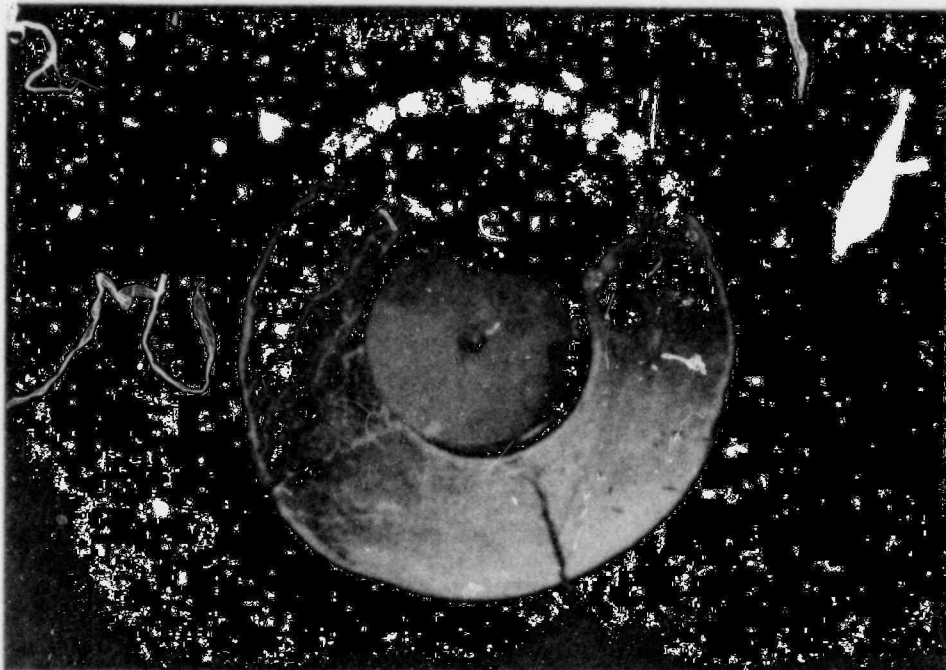
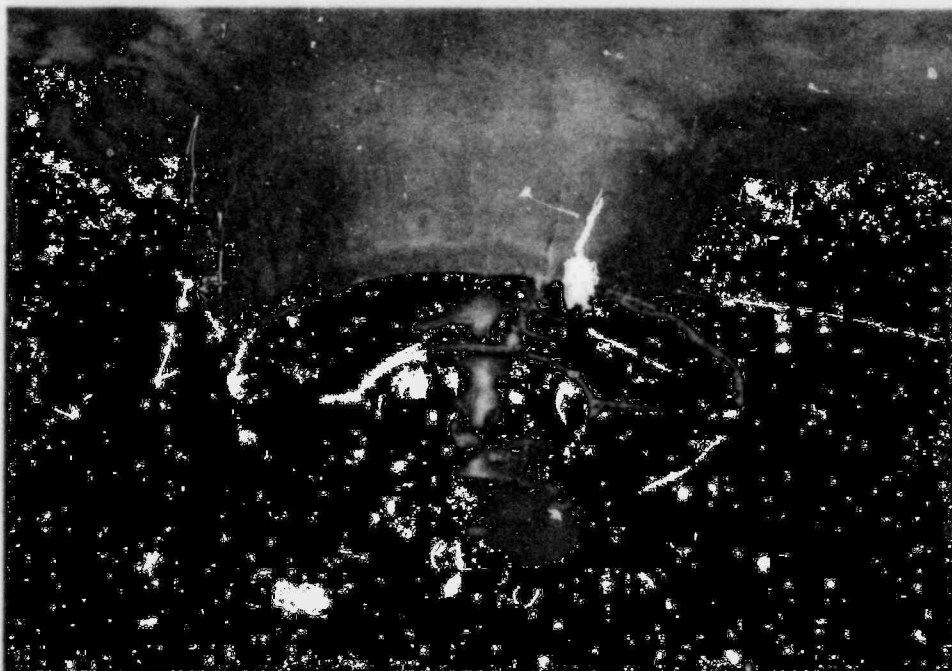
FIGS. 9-10. Locating pin on the inside of the outer cover of LP turbine.

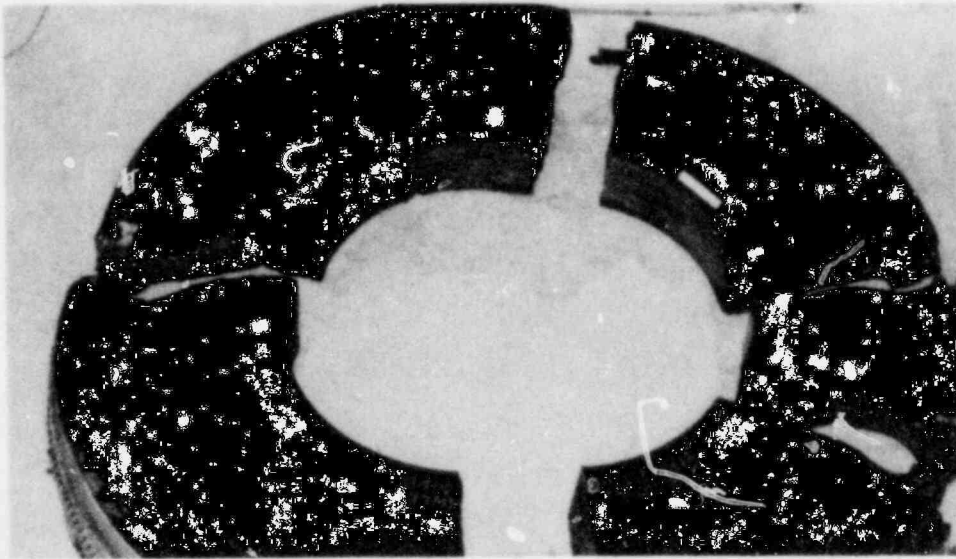
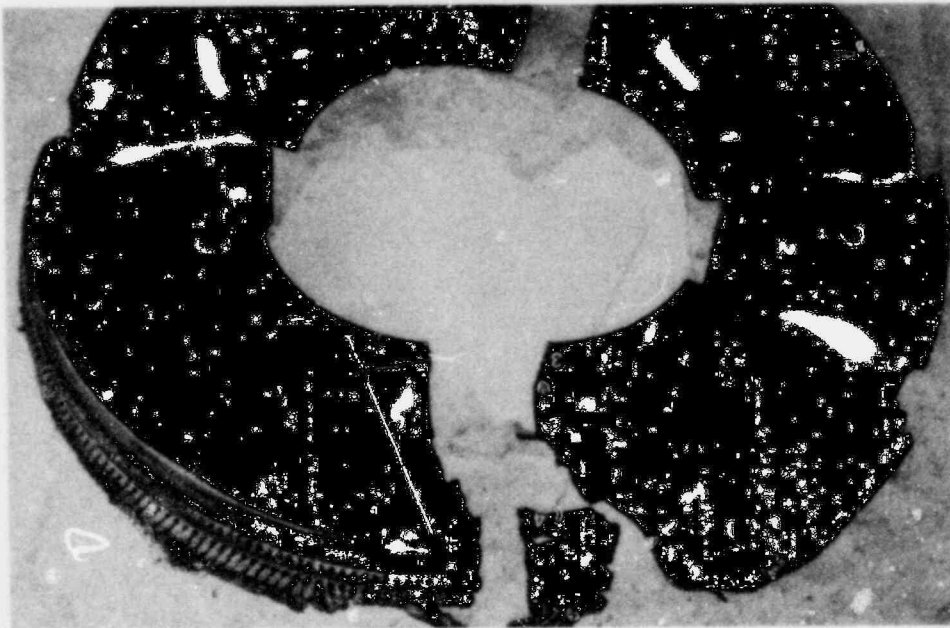
The No. 1 gen. disc had fractured into six sections. These were numbered 1 through 6, with No. 4 being a small section out of the rim (Figs. 11 and 12). The corresponding gov. disc had fractured into two large sections and six small pieces. The large sections were numbered 1 and 6 with arcs of approximately 130 and 190 degrees, respectively. The six smaller pieces are identified as Nos. 2, 3, 4, 5, 7, and 8 (Figs. 13, 14, 15, and 16). Both discs exhibited evidence of rubbing during the failure--especially on the gov. disc. The discs measure approximately 36 in. (0.91 m) i.d. by 80 in. (2.03 m) o.d., with the thickness at the rim and bore about 9 and 10 in. (0.23 and 0.25 m), respectively. The thinnest section of the web is about 4 in. (0.10 m).

FIGS. 11-12. View from above the No. 1 generator-end disc, inlet side up. Note 6-inch scale on Section 1.

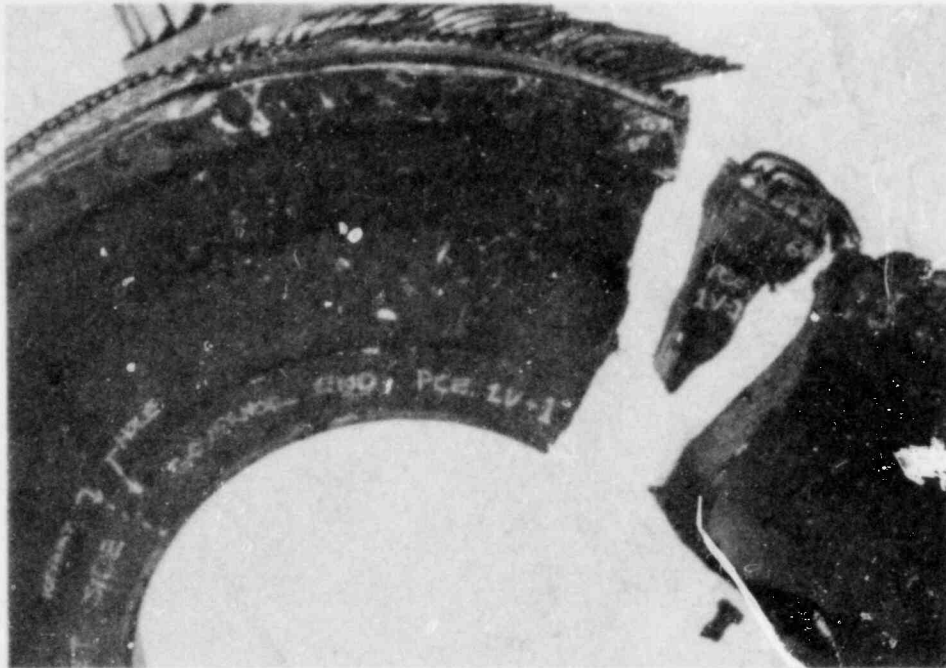
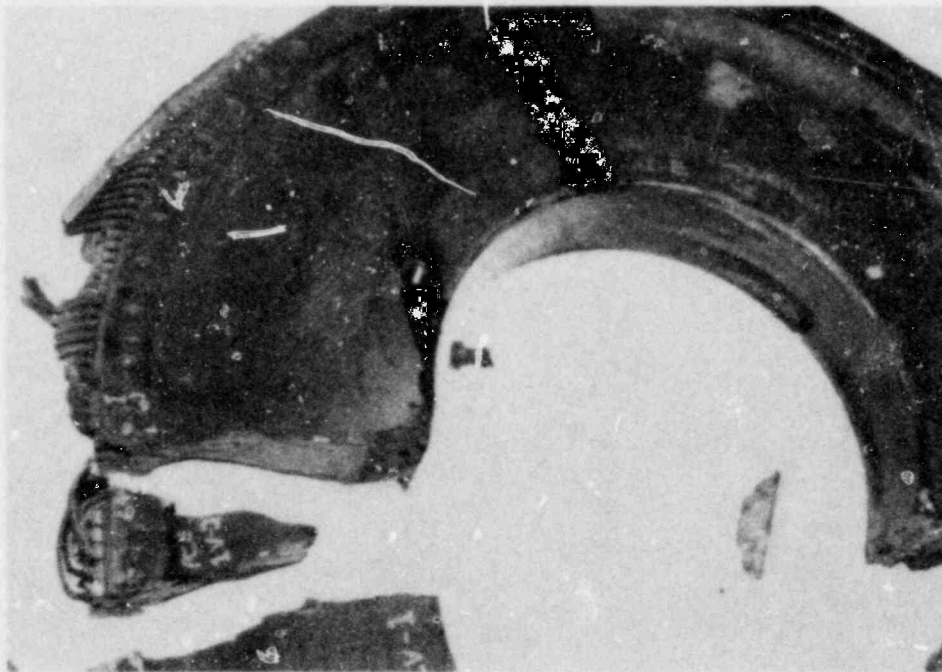
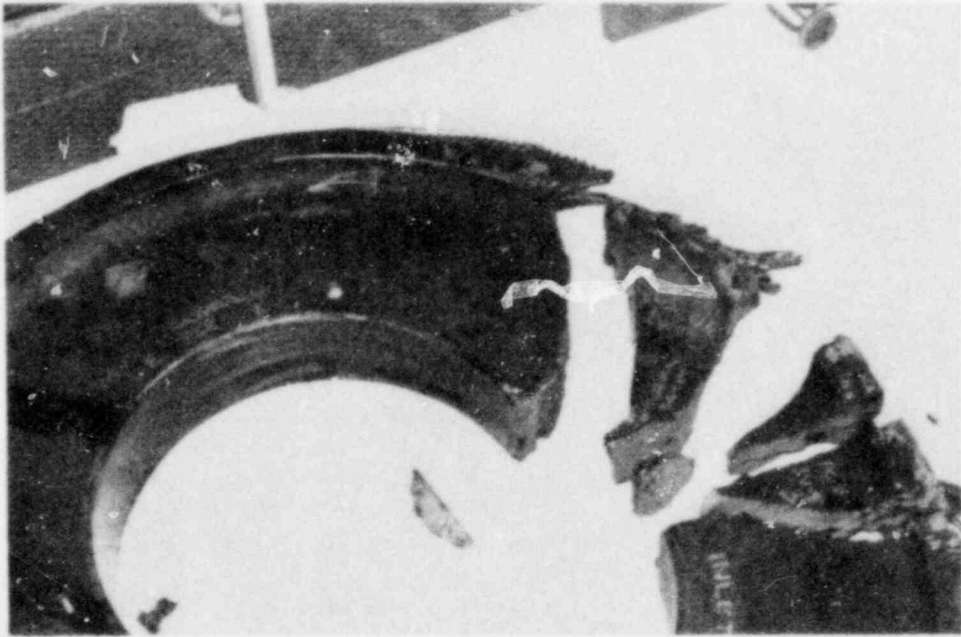
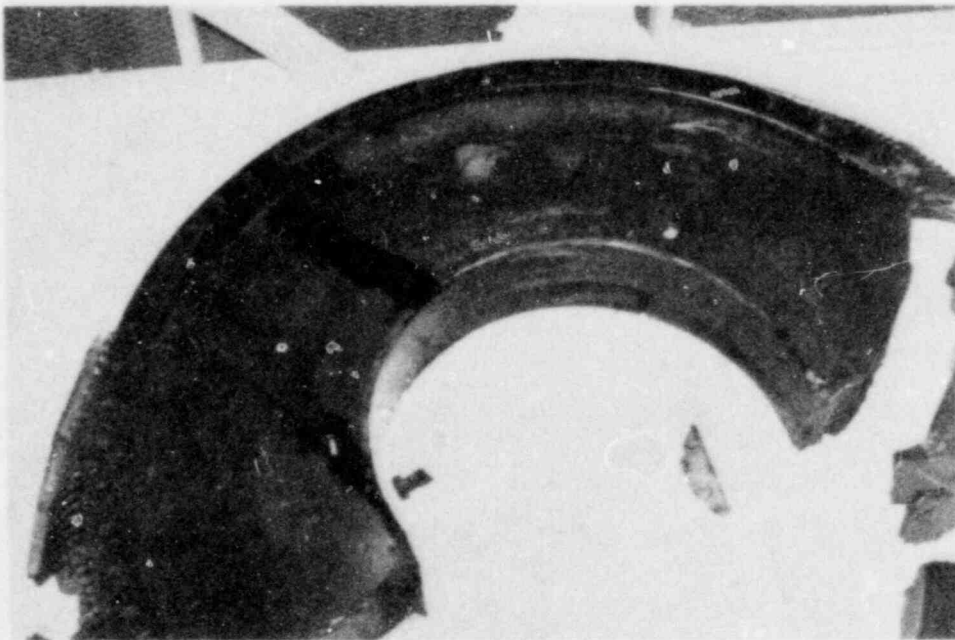
FIGS. 13-16. Views from above the No. 1 governor-end disc.

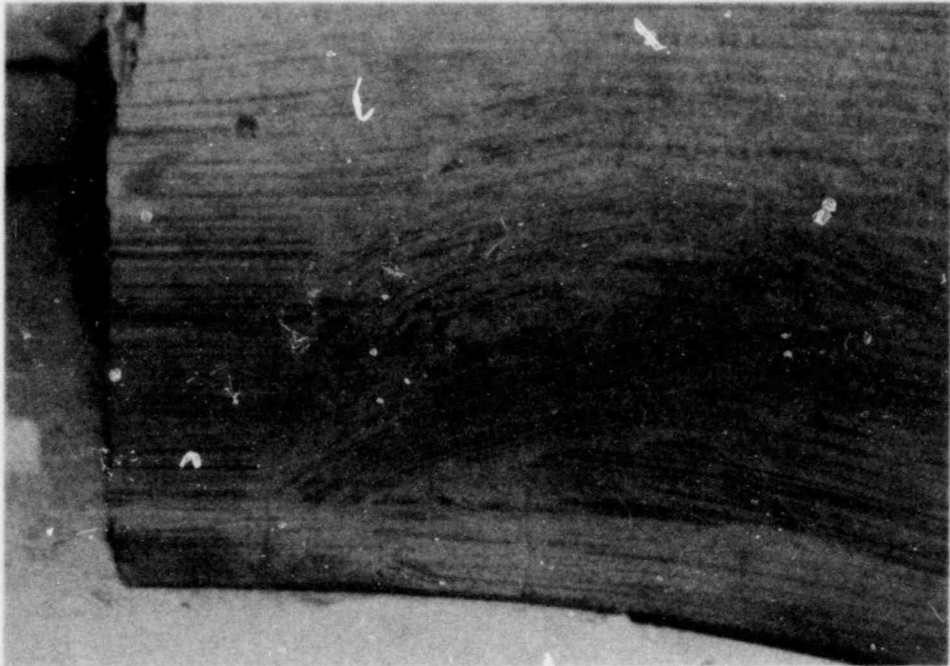
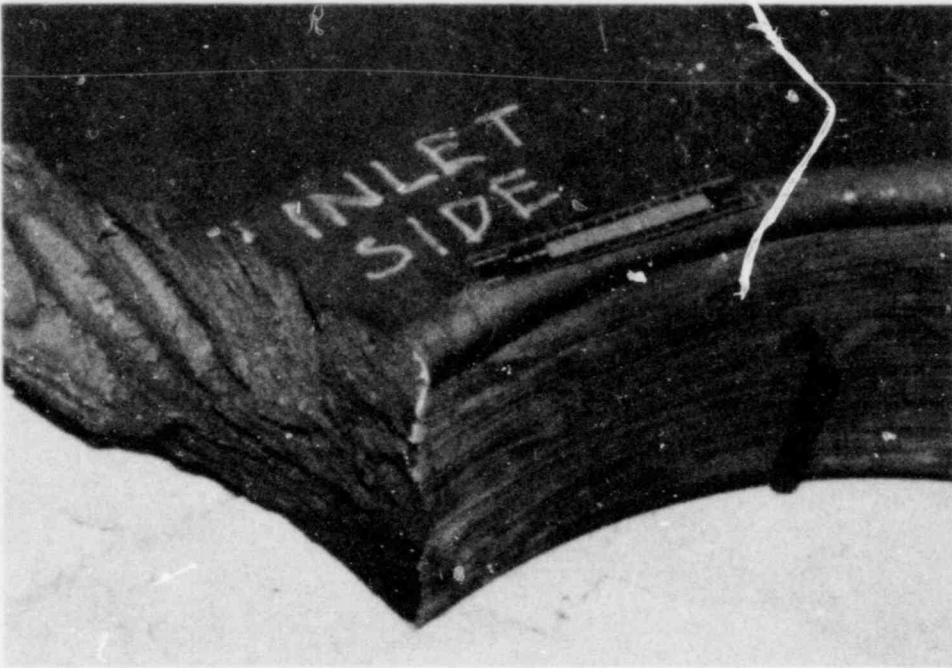
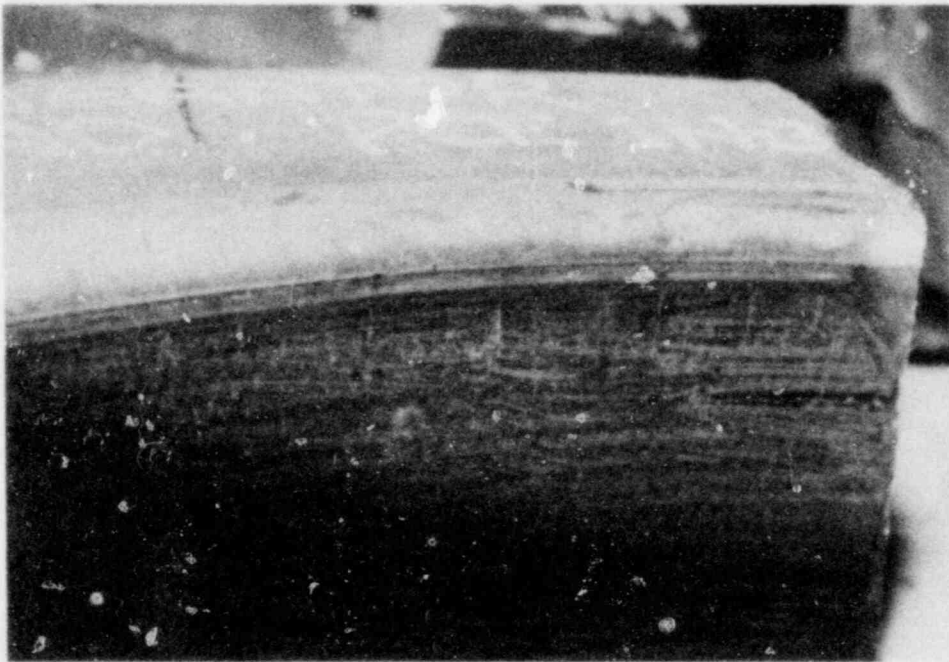
Numerous cracks (probably several hundred) were present on the bore surface of the gen. disc, generally running parallel to the shaft axis. Several of these cracks extended almost across the entire thickness of the disc (Figs. 17, 18, and 19). However, they appeared to be somewhat more concentrated near the disc faces in contrast to the center of the bore. Each of the fractured surfaces contained some three or four heavily discolored, oxidized, thumbnail cracks originating at the bore surface. These cracks appear typical of stress corrosion cracking (SCC). Figures 20 through 25 show the gen. disc failure surfaces starting with Section 1 and following through to Section 6.

Normally, one expects the keyway to be a source for crack initiation; but no apparent cracking was observed in any of the keyways. The disc contained three keyways, with the keyway pins still intact (Fig. 18). It is possible that the finish of the keyways was superior to that of the bore surface. It may also be that the corrodent responsible for the SCC along the bore surface did not penetrate into the keyways. The keyways should be examined for the presence of cracks and corrosion products.

FIGS. 17-19. Surface cracking on inner bore of the generator-end disc. Note that the keyway (Fig. 18) did not fail.

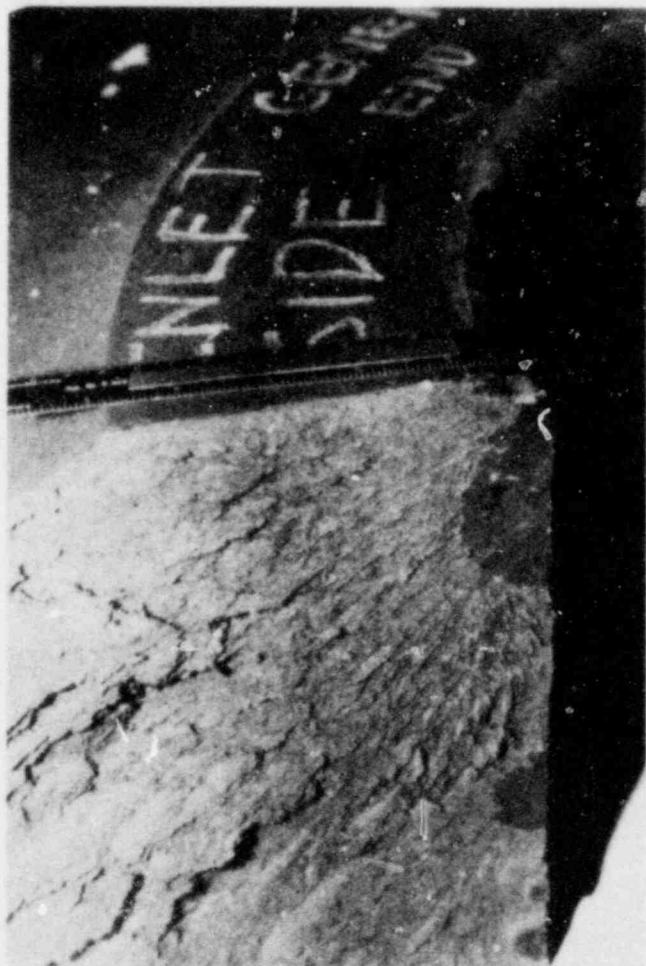
FIG. 20. Generator-end disc failure surface on Section 1, between Sections 6 and 1.

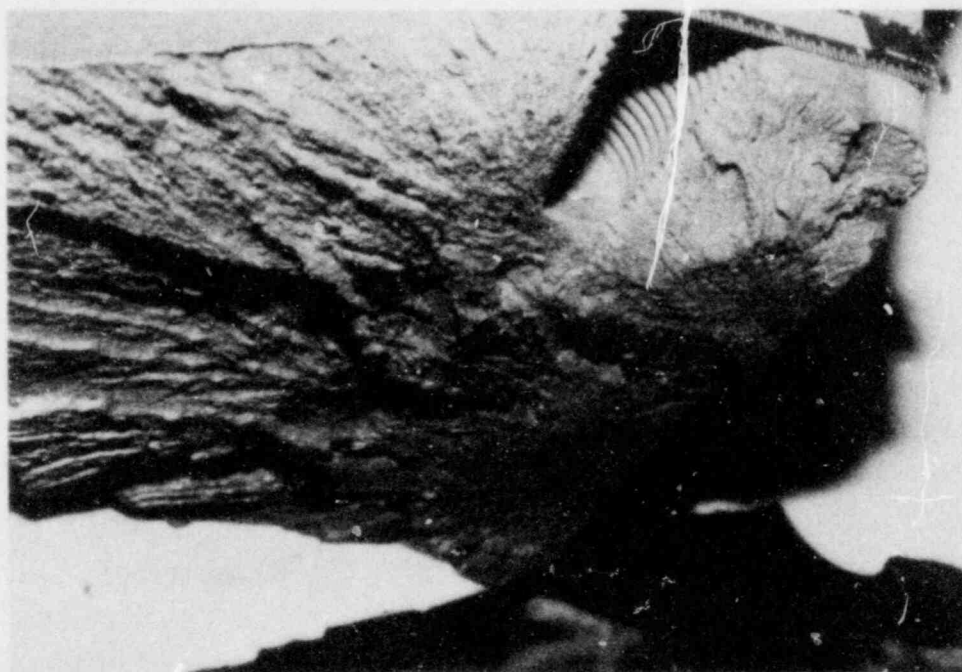
FIG. 21. Generator-end disc failure surface on Section 2, between Sections 1 and 2.

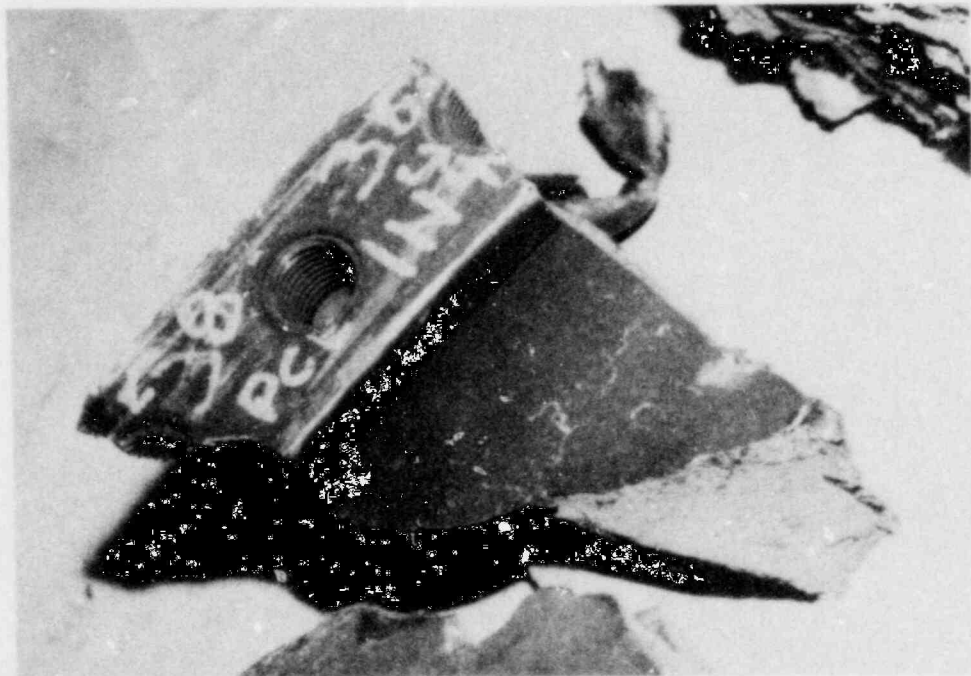
FIG. 23. Generator-end disc failure surface on Section 4, between Sections 3 and 4.

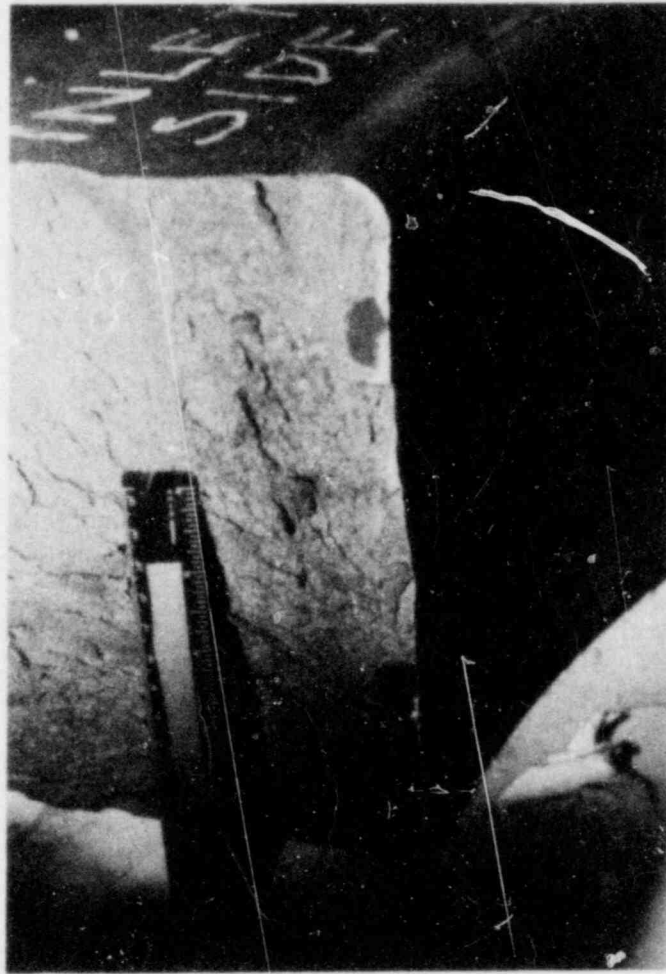
FIG. 24. Generator-end disc failure surface on Section 5, between Sections 4 and 5.

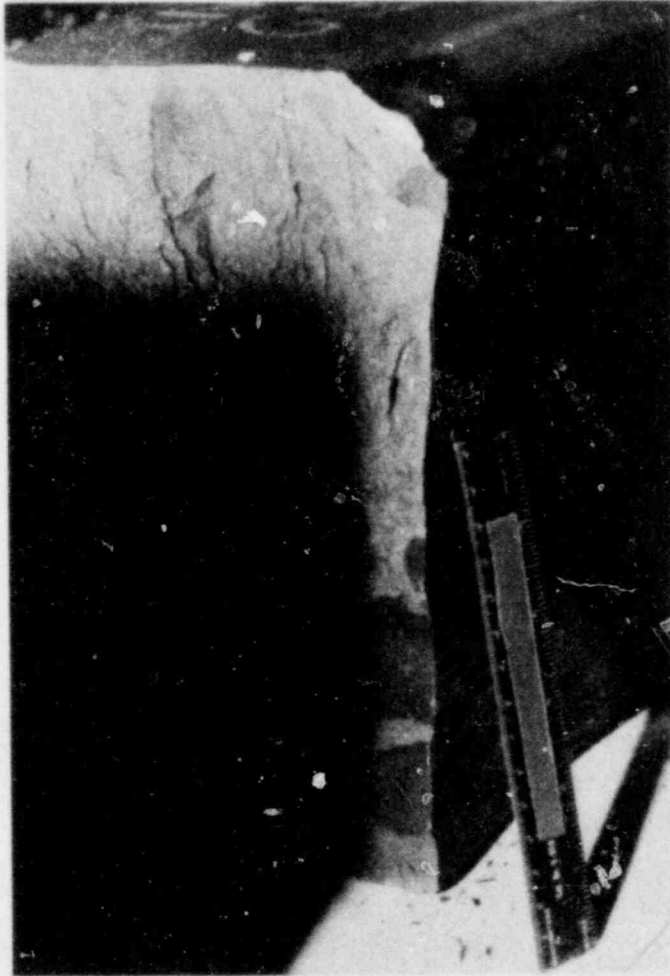
FIG. 25. Generator-end disc failure surface on Section 6, between Sections 5 and 6.

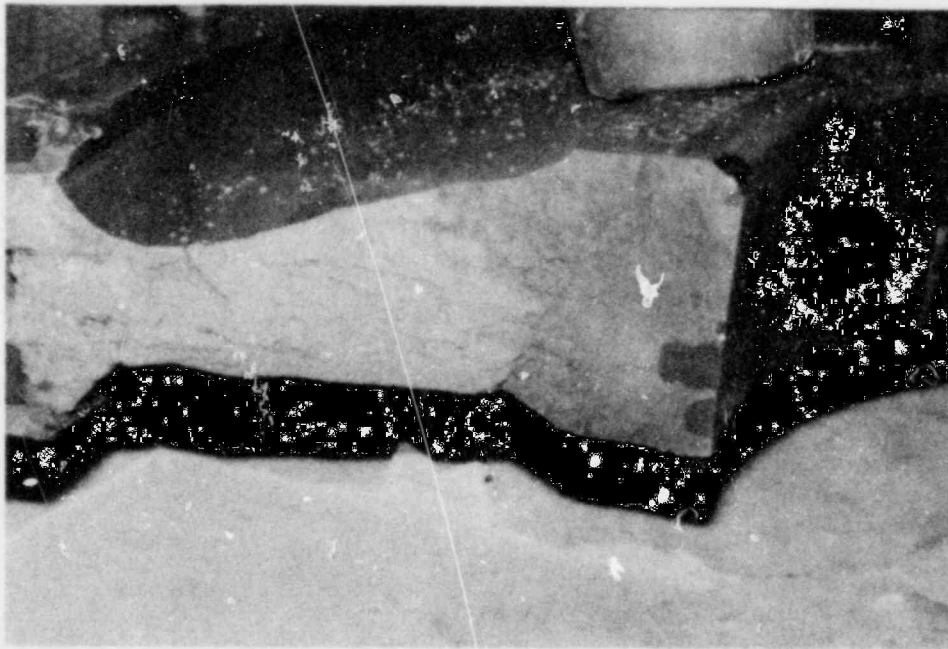
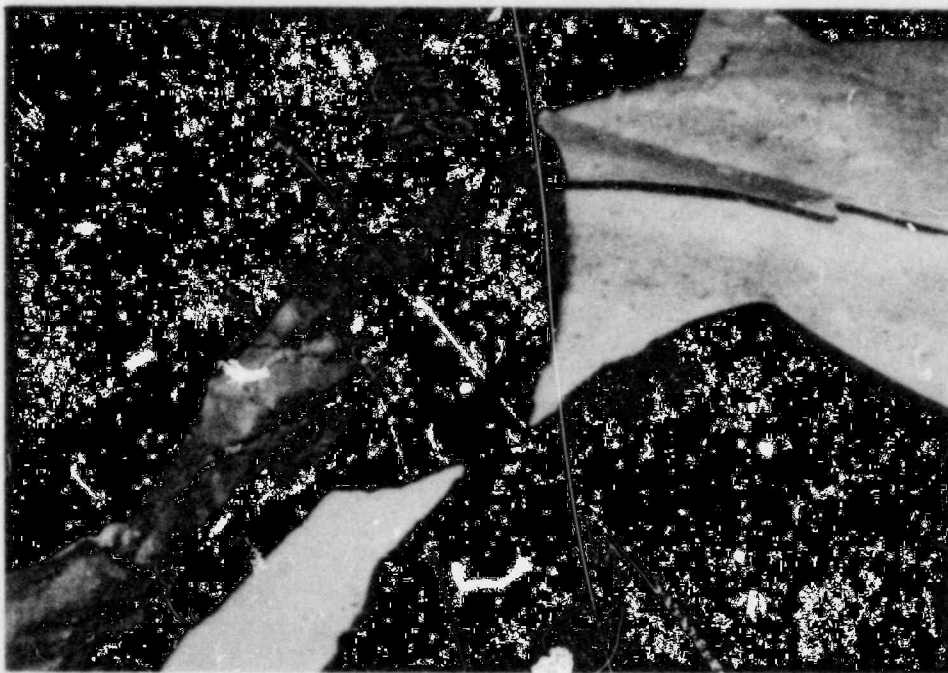
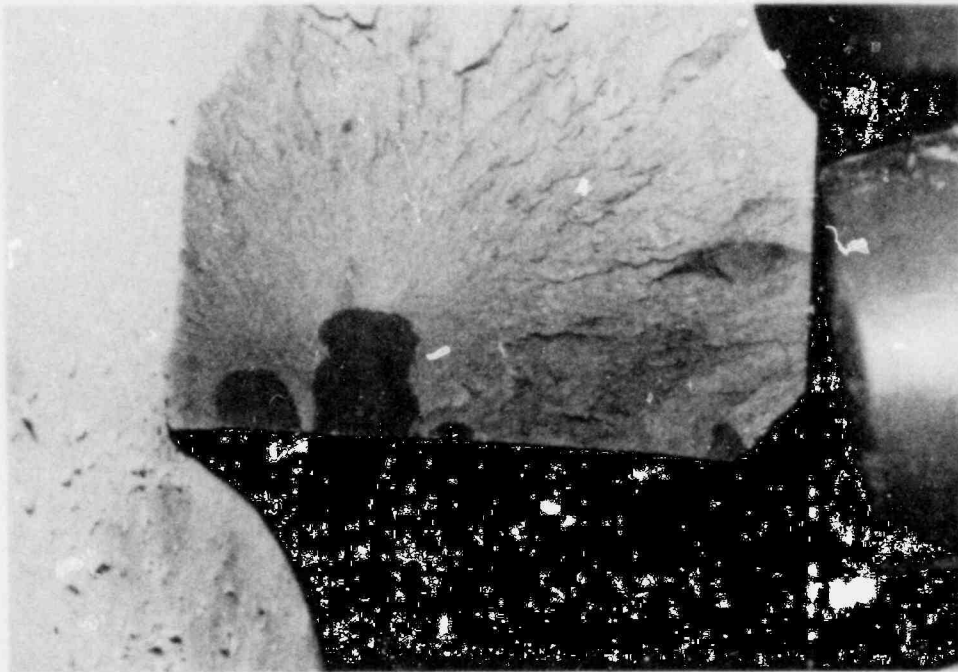
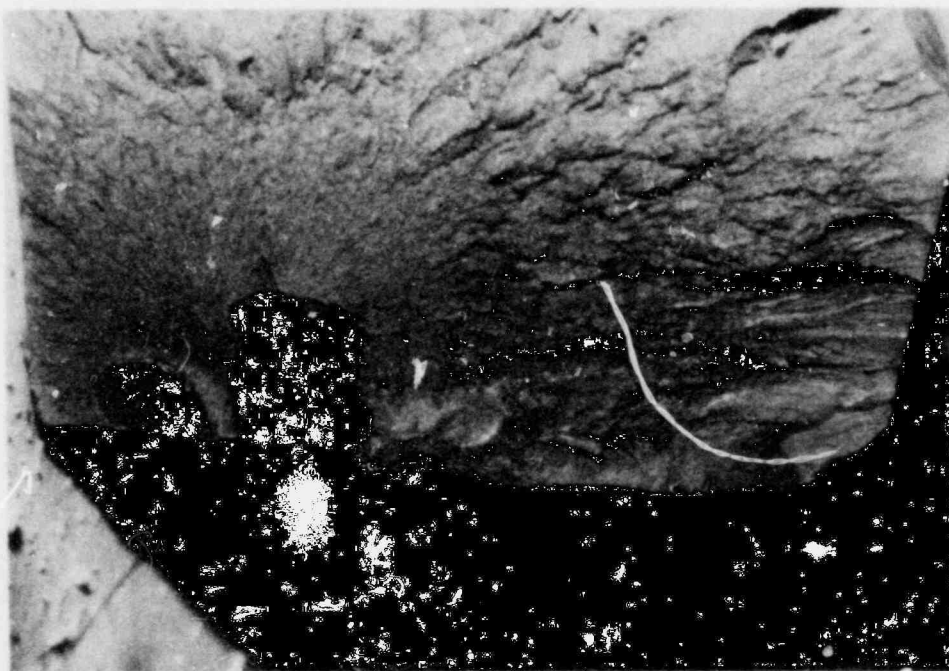
The deepest of the thumbnail cracks was located between Sections 5 and 6 (5/6) and measured about 1.9 in. (48 mm) deep by 1.5 in. (38 mm) wide (Figs. 26 through 29). This crack was distinct in that although its tip was curved, its sides were straight and parallel. It was clear from the fracture surface markings that this crack was the precursor to the 5/6 fracture. Three other thumbnail cracks were also present on the fracture surface but on slightly different planes. Crack propagation seemingly progressed along a plane originating from the deepest crack, producing a series of fine rivers or chevron markings. These markings fan out radially for about 5 in. from the tip of the 1.9 in. crack (Fig. 29) and intercept the markings originating from the three parallel cracks. The propagation then continues developing a much coarser fracture pattern to ultimate failure (Figs. 26 and 27).

FIGS. 26-29. Views of the largest observed thumbnail flaw on a failure surface. The crack is on the generator disc, Section 6, 5/6. Note the flow pattern around the adjacent flaw.

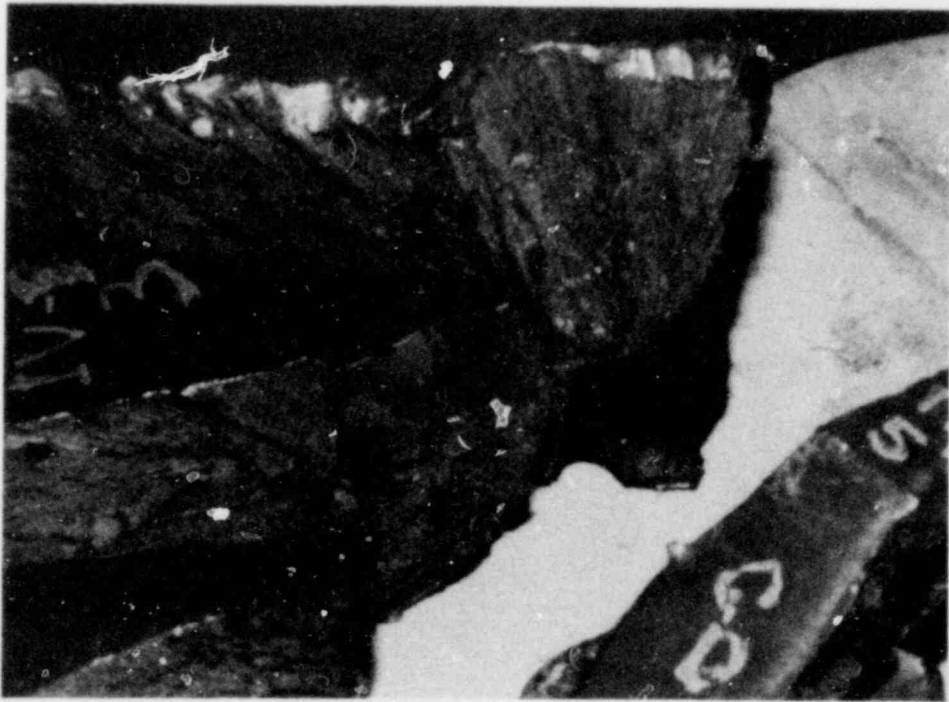
FIG. 30. Failure surface on governor-end disc showing apparent crack propagation away from the balance hole.

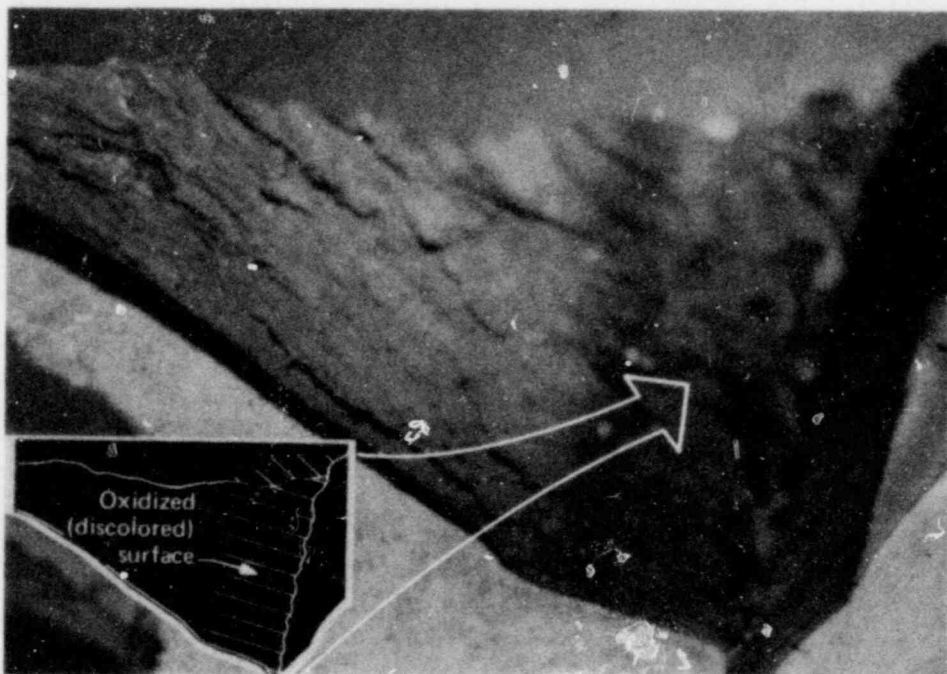
FIG. 31. No. 1 governor-end disc showing extent of rubbing and heat generation during failure.
