In the Matter of: §  
HOUSTON LIGHTING & POWER § Docket Nos. 50-4980L  
COMPANY, ET AL. § 50-4990L  
(South Texas Project, §  
Units 1 & 2) §  
\_\_\_\_\_ §

TESTIMONY ON BEHALF OF HOUSTON LIGHTING & POWER COMPANY, ET AL.  
OF  
RICHARD W. PEVERLEY  
ON  
INTERVENORS' CONTENTION 1(1)

19  
20 TESTIMONY OF RICHARD W. PEVERLEY  
21 ON INTERVENORS' CONTENTION 1(1)  
22

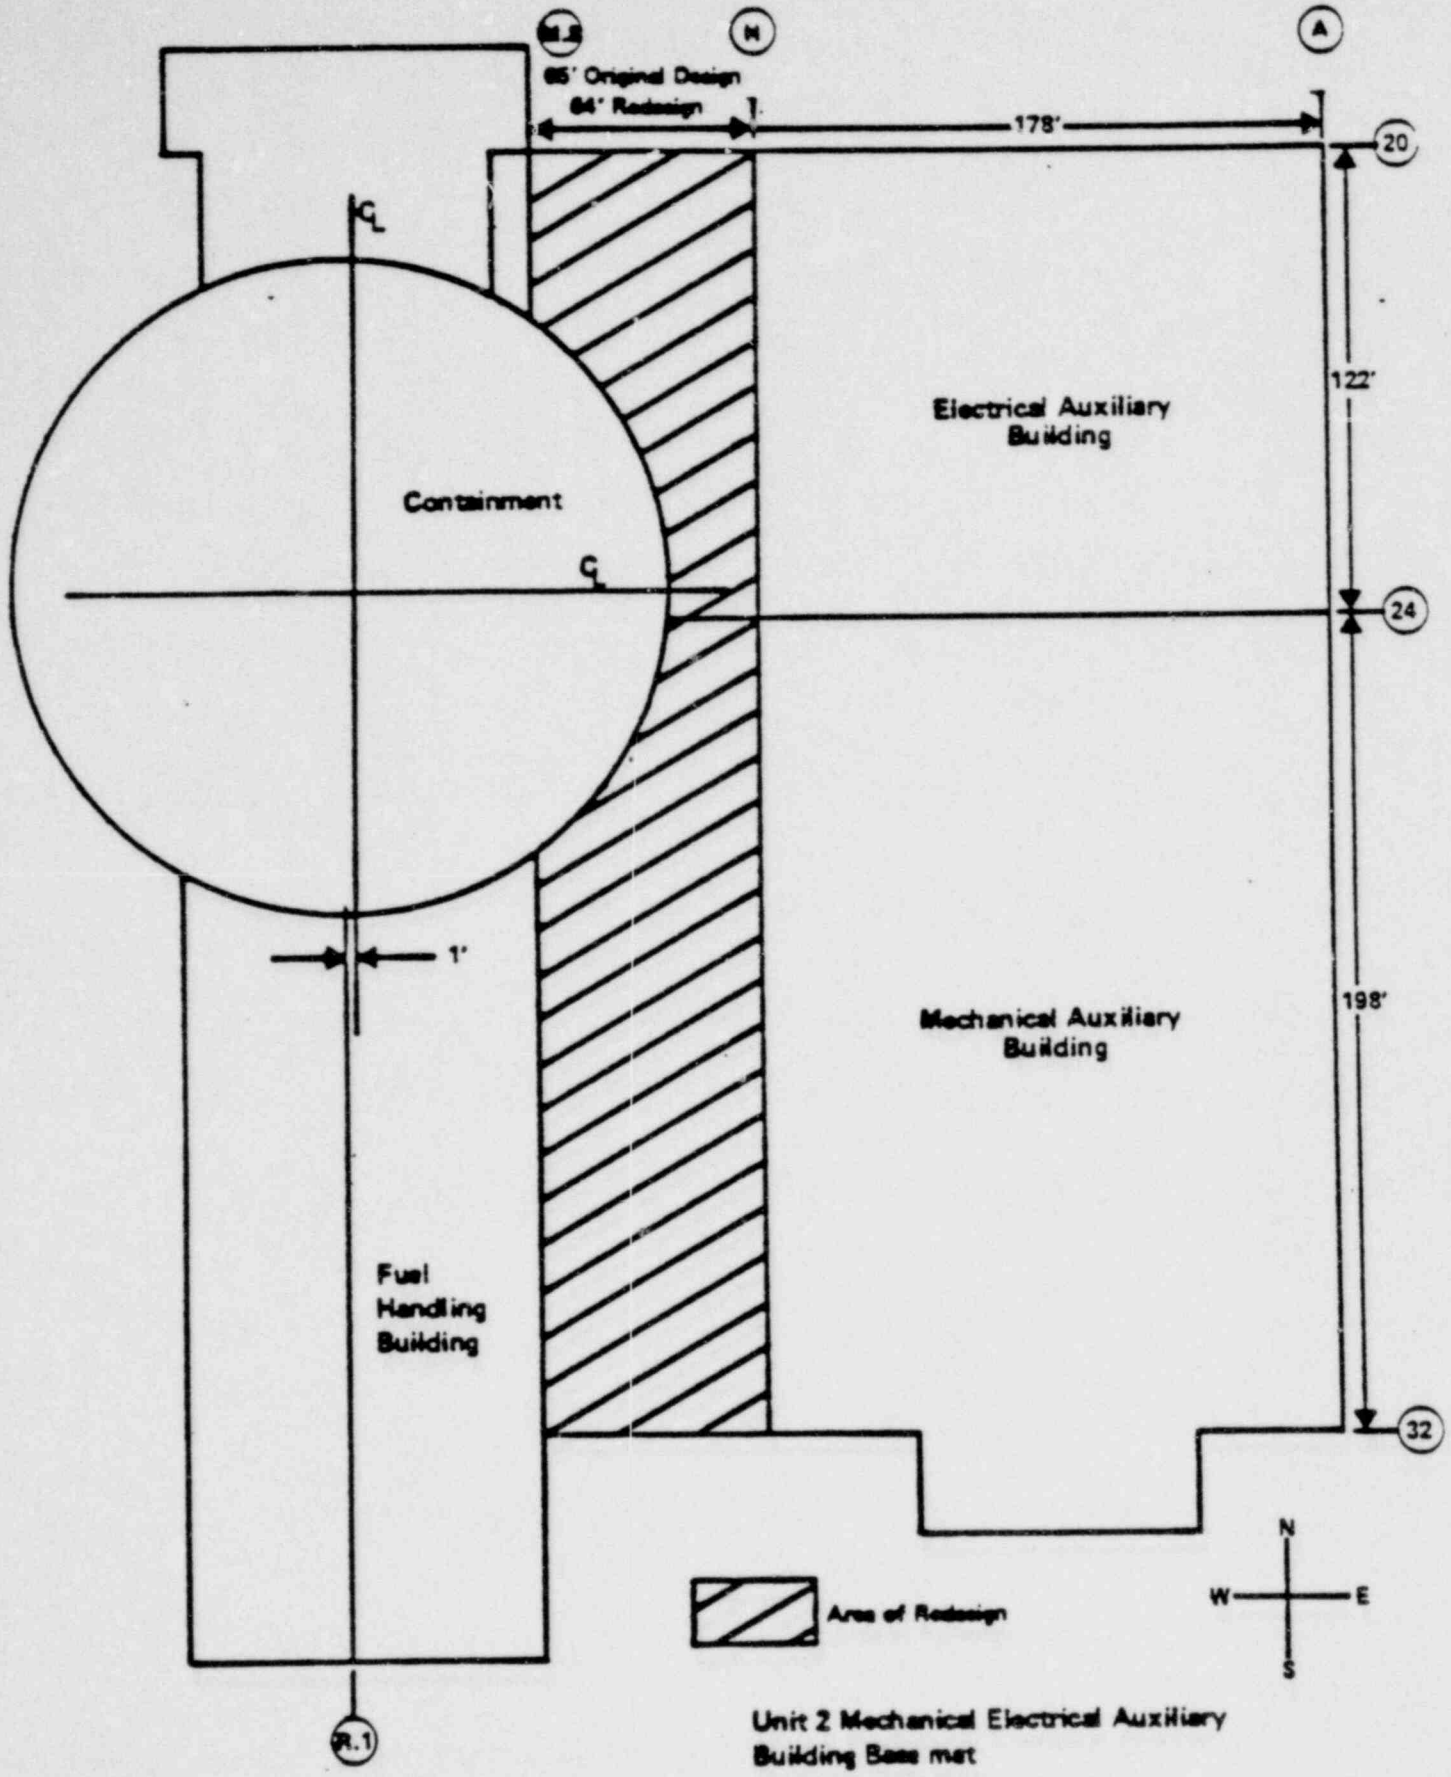
Unit 2 Mechanical Electrical Auxiliary Building Base mat

Redesign of the MEAB to compensate for the one foot dimensional error resulted in only interior spatial alterations. From Column Line A to Column Line H (see Attachment No. 1), the layout within the Building is unchanged from the original design. From Column Line H to Column Line M.8, the one foot has been compensated by reducing distances between column lines and removing excess floor space around the layout of systems and equipment. The general arrangement of equipment within the redesigned area is unchanged by the one foot dimension change. Approximately three-fourths of the Building (Column Line A to Column Line H) is unchanged from the original design and the redesign affected only the West one-fourth of the Building. In compacting this area of the Building, all safety criteria and bases, stated in the safety analysis report, were determined to have been met for layout of the systems and components. The following generic drawing categories were reviewed for the MEAB design:

A. 11 The surveying error most likely occurred because, instead of using the containment/reactor centerline as the reference as had been intended, the building slab survey calculations and layout in the field used the dimensions relative to column line R.1 in the Fuel Handling Building. Column line R.1 in the Fuel Handling Building is offset one foot to the west of the containment/reactor centerline (see Attachment No. 1) thus resulting in the east edge of the Mechanical-Electrical Auxiliary Building being laid out one foot short of the design.
