April 9, 1981
Fort St. Vrain
Unit No. 1
P-81119

REPORTABLE OCCURRENCE 81-022
ISSUE 0
Page 1 of 4

REPORT NO. 50-267/81-022/03-L-0

IDENTIFICATION OF
OCCURRENCE:

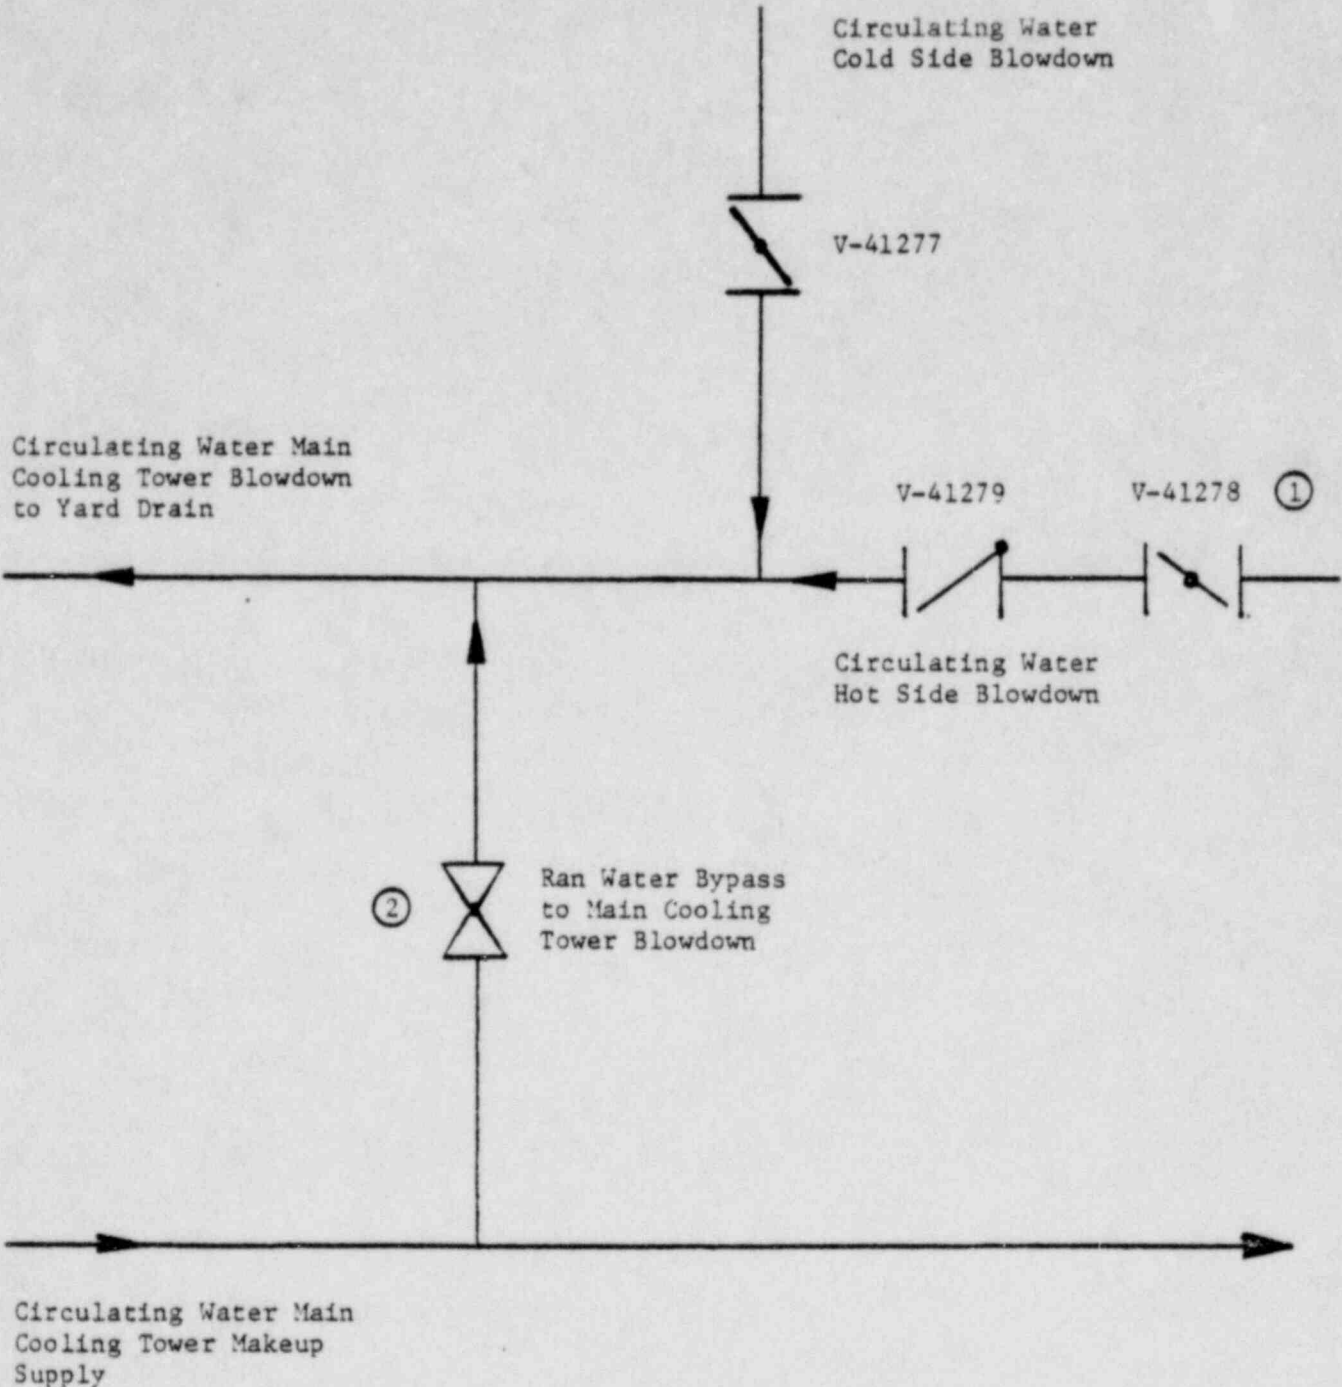
FIGURE 1

On several previous occasions, the non-radioactive liquid effluent has exceeded the LCO NR 1.1 limit for residual chlorine. These events were reported in Reportable Occurrences 79-61, 80-28, and 81-004. Because of the difficulty in obtaining the exact chlorination required by the system, plant operations have been modified to include closing the blowdown discharge valve (1) (see Figure 1) from the circulating water system during chlorination to prevent inadvertent discharge of any high residual chlorine to the Goosequill ditch. To maintain minimum blowdown rate requirements during the chlorination, the raw water bypass valve (2) was opened to make up the lost flow.

On Friday, February 20, 1981, this was done during the regular chlorination of the circulating water system; however, following the chlorination, the blowdown discharge valve (1) was not re-opened. This resulted in the continued concentration of total dissolved solids in the circulating water system due to evaporation. The circulating water system was sampled Tuesday, February 24, 1981, and the total dissolved solids were found to be high. The blowdown valve (1) was fully opened, and the blowdown of the circulating water system continued at this rate for approximately two hours when it was noted that the Goosequill total dissolved solids was 3175 parts per million was in excess of the LCO NR 1.1 limit of 2300 parts per million. The blowdown rate was adjusted to reduce the total dissolved solids being discharged to the plant effluent and the liquid effluent was within required chemical limits by the next shift. The blowdown was continued and has maintained the total dissolved solids within acceptable limits. The water discharged to the Goosequill ditch during this event followed the regular discharge

High total dissolved solids in the plant non-radioactive liquid effluent was the result of two problems:

1. Excessive build-up of total dissolved solids in the circulating water system between February 20 and 24, 1981, due to no system blowdown during this period.
2. The following blowdown of the systems on Tuesday, February 24, 1981, at a rate greater than the dilution capability of the Goosequill ditch flow.

Circulating water system blowdown was adjusted to a lower rate, and the total dissolved solids returned to acceptable values by the time of the next sample.
