April 9, 1981
Fort St. Vrain
Unit No. 1
P-81117

REPORTABLE OCCURRENCE 79-05

FORT ST. VRAIN NUCLEAR GENERATING STATION
PUBLIC SERVICE COMPANY OF COLORADO
16805 WELD COUNTY ROAD 19 1/2
PLATTEVILLE, COLORADO 80651

REPORT NO. 50-267/79-05/03-X-1

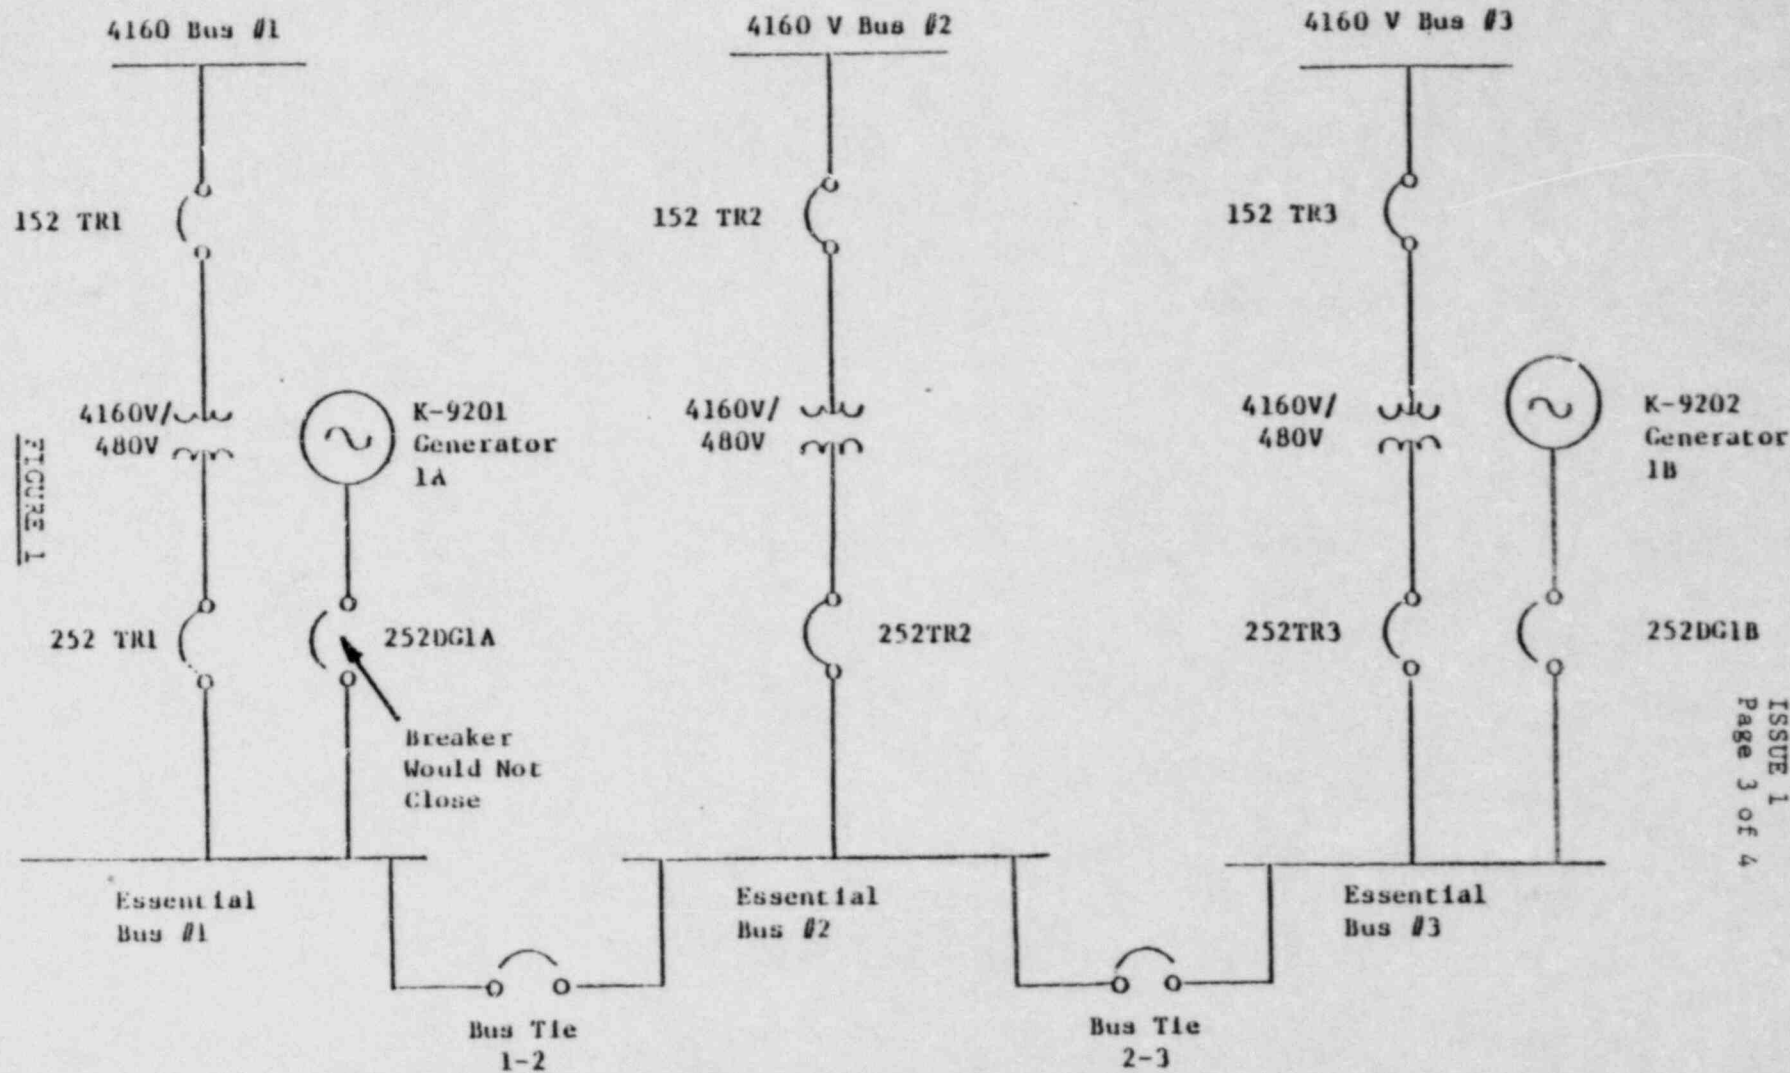
FIGURE 1

While the plant was shutdown, the Surveillance Test was being run, which simulates the loss of outside electrical power and main turbine trip. Upon simulation of loss of outside electrical power and turbine trip, both diesel generators started automatically. However, the diesel generator 1A output breaker (252 DGLA) to the essential 480 volt bus No. 1 did not close (refer to Figure 1). Diesel generator 1B had been interlocked to simulate that it would not be the first generator to reach operating conditions, as required by the procedure. Therefore, diesel generator 1B correctly did not close in on 480 volt bus No. 3, because diesel generator 1A had not closed in to supply 480 volt bus No. 1 first.

The breaker was examined and the manufacture's representative consulted to determine the cause of failure. Upon dismantling the breaker, it was determined that the grease used for several pivot pins had hardened due to the high temperature encountered during normal conditions in the switchgear cabinets. The hardened grease acted to bind the pivot pins and the moving assemblies, preventing the breaker from closing. This problem was of an intermittent nature.

The immediate corrective action was to replace the breaker with a spare and complete the surveillance.

Following this, the breaker was dismantled and relubricated, which again made it operable.

A new Electrical Maintenance Procedure has been written, using the manufacturer's recommendation, to completely dismantle the breakers and relubricate them. This maintenance is scheduled for completion every six months.
