Subject: Requests for Additional Information in Fermi 2 Operating License Application

HUMAN FACTORS ENGINEERING
CONTROL ROOM DESIGN REVIEW/AUDIT REPORT
OF
ENRICO FERMI 2
DETROIT EDISON COMPANY

ENRICO FERMI - 2 NUCLEAR POWER STATION

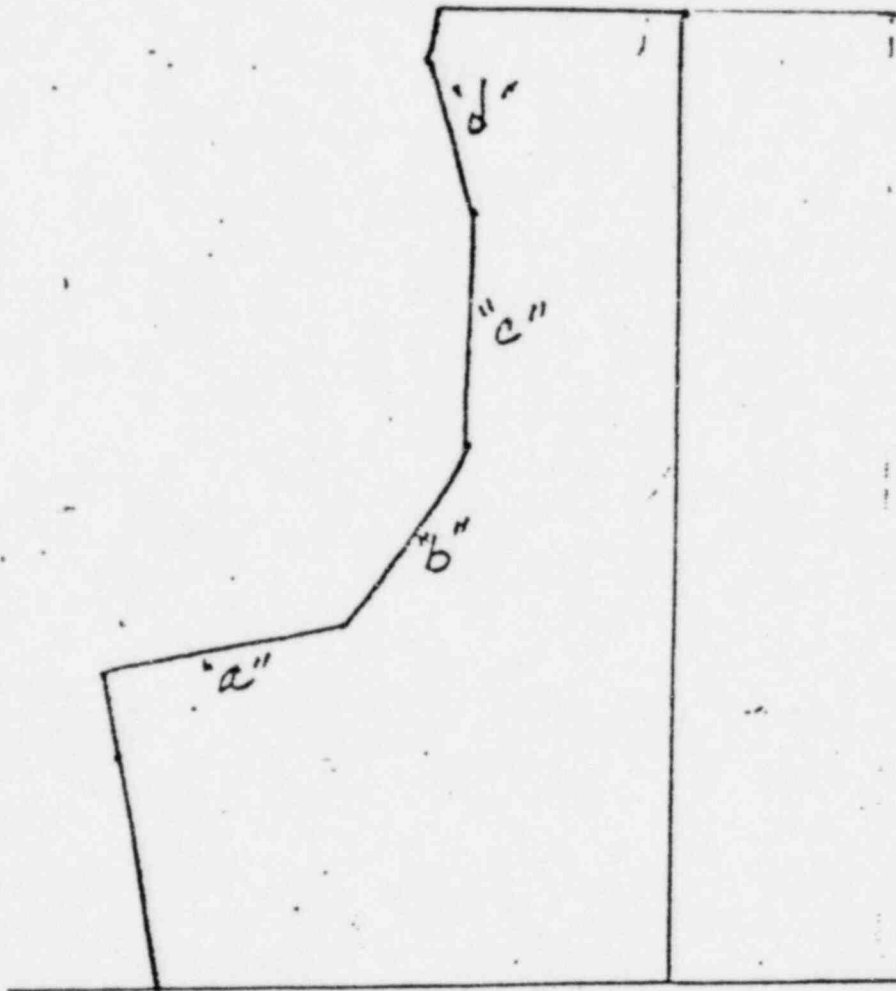
Figure 1

<u>PRIORITY RATING</u>	<u>FINDING</u>	
1	1	The HVAC could not be evaluated because it was not completely installed.
3	2*	On Panel-805 the lighting on the "c" surfaces was lower than recommended levels whereas "a" and "b" surfaces were within an acceptable range. (See Fig. 1) (See Fig. 1)
3	3	Under some lighting conditions the contrast between indicator lights and background is low on Panel-805. (CMC switch on surface "b"; push button switch on the sloping surface "a".) (See Fig. 1)
1	4	There are inadequate normal and emergency lighting levels on Back Panels 812 and 813, with the existing temporary system.
1	5	There is no emergency lighting available at the remote shutdown panel.
3	6	It is difficult to read the CRTs on Panels 603, 804, and the operator console because of low contrast caused by reflections.
3	7	There are shadows on the labels under the recorders on Panels 601, 603, 804, 805, which make them difficult to read.

Sketch showing locations of Control Board surfaces mentioned in the Description of Findings 2, 3, and 10.
