# Public Service Company of Colorado

May 22, 1981  
Fort St. Vrain  
Unit No. 1  
P-81150

REPORTABLE OCCURRENCE 81-030

REPORT NO. 50-267/81-030/03-L-0

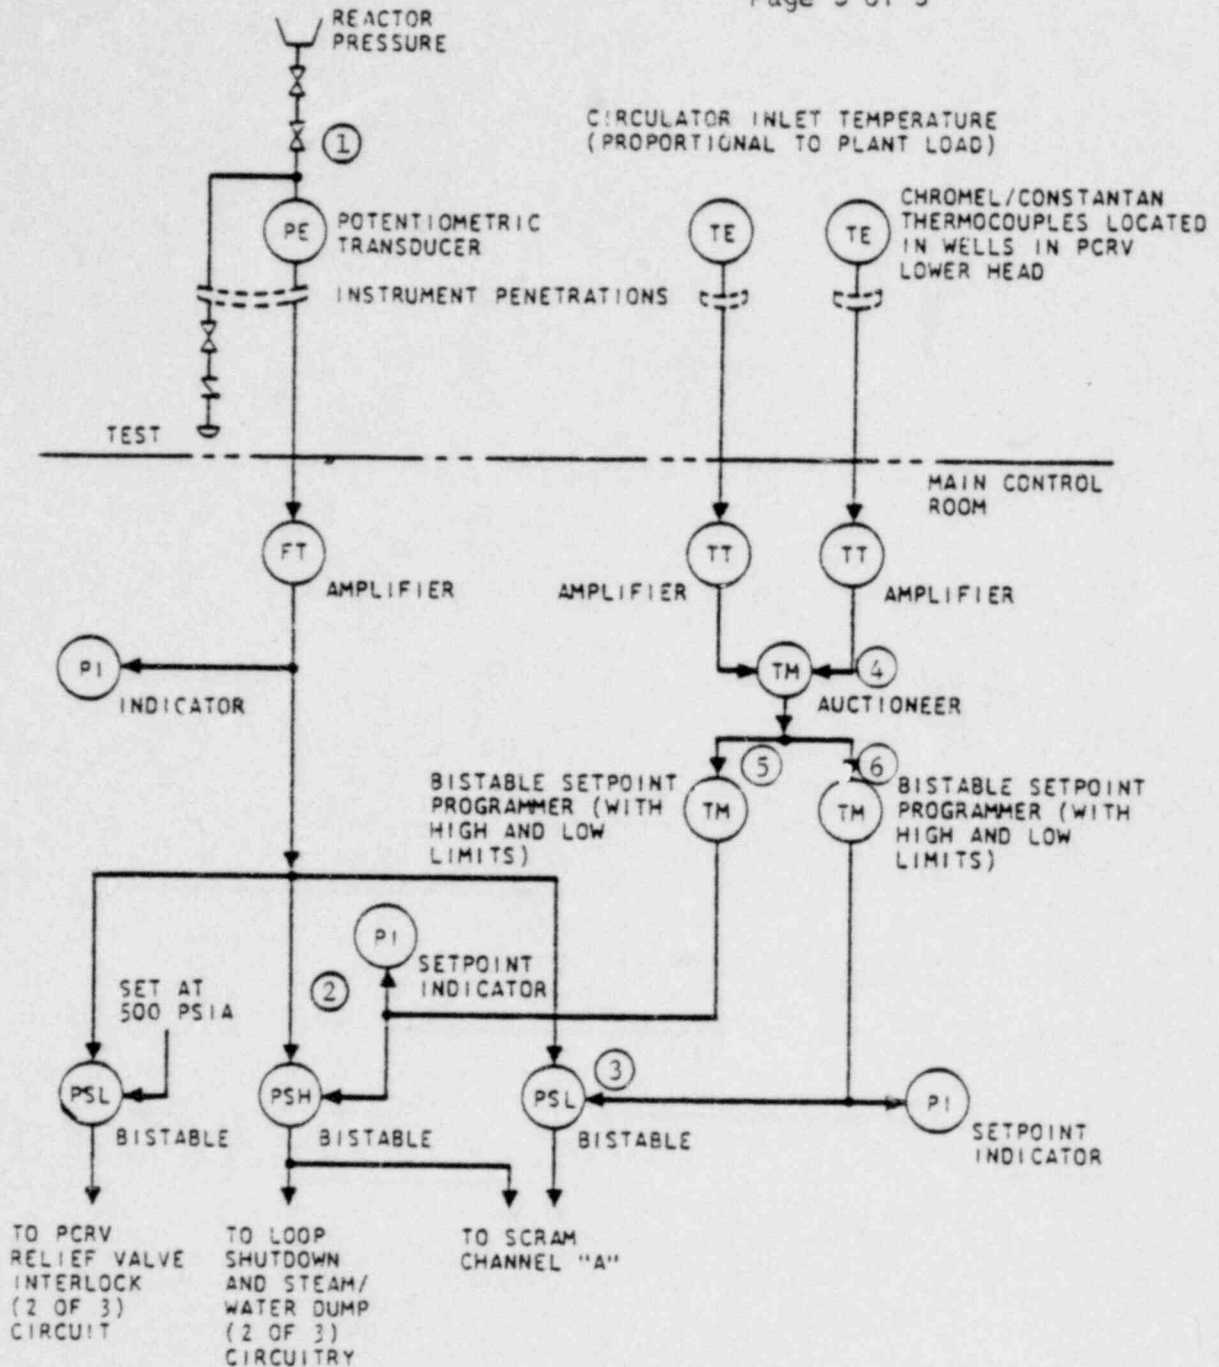
FIGURE 1

See Figure 1. While performing the monthly calibration check of the primary coolant pressure scram channels, plant instrument personnel observed that two of the pressure transmitters (1) were out of calibration in the nonconservative direction and would have resulted in the pressure switch highs (2) tripping at a higher pressure than allowed by LCO requirements. The low readings of the pressure transmitters (1) would have caused the pressure switch lows (3) to trip sooner at a higher, more conservative pressure than required.

The low pressure signals were due to instrument drift of the pressure transmitter.

The pressure transmitters were calibrated during the procedure and returned to service.

Once a month, on a temporary basis, the pressure transmitter voltage outputs will be checked against reactor pressure to determine if further instrument drift is occurring. The monthly test will be conducted until the next regularly scheduled surveillance calibration is required or until it is determined that instrument drift is not occurring.

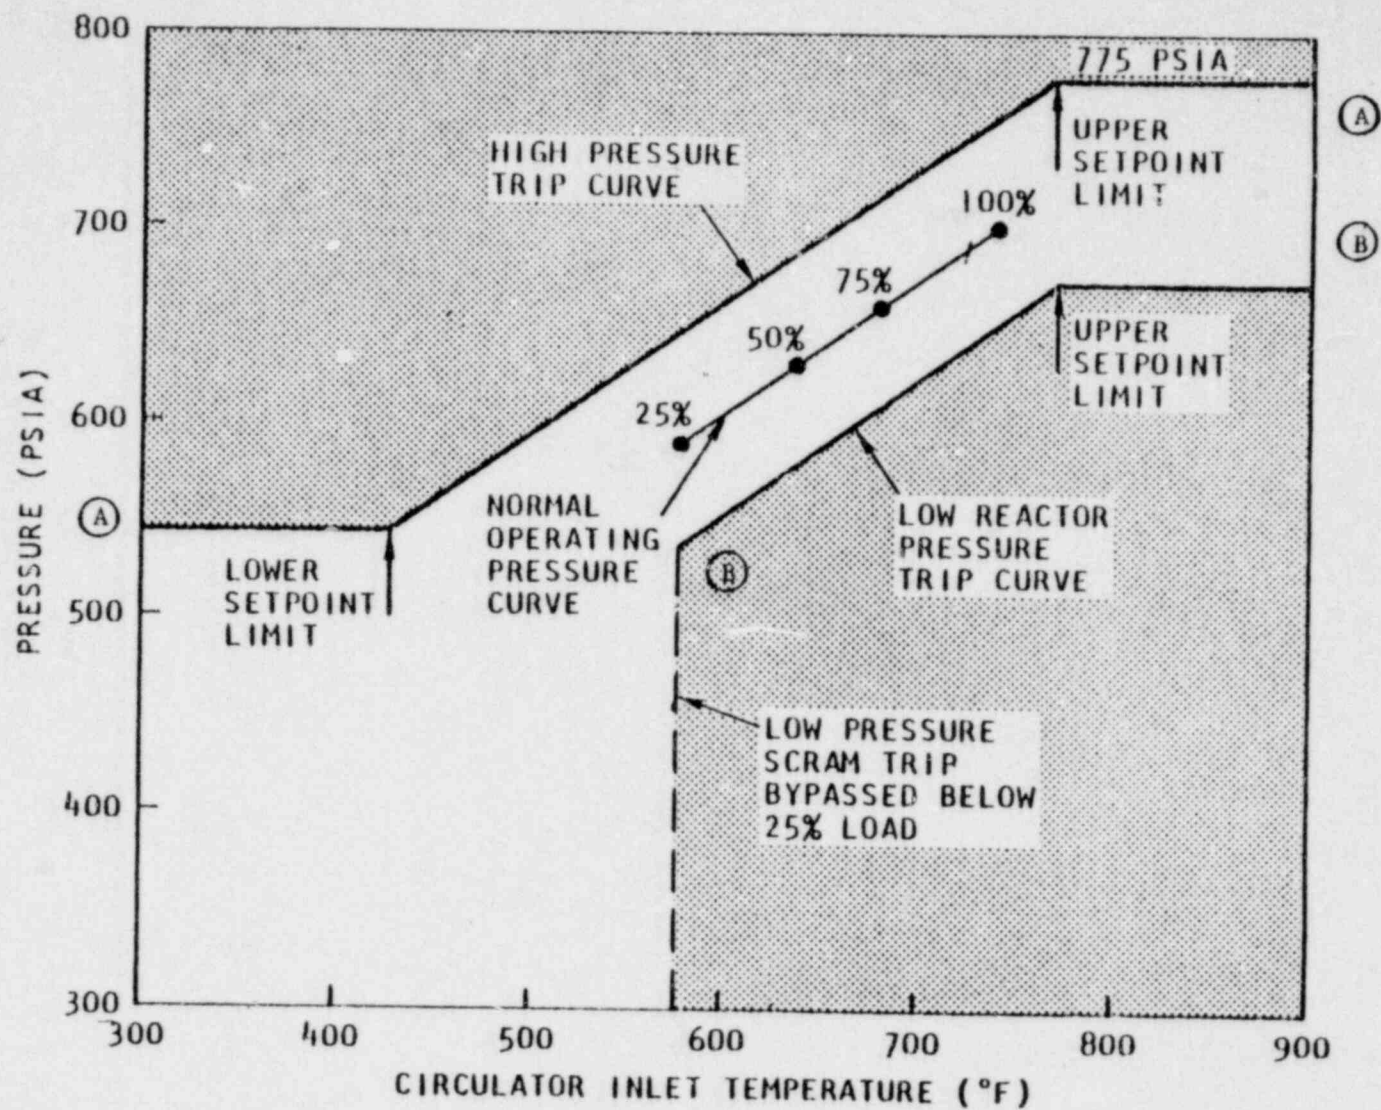
FIGURE 2

The high and low pressure trips (2) and (3) are programmed by circulator inlet temperature through an auctioneer circuit (4) and a bistable setpoint programmer (5) or (6). The programmed pressure temperature curve is shown in Figure 2. The low output signal from the pressure transmitter could have resulted in the high pressure trips occurring above the allowable high pressure curve (line (A) (A)). The low pressure trips would have occurred above low pressure trip curve (line (B) (B)) in a conservative direction.

Although the high pressure trips could have occurred at a value less conservative than that established in the Technical Specifications, they would not prevent the fulfillment of the functional requirements of the systems.
