SHOREHAM NUCLEAR POWER STATION

SHOREHAM NUCLEAR POWER STATION - UNIT 1
Docket No. 50-322

HUMAN FACTORS ENGINEERING
CONTROL ROOM DESIGN REVIEW

LILCO RESPONSE TO NRC AUDIT FINDINGS
SHOREHAM NUCLEAR POWER STATION - UNIT 1

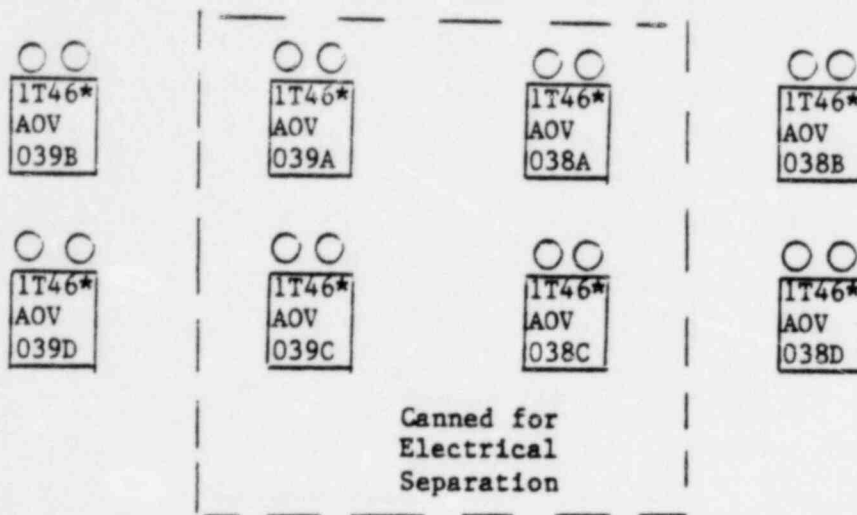
The mimic shows the actual position of the valves in the flow paths. The switches are located for electrical separation. See below:

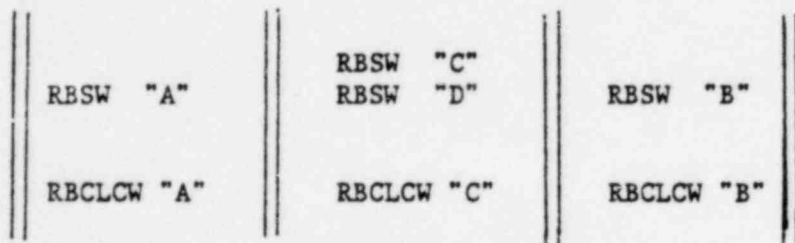
Reactor Building Closed Loop Cooling Water Pump ABC and Service Water Pump ABCD control sequences are not in standard sequential order. (2)

Shoreham is a two train plant, but because of safety system power requirements three safety buses with diesel back-up were provided. Therefore, the Division III (orange) train is not a complete separate entity. It is integrated with Division I and II for ease of operation and separation. Board layout for the three trains is Div. I, Div. III, and Div. II. See below:

Reactor Building Service Water Pumps A and C are in the same mechanical flow loop, and pumps B and D are in the other mechanical flow loop. RBCLCW Pump "C" can be mechanically lined-up with either the A or B pumps. LILCO will demarcate to show division I, II and III separation prior to fuel load.

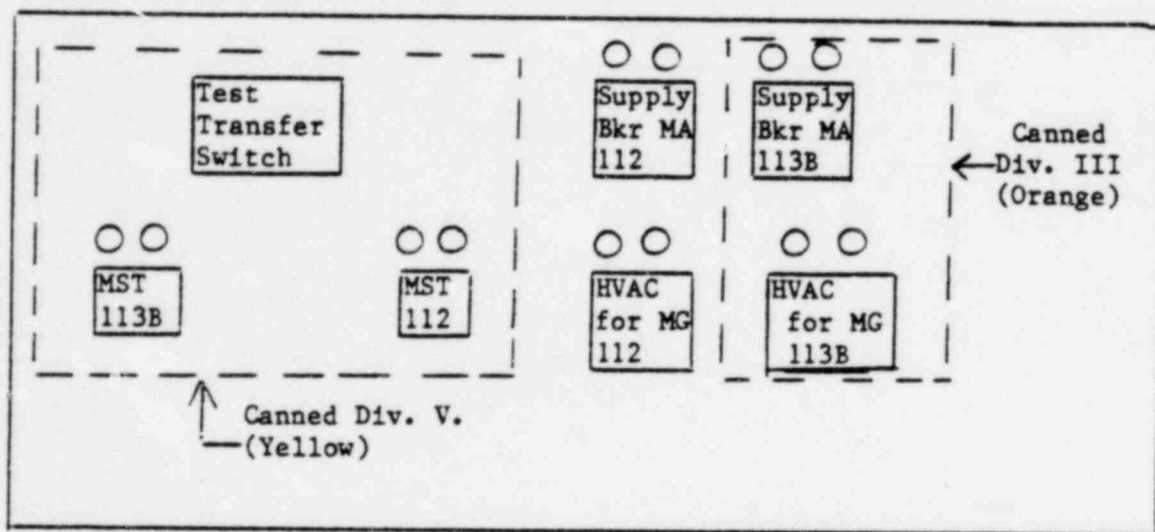
Div. II Section of H11-P601

Transfer switch MST 113B and related switch MG 113B are separated by switch 112 and a breaker. Similar arrangements are found for switch 111 and switches 113A. (2)

The layout was designed for electrical separation. See diagram below:

LILCO will review switches MST 112 and 113B and provide color pad enhancement for the entire switch cluster diagramed above. A similar change will be accomplished for Division I switches on panel 601. This will be accomplished prior to fuel load.
