# DAIRYLAND Power

February 25, 1981

SUBJECT: DAIRYLAND POWER COOPERATIVE  
LA CROSSE BOILING WATER REACTOR (LACBWR)  
PROVISIONAL OPERATING LICENSE NO. DPR-45  
REPORTABLE OCCURRENCE NO. 81-02

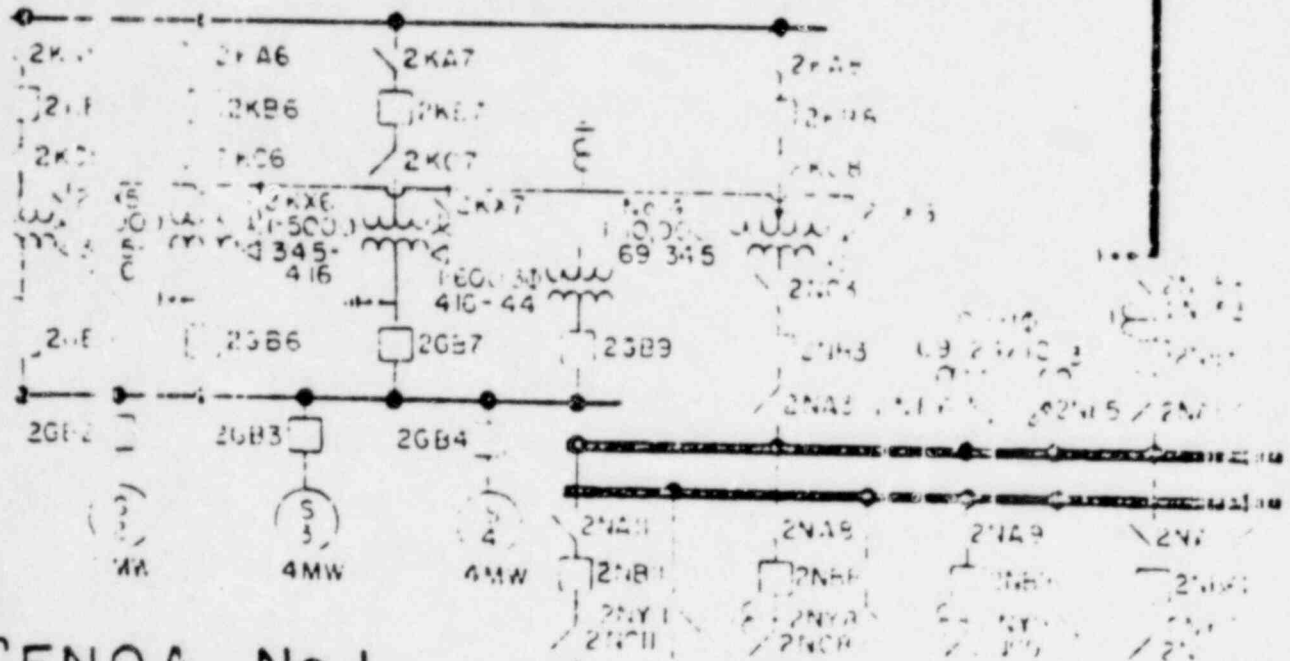
FIG. 15.1

On February 1, 1981, at 1134, at 28% Reactor Rated Thermal Power, the physically independent circuit between the off-site transmission network and the onsite power distribution system was interrupted when the switchyard operator opened manual Disconnect Switch 25NA4, which disconnected the reserve auxiliary transformer from the 69KV transmission line. (See attached sketch). The emergency diesel generators started automatically and supplied the essential buses. The reactor shut down automatically. All systems functioned properly. Off-site power was restored within 14 minutes.

The switchyard operator was given a switching order to open 25NA1, the air break disconnect to the main transformer. Though the disconnect switch is labeled correctly and the operator had performed a visual check of the label and order, he incorrectly opened 25NA4, the air break disconnect to the reserve auxiliary transformer, which was supplying station power. All subsequent automatic actions functioned and the Control Room Operators carried out the loss of off-site power procedure properly. Disconnect switch 25NA4 was re-closed after the oil circuit breaker 25NB4 was opened and the correct disconnect switch, 25NA1, was opened.

The actions of the switchyard operator were reviewed by plant management. The operator was interviewed to determine the reason for the mis-switching. The problems encountered with the Control Room switch for OCB 25NB1 caused concern for that event and may have interfered with his concentration. Whenever possible, outside switching orders will be executed in the presence of a second person to provide a double check. Also, additional practical training on the switchyard will be provided for all operators.
