UNITED STATES
NUCLEAR REGULATORY COMMISSION
WASHINGTON, D. C. 20555

LOSS OF DC BUS AT MILLSTONE 2SEQUENCE OF EVENTS

LOSS OF DC BUS AT MILLSTONE 2ANALYSIS AND CONCERNS

LOSS OF D.C. BUS AT MILLSTONE 2
REQUEST FOR ADDITIONAL INFORMATION

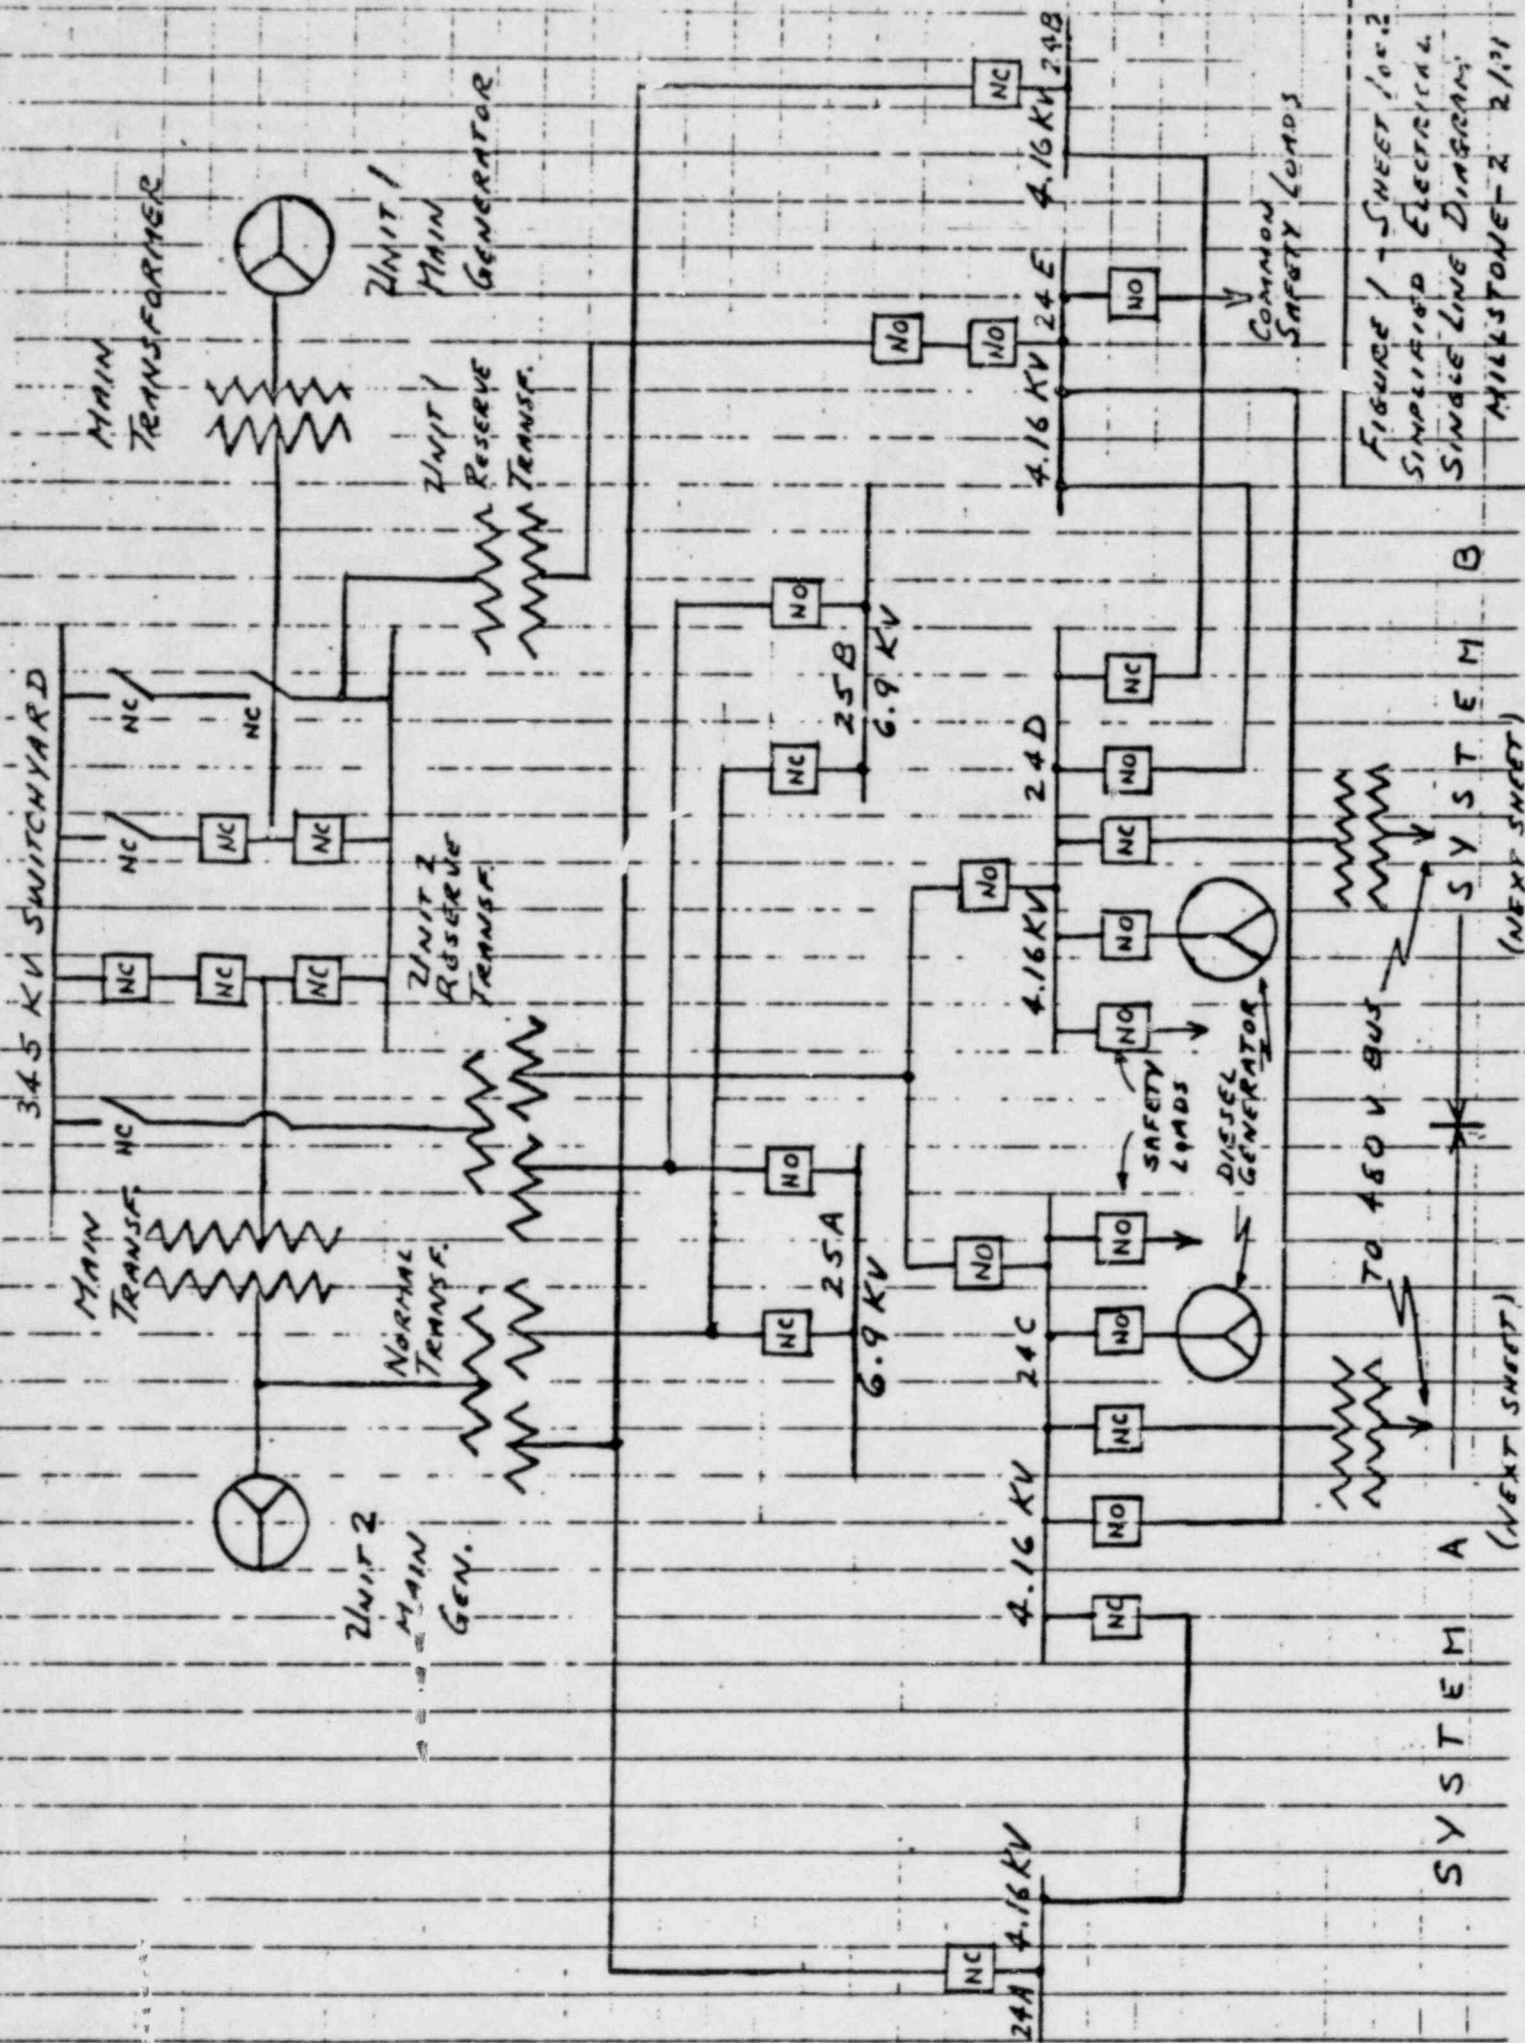
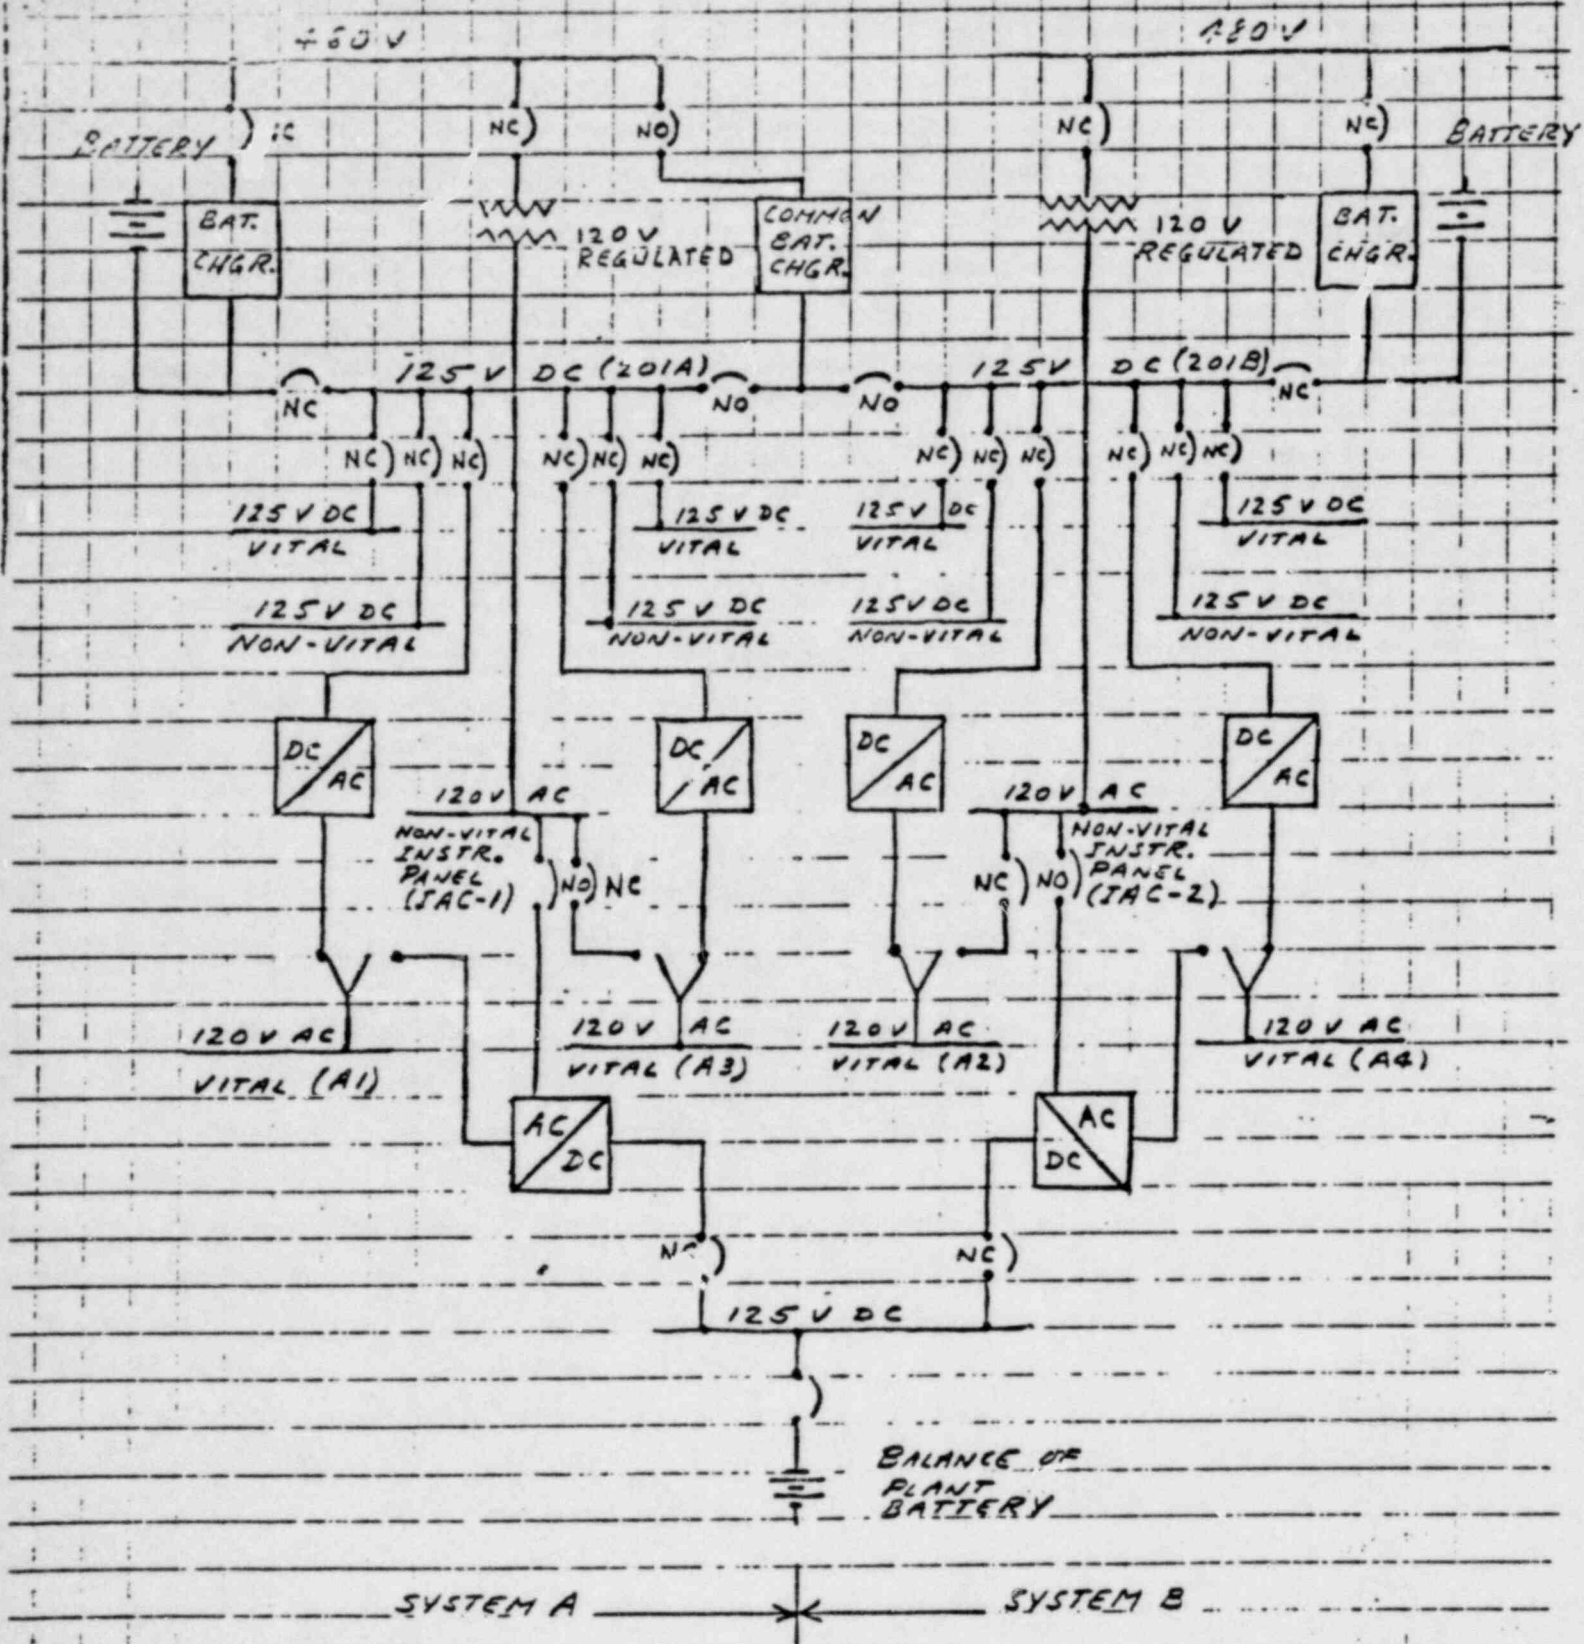
FIGURE 1 - SHEET 2 OF 2
SIMPLIFIED ELECTRICAL
SINGLE LINE DIAGRAM
MILLSTONE-2 2/81

The Millstone 2 design consists of two redundant and independent emergency power systems. These will be referred hereinafter as the A and B systems. The enclosed Figure 1 depicts a simplified single line arrangement of the ac and dc redundant emergency power systems and will be used to support the description of the following sequence of events.

Ten minutes after the initiating event occurred, system B diesel generator experienced a malfunction caused by a water leak which sprayed the speed controller. This resulted in an underspeed condition followed by a low oil pressure trip of the diesel generator. The low oil pressure trip corresponded to an electrical frequency of approximately 45 hertz. At approximately the same time, several fuses were blown in the instrumentation loops being powered from a 120 V ac non-vital instrument panel associated with system B. This panel has been identified in the enclosed Figure 1 as IAC-2.

As a result of evaluating the effects of this event, it was noted that the independence between the two redundant electrical systems could possibly be compromised at the 120 V ac level. As shown in the enclosed Figure 1, each system has two vital 120 V ac buses and one non-vital bus. One vital bus of each system is fed automatically, upon loss of the normal source, from a dc/ac inverter for which the source of dc is the balance of the plant battery (referred as the turbine battery). The other vital bus of each system is fed automatically from the non-vital bus upon the loss of the normal supply. Each non-vital bus can also be supplied from the same dc/ac inverter connected to the balance of the plant battery and used as mentioned before as an automatic alternate source for one of the vital buses. Thus, the design provisions to assure continuity of power to the vital buses from the common balance of the plant battery could also result in the compromising of the required independence between redundant electrical systems.
