U. S. NUCLEAR REGULATORY COMMISSION
OFFICE OF INSPECTION AND ENFORCEMENT

Report No. 30-10749/81-01

Licensee: Midwest Inspection Services, Ltd.
Green Bay, WI

Investigation Summary

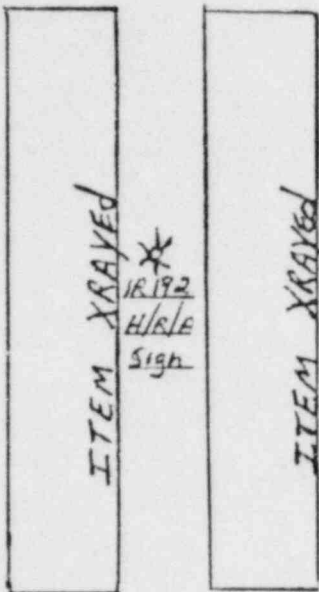
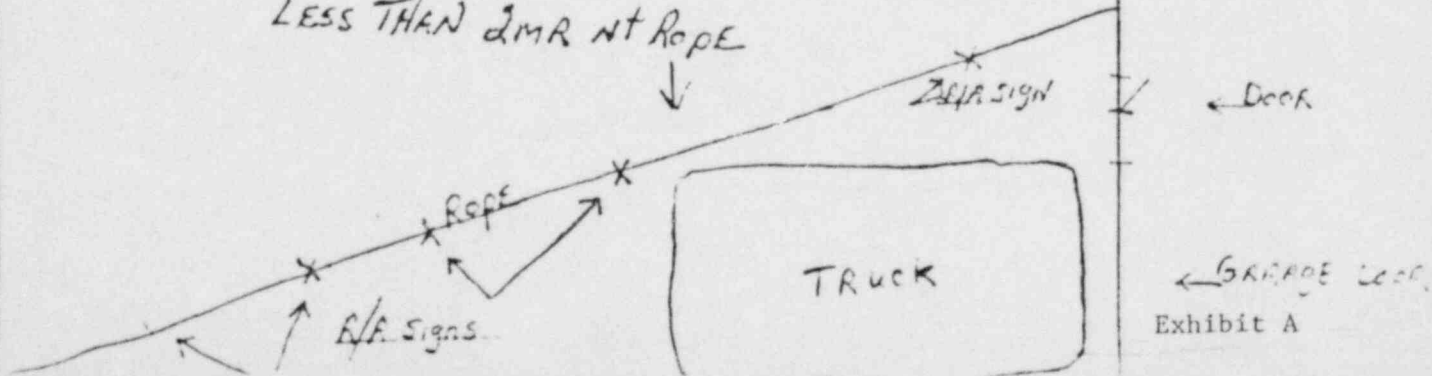
Exhibit A

Webb also pointed out where the radiographers' truck had been located, as well as the location of the rope and warning signs which separated the area from the remainder of the plant. Subsequently, a sketch of the area was obtained, a copy of which is attached to this report as Exhibit A.

Based upon the above, if an individual was in contact with the outside wall during one of the radiographic operations, in which the configurations would result in the highest radiation level at the wall, he would receive about 27 millirem. The licensee's survey record (See Exhibit A) shows that the radiation level at the wall with the source in the same configuration was 2 mR/hr. The cause of the difference between the above calculations and the survey results could not be determined. The presence or absence of objects near the wall during actual radiographic operations that might reduce the radiation levels could not be determined. Also, the validity of the survey readings recorded by the radiographers could not be formally established or disproved.
