Re: Oconee Nuclear Station
Docket No. 50-269

DUKE POWER COMPANY
OCONEE NUCLEAR STATION

Report Number: RO-269/81-5

Identification of Occurrence: Leaking LPI Check Valve

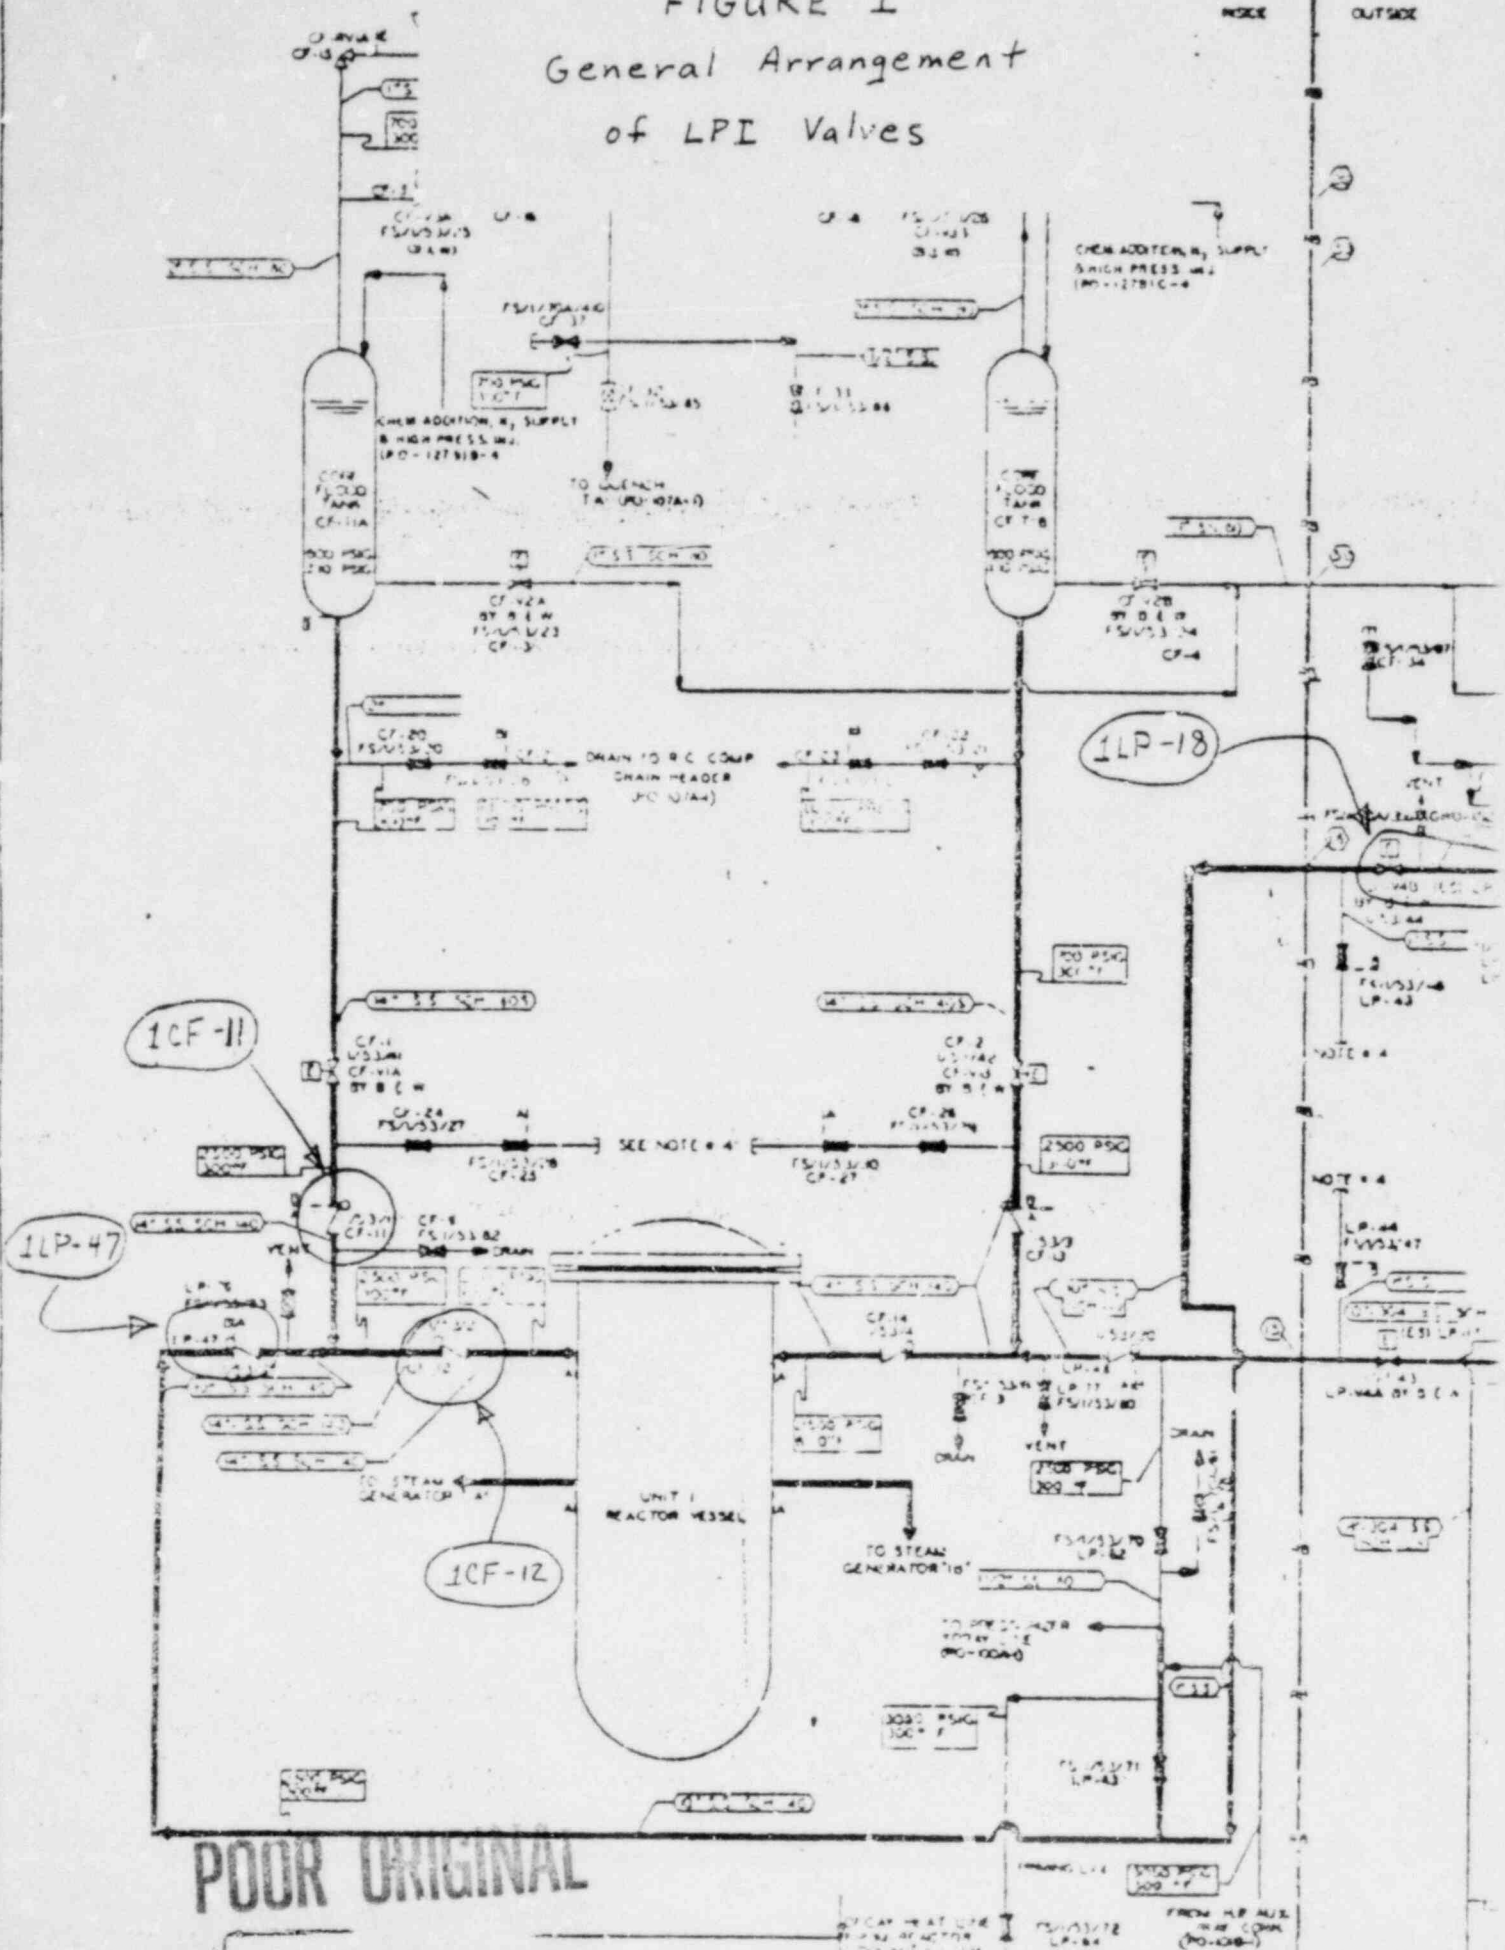
FIGURE 1
General Arrangement
of LPI Valves

Analysis of Occurrence: Prior to the testing of 1 CF-12, backup check valves 1 CF-11 and 1 LP-47 (see Figure 1) had been leak tested and both had shown zero leakage. In addition, the LPI loop "B" motor operated valve 1 LP-18 was in its normal closed position during this period of time. Thus, the prevention of leakage from the RCS to the low pressure section of the LPI system was assured.

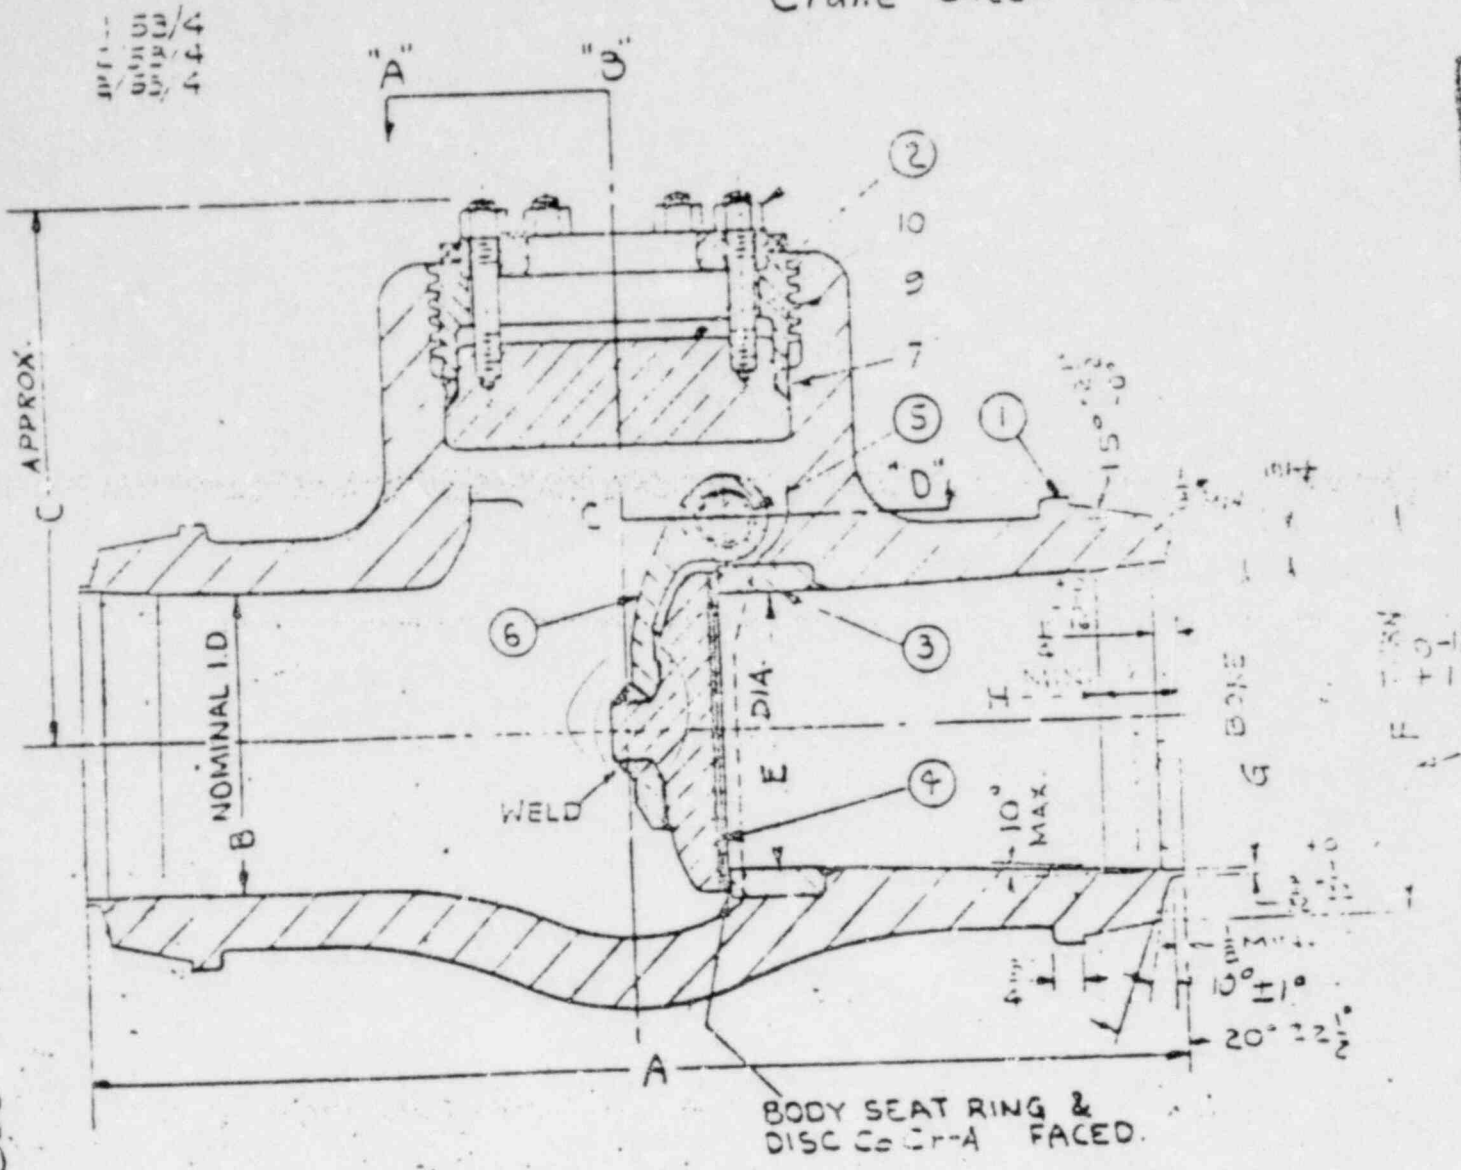
FIGURE 2
Crane Check Valve Detail

Apparent Cause of Occurrence: 1 CF-12 is a 14-inch Crane Co. 1500 PSI Alloy Steel Swing Check Valve (design pressure of 2500 PSIG). Figure 2 provides some details about this type of valve. The disc in this type of valve has a cylindrical "knob" on its back which is inserted through a hole in the hinge arm and then has a retainer ring welded to it to hold the assembly together (see Figure 3). This method of assembly allows the valve disc to pivot to a certain extent on the hinge arm. By pivoting, the disc is allowed to find its seat properly should the mating surfaces become slightly altered. A manufactured tolerance of 3 to 11 mils between the disc "knob" and the hinge at the pivot prevents the disc from swaying too freely.

Examination of the valve disc-hinge assembly in 1 CF-12 has shown that the disc had become frozen at the pivot in a cocked position. Consequently, only about half of the disc was seating. The "freezing" of the disc at the pivot was apparently caused by a buildup of deposits in the gap between the hinge and the disc "knob" on the side of the knob closest to the hinge pin. While there is flow through the valve, the disc is normally in a cocked position, and it is postulated that the flow could carry deposits into the pivot gap area, where they could accumulate. The accumulation of deposits could then cause the disc to remain slightly cocked when the flow was stopped.

During examination of the valve disc, the retaining ring was removed and unsuccessful attempts were made to remove the disc from the hinge. Both the hinge and disc are made of the same type of stainless steel (ASTM Spec. No. A351 GR. CF8M) and under the high temperature of unit operation, some galling could have occurred. At the time of this report, the disc is still connected to the hinge.

Corrective Action: The unit was returned to cold shutdown conditions so that the valve could be repaired. The valve seat of 1 CF-12 was lapped and the internals (disc, hinge, and hinge pin) were replaced with new parts. The valve was retested on March 2, 1981 and revealed zero leakage by the seat.

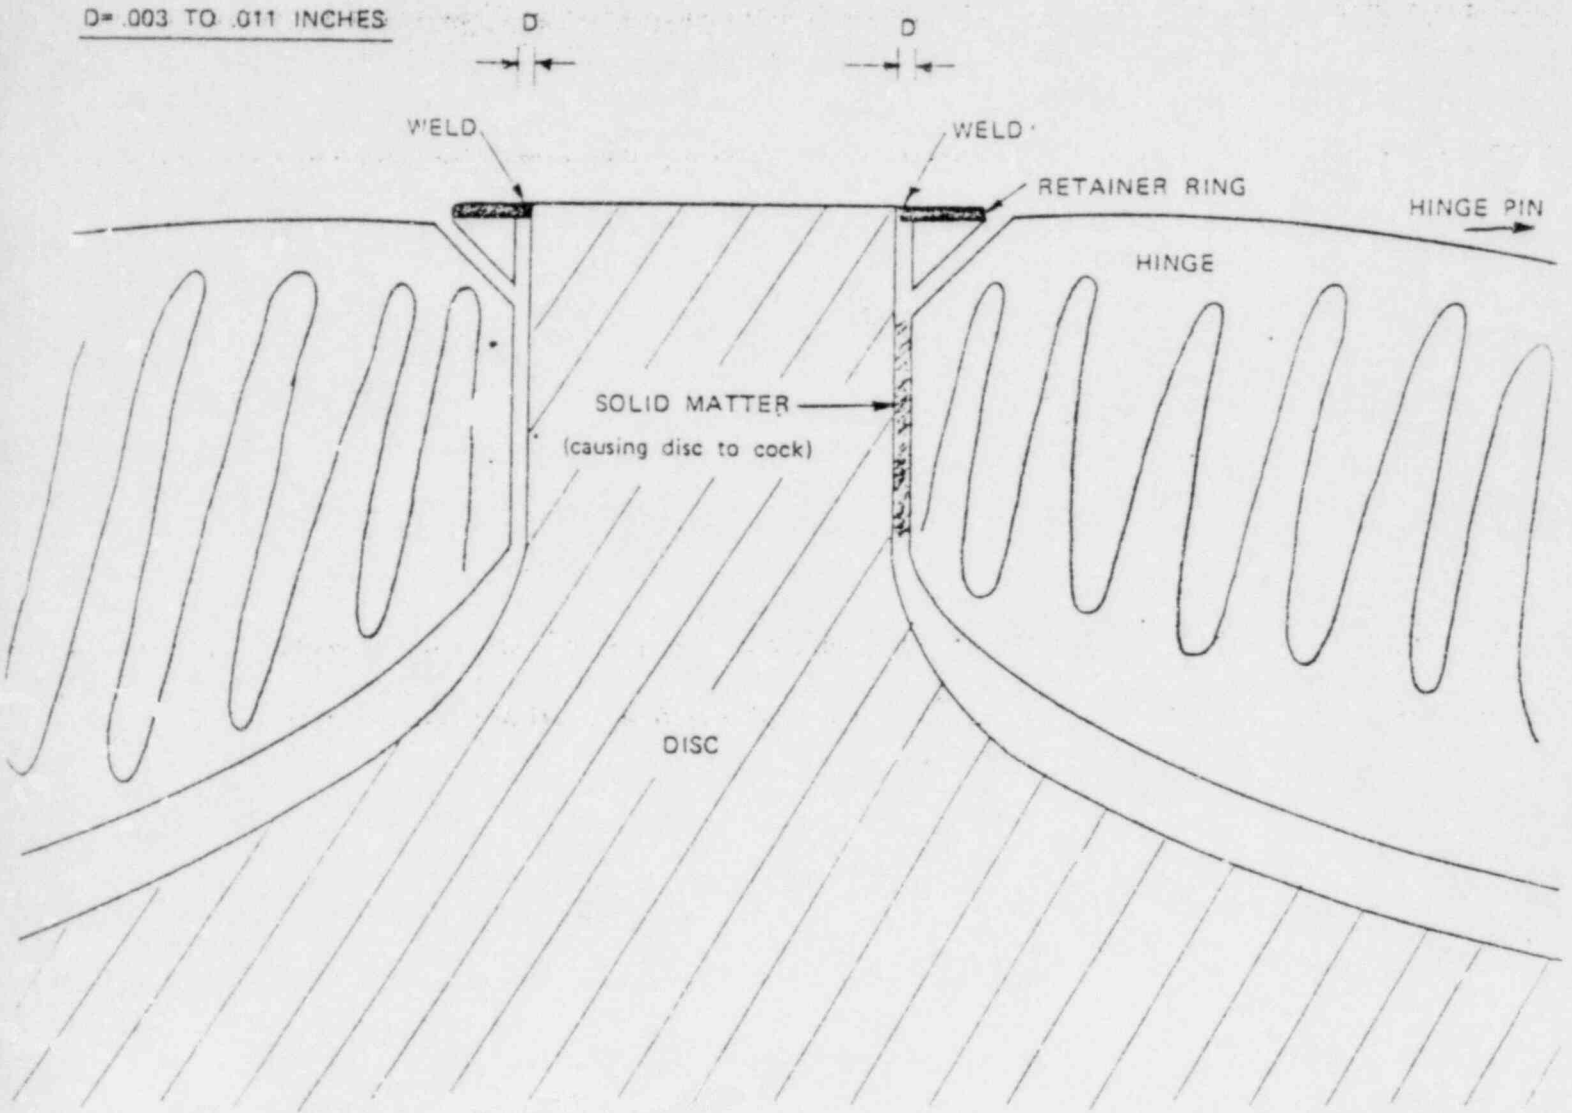
FIGURE 3

VIEW OF DISC PIVOT

D = .003 TO .011 INCHES
