U.S. NUCLEAR REGULATORY COMMISSION
OFFICE OF INSPECTION AND ENFORCEMENT

Report No. 50-483/81-04

Facility Name: Callaway Nuclear Plant, Unit 1

Investigation Summary: Investigation on February 20, March 3-6, 23-27, 1981,
(Report 50-483/81-04)

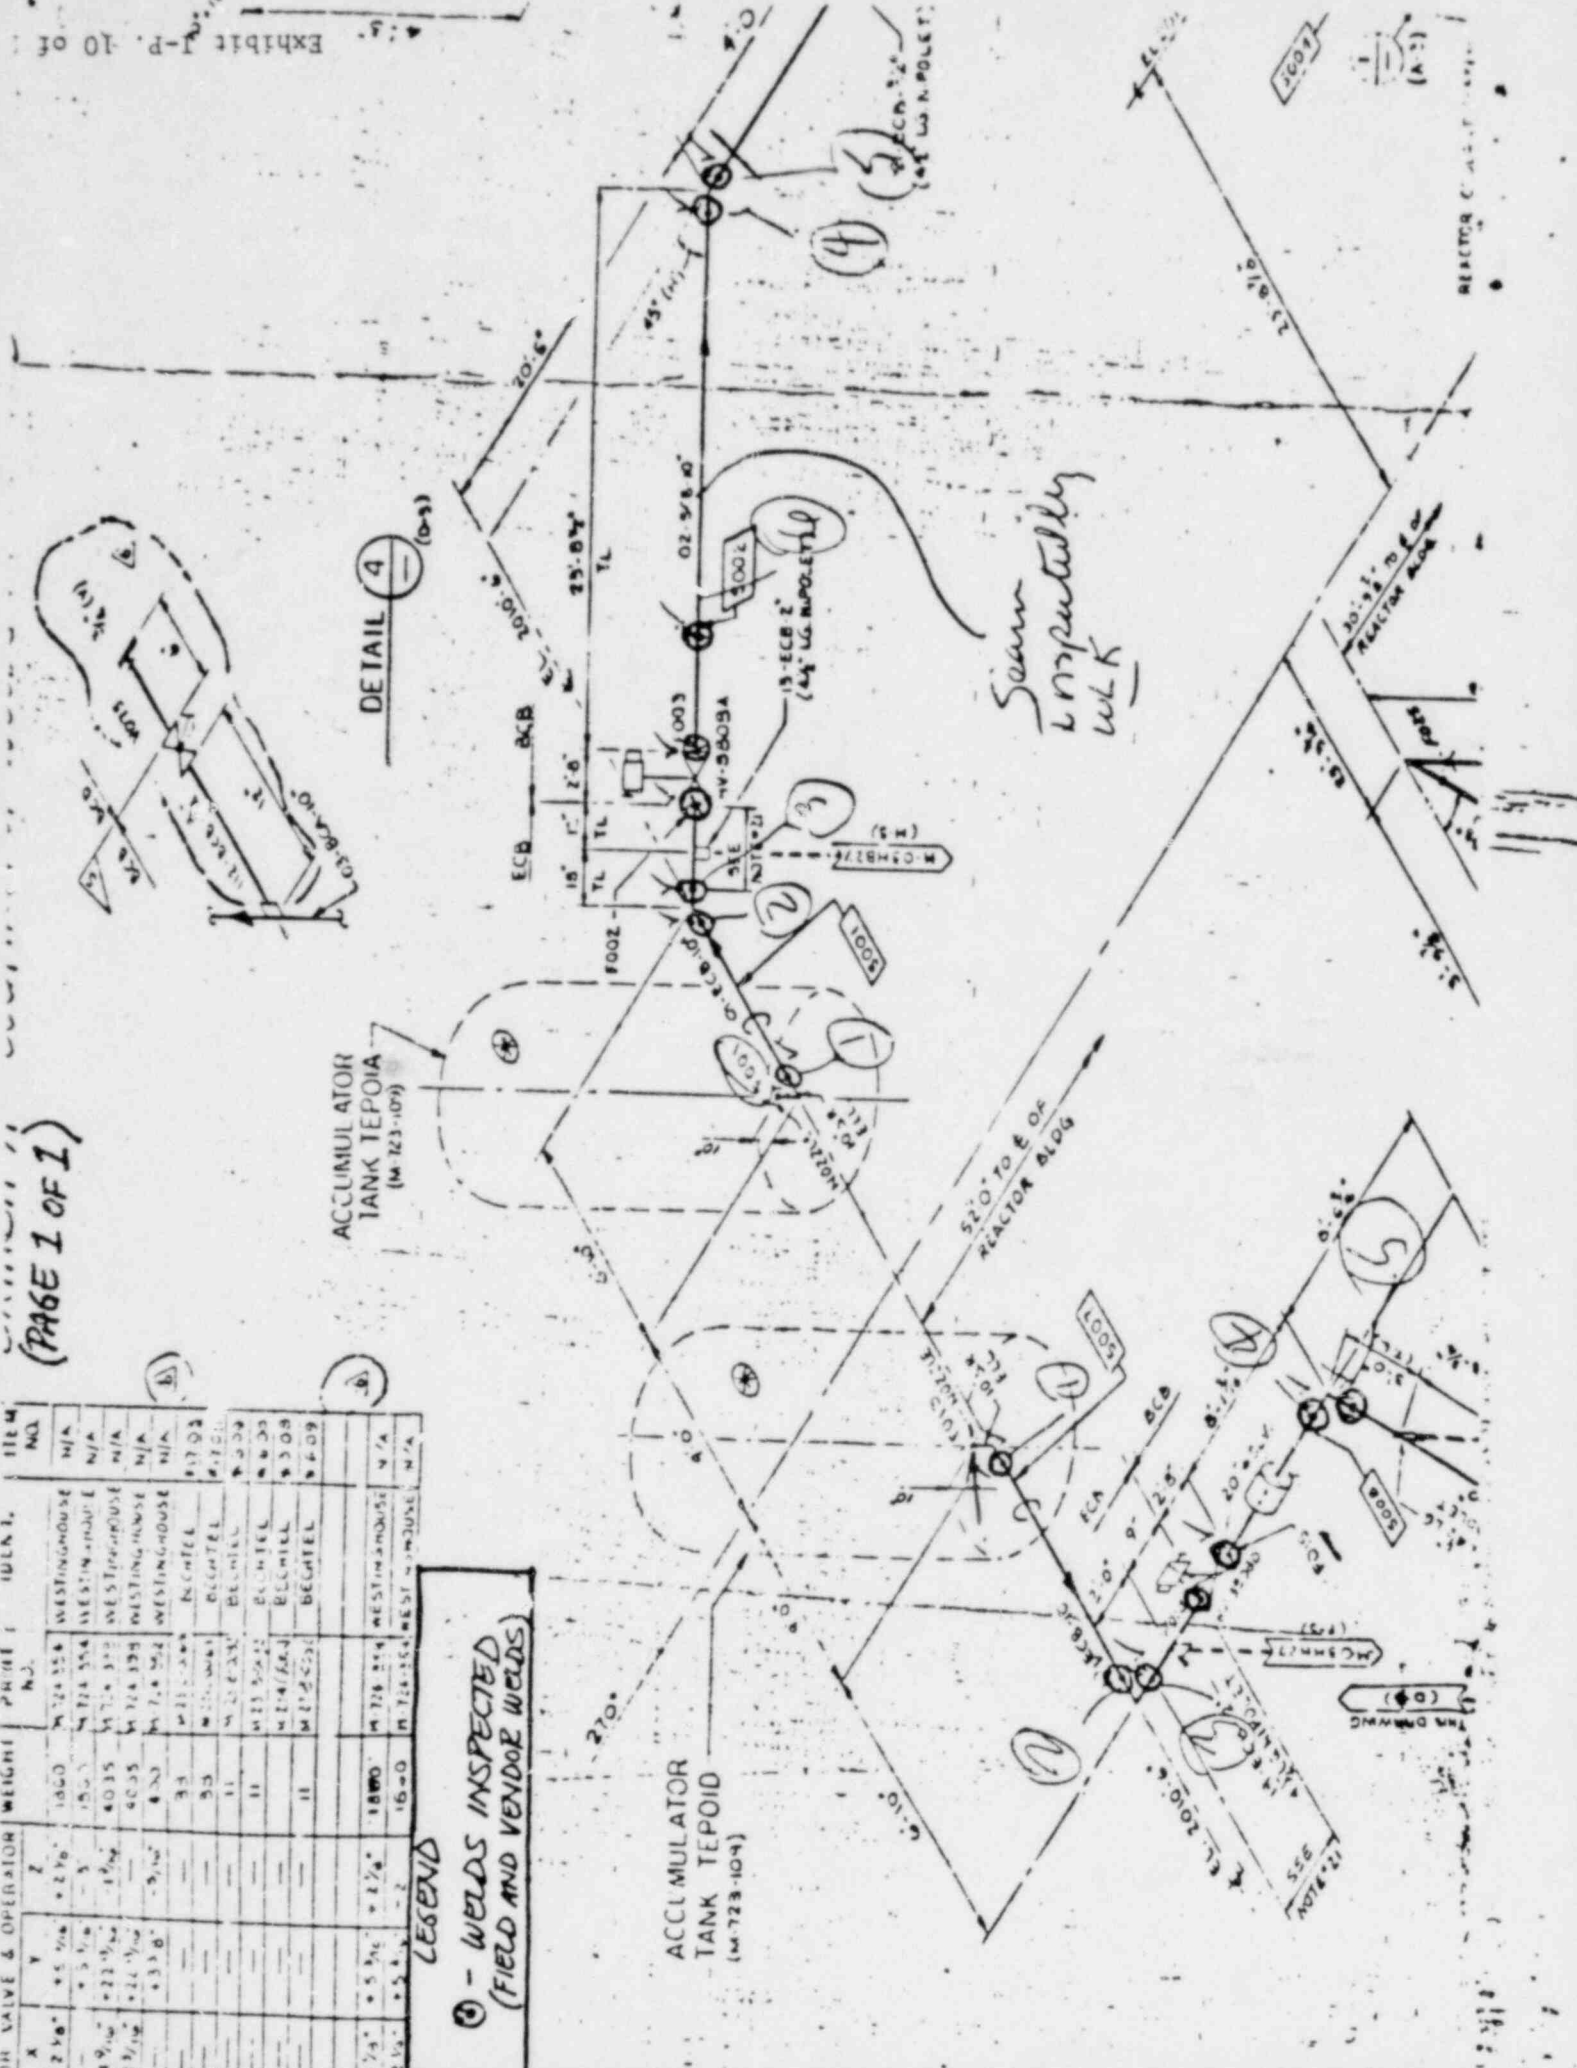
LEGEND
 (C) - WELDS INSPECTED (FIELD AND VENDOR WELDS)

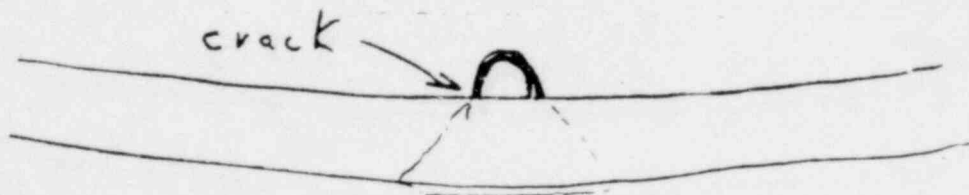
The seam weld with the crack is located in S 002 and is approximately 4" to 6" from F 004. The edge preparation for F 004 violated the minimum wall requirements and I believe an NCR tag was placed on it. By looking back into the pipe with a flash light it appeared that there was an excessive amount of fall through in the seam weld from the 45° elbow to F 004.

The seam is placed on the bottom of the pipe and a cross sectional view would look as shown here.

Because of the fall through I doubt that it would show up clearly with radiograph.
