Reconnaissance Report: Effects of November 8, 1980 Earthquake on Humboldt Bay Power Plant and Eureka, California Area

U.S. Nuclear Regulatory Commission

Office of Nuclear Reactor Regulation

Manuscript Completed: April 1981

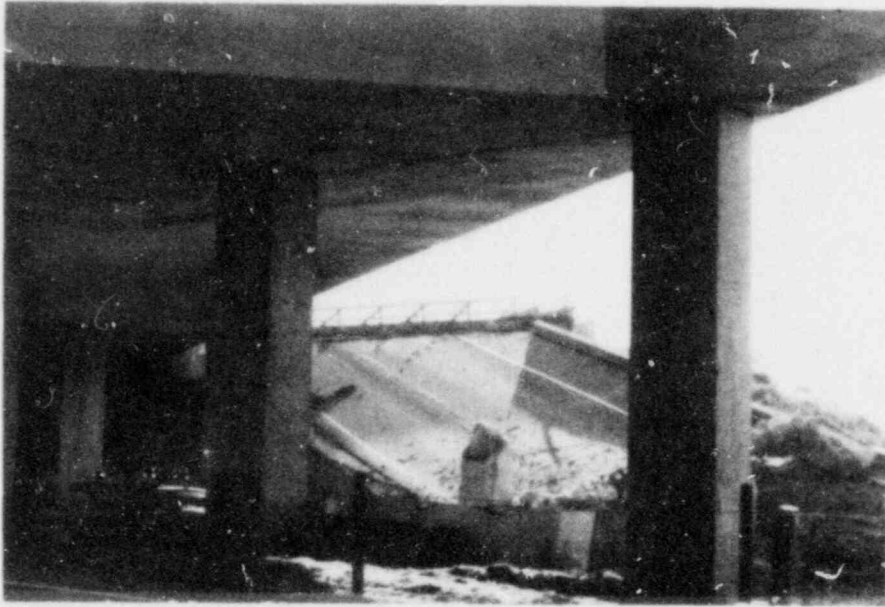
The most conspicuous earthquake damage in the area around the Humboldt Bay Power Plant was the collapsed span of the west lane of the concrete overpass on U.S. 101 about 3 miles south of the plant (see Figure 2). This damage was reported nationally by the news media.

Figure 2: U.S. 101 Overpass

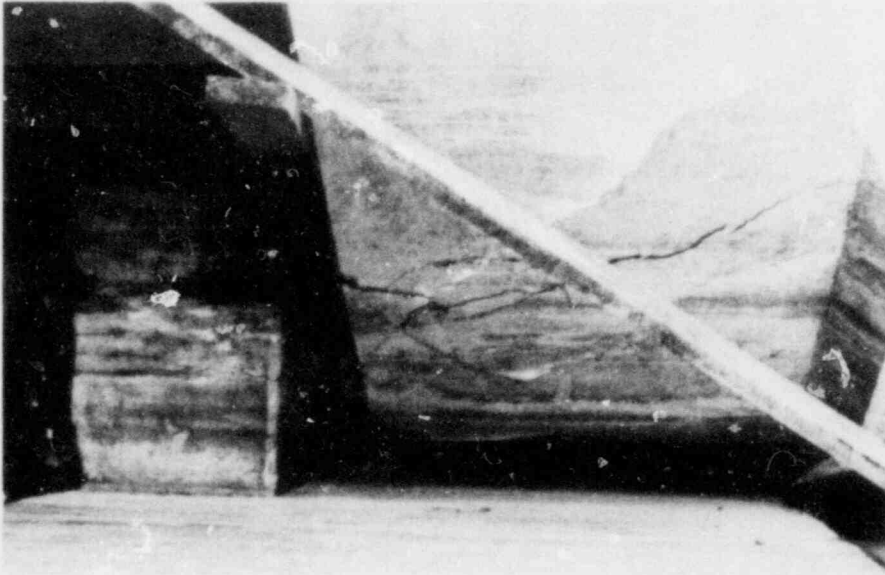
At the ends of the overpass which contact the embankments, the four spans are supported by bearing plates which, in turn, are supported by concrete piers (Figure 3). Of the three ends of the still-intact spans, one had the bearing failure in the concrete of the span shown in Figure 3, but no collapse resulted. The other two ends experienced only bolt failures in the bolts attaching the bearing pads to the concrete (Figure 4). In the spans between the embankments, the sliding joints shown in Figure 5 were incorporated in the design. These joints provided approximately a 6-in. overlap.

Figure 3: Bearing Failure of Support for the U.S. 101 Overpass

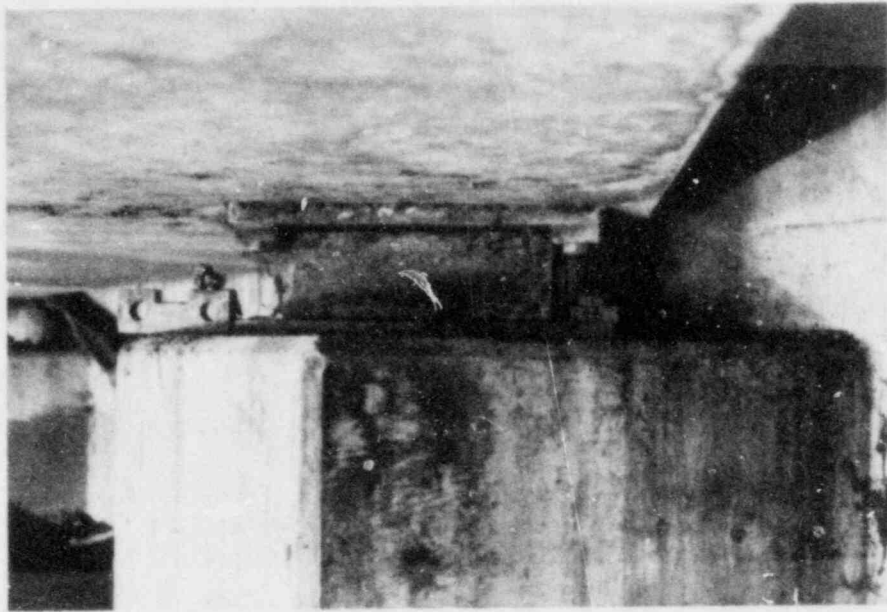
Figure 4: Typical Bolt Failure in Bearing Support of the U.S. 101 Overpass

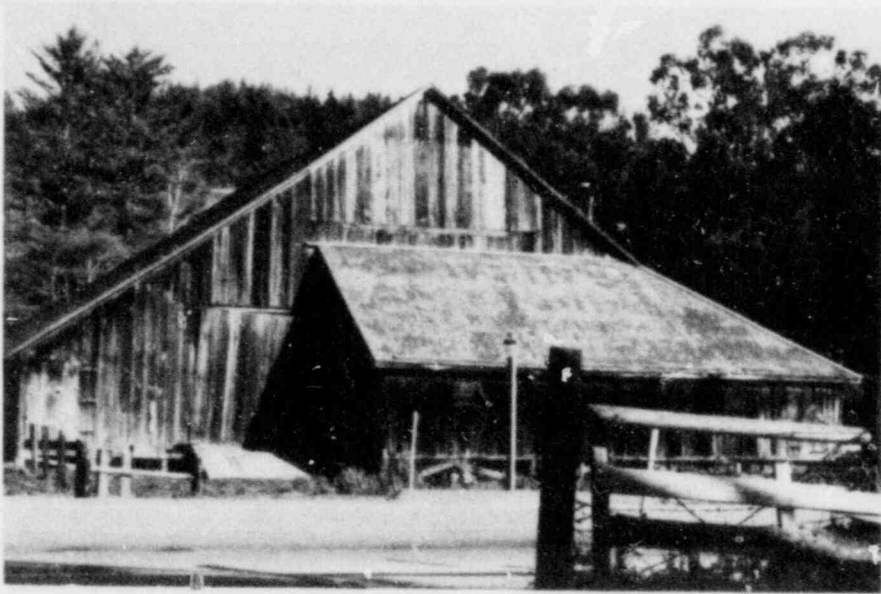
It is interesting to note that a relatively fragile-looking wooden structure (shown in Figure 6) within several hundred feet of the collapsed span of the overpass was still intact following the earthquake.

Figure 6: Wooden Structure Within a Few Hundred Feet of the U.S. 101 Overpass

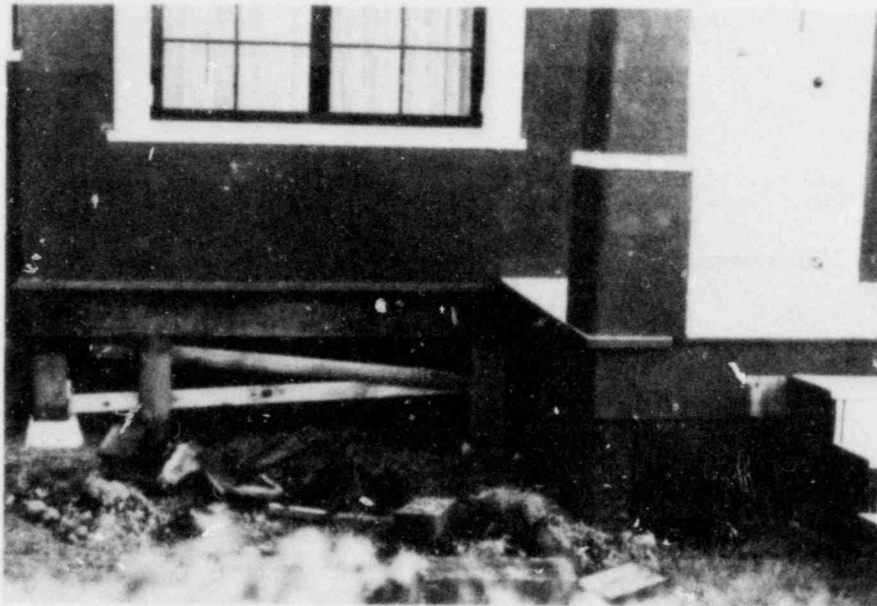
At Fields Landing, about a mile south of the plant, some other damage was noted. Several small-to-medium-sized two-story houses supported by wooden posts about a foot to a foot-and-a-half high and resting on concrete piers were swayed off these posts and hit the ground. No lateral bracing had been supplied for the posts. One of these houses is shown in Figure 7. In the photo, the house has already been raised back into position and lateral braces have now been supplied. Note that some lateral bracing had been in place for similar posts which supported the intact structure shown in Figure 6. Other problems reported in the Fields Landing area included a few damaged masonry chimneys and a few toppled stacks of lumber in a lumber yard.

Figure 7: House at Fields Landing Which Swayed Off the Supporting Posts. (Note: House is shown here after being reraised. Lateral bracing of the posts was not present prior to its fall.)

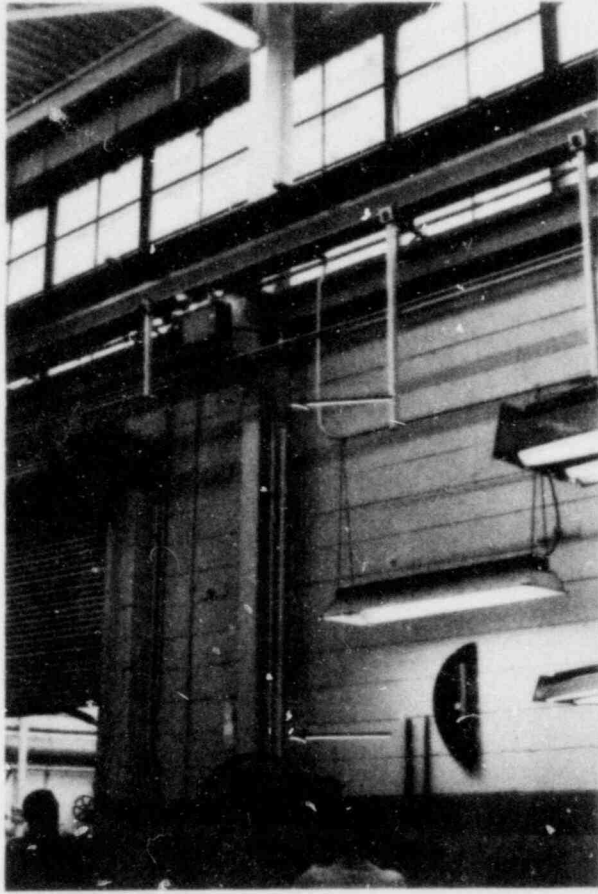
The only real structural damage which was observed was a permanent deformation of the east reinforced masonry wall of the plant's one-story cold machine shop. The wall is about 18 ft high; it spans horizontally approximately 70 to 80 ft between cross walls. The permanent deformation was evidenced by a gap which opened up between the overhead crane support columns (structurally detached from the wall) and the wall at those columns located away from the cross walls (see Figure 8). The gap size varied from zero at the bottom of the wall to about 1/2 in. at the top. No gaps existed before the quake. Close examination of the wall revealed small cracks running essentially horizontal in some bed joints; these apparently were induced by flexure of the wall during the quake.

Figure 8: Gap Between the East Reinforced Masonry Wall of the Cold Machine Shop and the Overhead Crane Support Columns

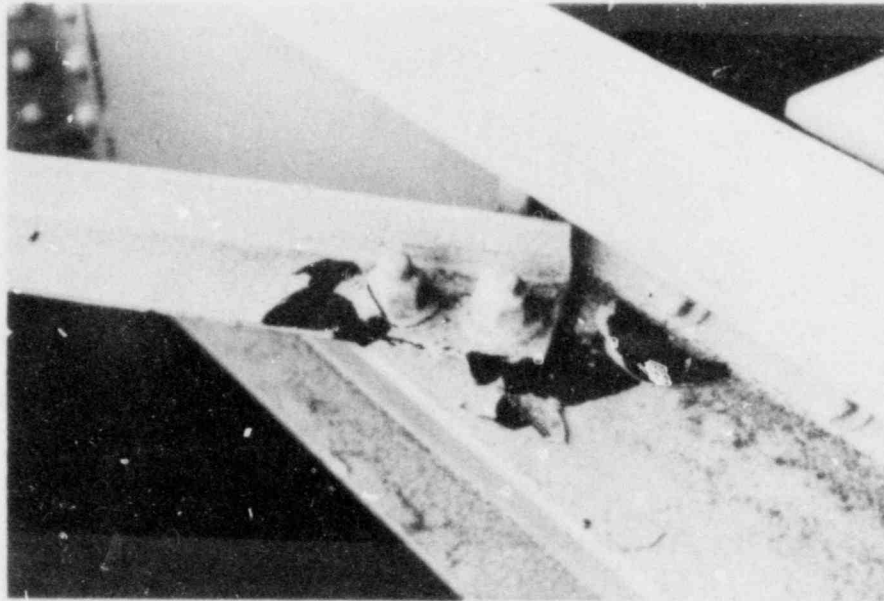
Chipped paint was noted on two structural members which were part of the sway brace system for the Unit 2 boiler (see Figure 9). The chipping occurred at

bolted joints and seemed to be the result of their slippage. Although this chipping indicated loading of these members as a result of the swaying of the boiler, no obvious metal distress was apparent, and no other effects were noted. The vendor for the boiler (Riley and Stokes) also conducted a post-earthquake inspection of the Unit 2 boiler and reported no damage. The boiler was designed to resist a 0.2 g horizontal load.

Figure 9: Part of the Lateral Support Structure for the Unit 2 Boiler. (Note chipped paint at bolted joint with no obvious metal distress.)

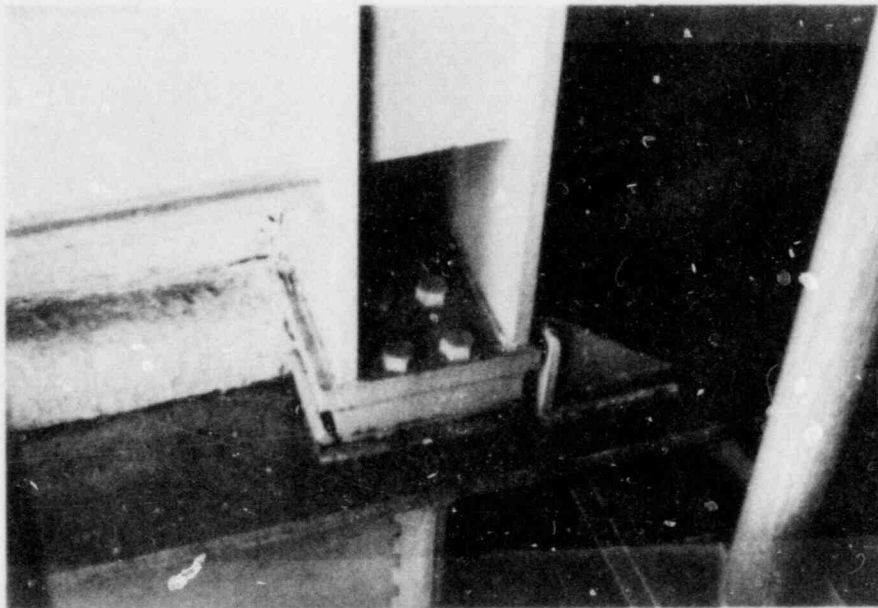
Figure 10 shows a bent lateral support for a structural member for the Unit 2 preheater. However, this damage has occurred during the 1975 event, and the only effect of the recent quake was the chipping of some paint between the vertical member and angle on the right-hand side. Although this chipping indicates that some contact occurred, no additional deformation was obvious.

Figure 10: Lateral Support Damaged During the 1975 Earthquake But Not Damaged Further by the November 8, 1980 Earthquake

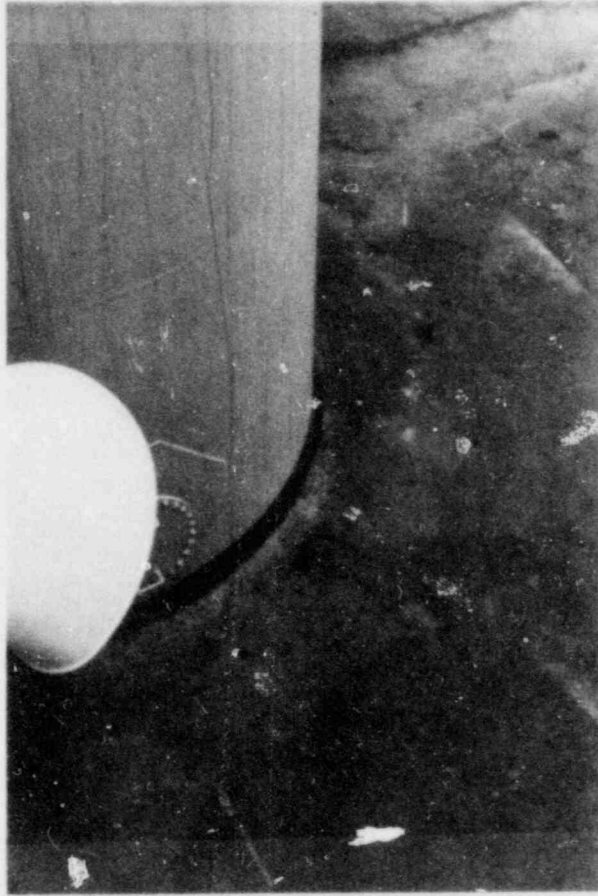
Movement at the base of three water storage tanks was evidenced by disturbance of the asphalt surrounding and in contact with the tanks at their bases. These tanks were the condensate storage tanks for Units 1 and 2 (estimated to be 25-30 ft in diameter and 40-50 ft high) and the raw water storage tank for the plant (estimated to be 35-40 ft in diameter and 50-60 ft high). A typical example of this movement was seen at the base of the Unit 2 condensate storage tank (Figure 11). At the time of the event three tanks were resting on the ground and were at least two-thirds full of water. No damage to the tanks themselves or attached piping was evident. The asphalt disturbance indicated E-W movement, but the disturbance was such that it was not readily discernible whether the tank movement was translational, rotational, or some combination thereof.

Figure 11: Asphalt Disturbed at the Base of the Unit 2
Condensate Storage Tank

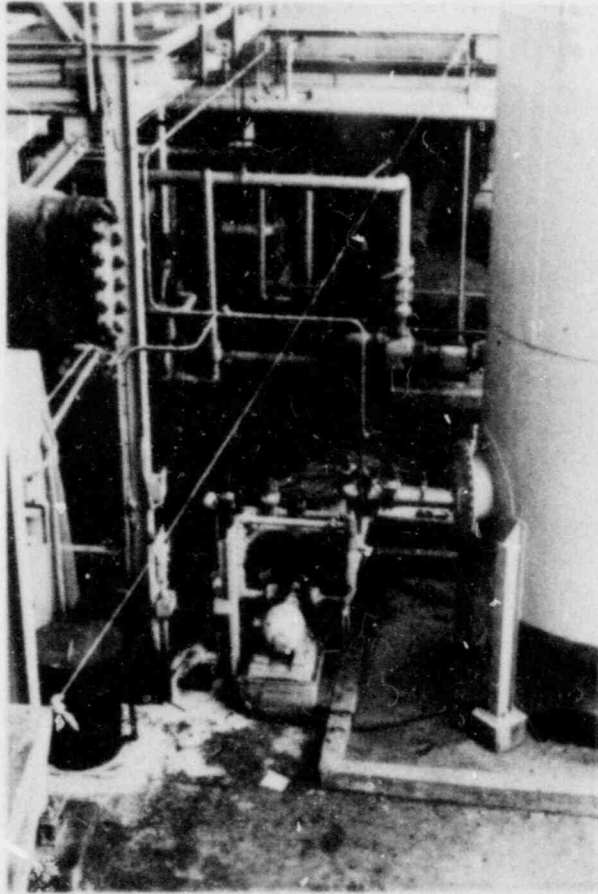
No damage to other tanks on site was reported. The Unit 3 condensate storage tank was not readily accessible for inspection; however, the tank was empty at the time of the event and no damage was anticipated. The tank pictured in Figure 12 showed no signs of "damage." Also, note that one of the hydrogen bottles shown in Figure 13 (2nd from left) was not chained. The wall against which the bottles are standing is perpendicular to the direction of strongest motion, yet it was not obvious that the tank had been disturbed.

Figure 12: Column-Supported Tank Apparently Undamaged

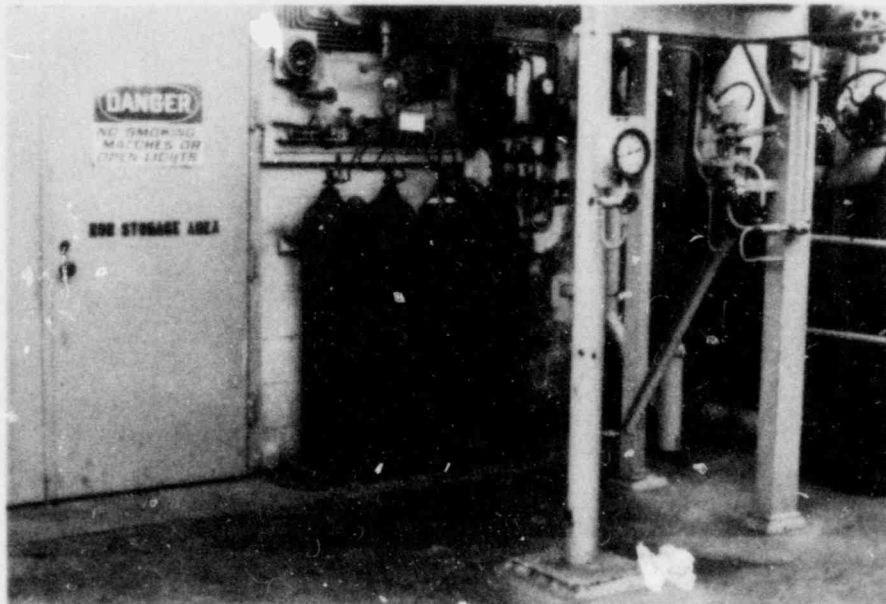
Figure 13: Unchained Hydrogen Bottle Apparently Undisturbed.
(Strongest motion was perpendicular to the wall.)

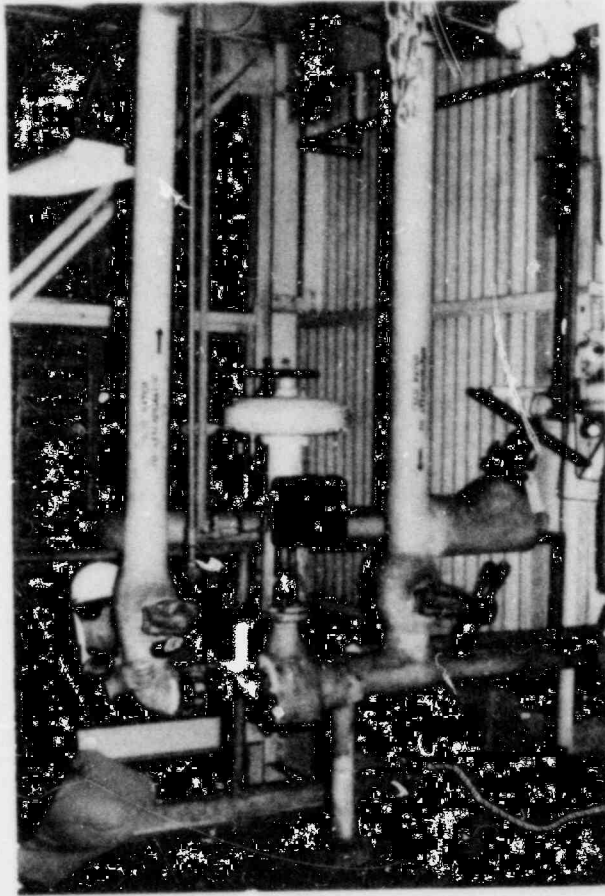
The second failure was a pinhole leak in a weld joint for a 2-in. boiler feedwater line for Unit 1. Reportedly, examination during repair revealed substantial wall erosion, necessitating the replacement of a complete spool piece. Figure 14 shows the piping and configuration after the repair. Note the chipped grout at the bottom of the support base plate. Unfortunately this figure does not show that only a vertical deadweight support was provided at the top of this piping configuration. Given the chipped grout and the piping configuration, it is obvious that the area where the leak occurred was highly stressed. The coupling of this stress with the pipe wall erosion apparently led to the development of the leak.

Figure 14: Eroded 2-in. Spool Piece of the Unit 1 Boiler Feedwater Piping Which Leaked at a Weld. (Note the chipped grout under the left side of the support base plate at floor.)

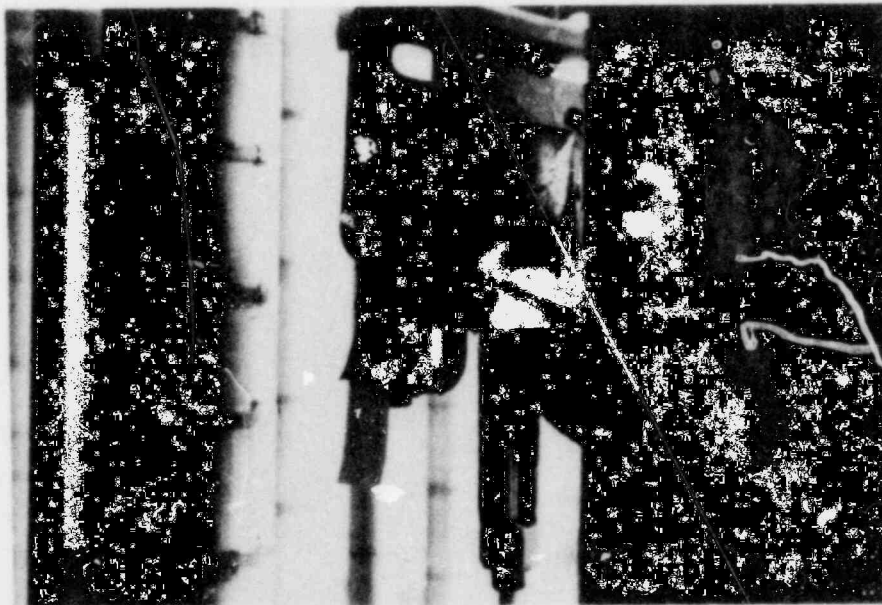
The third failure was a sheared bolt on a Grinnel vertical spring hanger for the Unit 1 main steam line (see Figure 15). The support was exposed to the weather and badly corroded. Examination of the sheared bolt indicated that the corrosion had frozen the bolt to the slot in which it was intended to slide. Only about two-thirds of the failure plane appeared to be attributable to the earthquake; about one-third of the surface appeared to have been cracked before the event. An identical hanger on the opposite side of the line (which appeared to have moved properly) seemed to be undamaged. Failure appeared to be the result of the locking of a partially failed bolt, which caused its overload.

Figure 15: Sheared Bolt in Severely Corroded Unit 1 Main Steam Line Vertical Spring Hanger

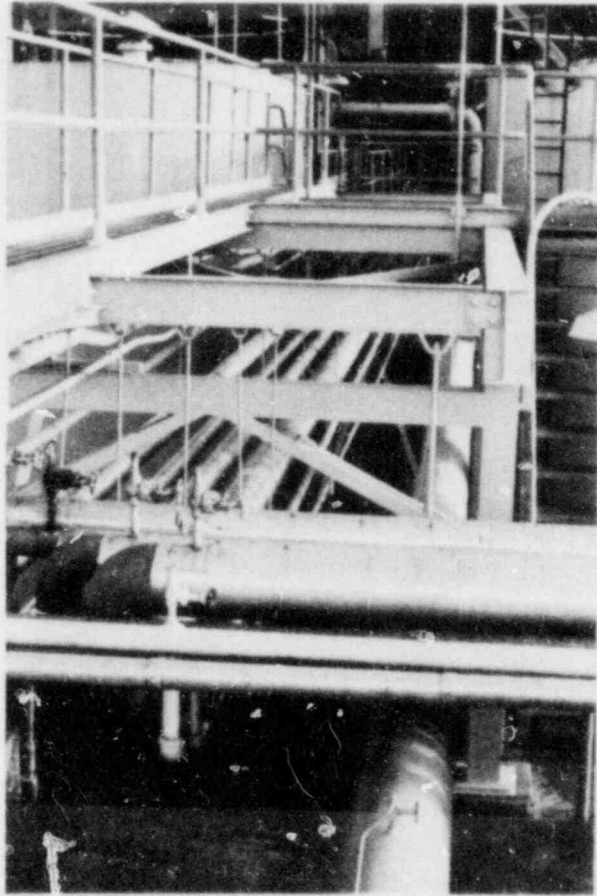
Figure 16 shows spans of fossil plant piping about 60 ft long, supported by deadweight hangers only, which were apparently undamaged. The hangers are about 2 to 3 ft long. The direction of strongest motion was perpendicular to the spans. Interestingly, no denting of the insulation was obvious from vantage points approximately 15 to 20 ft away. Figure 17 shows typical weathered Unit 1 and 2 piping which was undamaged.

Figure 16: Apparently Undamaged Long Piping Spans (approx. 60 ft) Perpendicular to the Direction of Strongest Motion and Supported by Only Deadweight Hangers

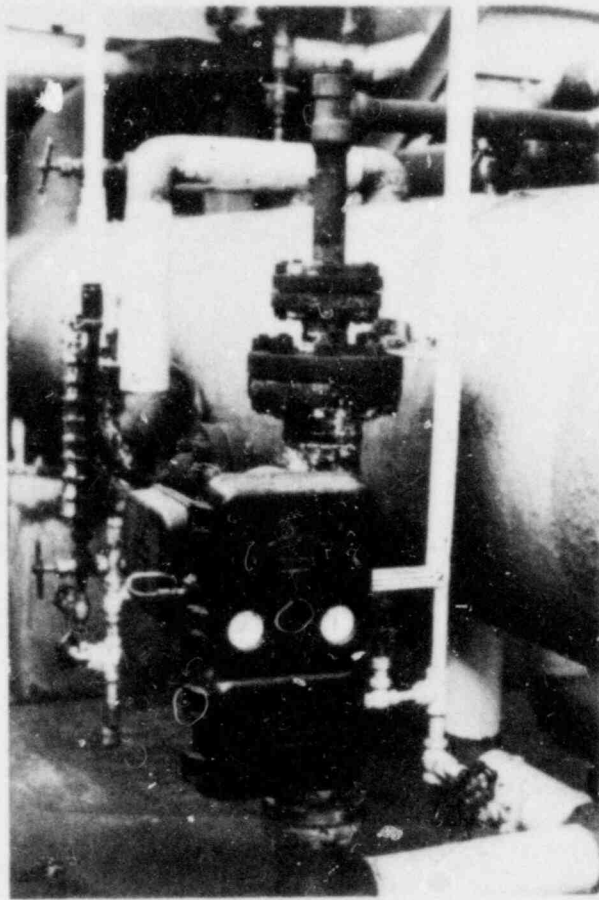
Figure 17: Typical of Weathered Units 1 and 2 Piping Undamaged by the Event

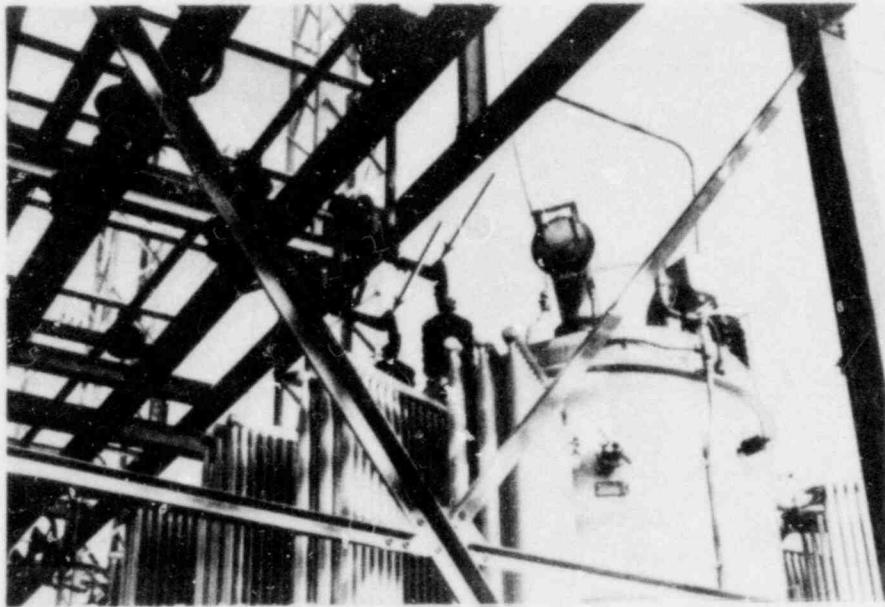
All transformers observed were anchored at their bases. Figure 18 shows the Unit 1 transformer for house power. This reportedly had been observed to be leaning before the earthquake. After the earthquake, the tilt seemed to be increased somewhat because of differential foundation settlement. Although difficult to see in the photograph, this tilting was manifest by the bending of the bus bars extending from the insulators at the top of the transformer.

Figure 18: Deformed Bus Bars Extending from Insulators atop the Unit 1 Transformer for House Power

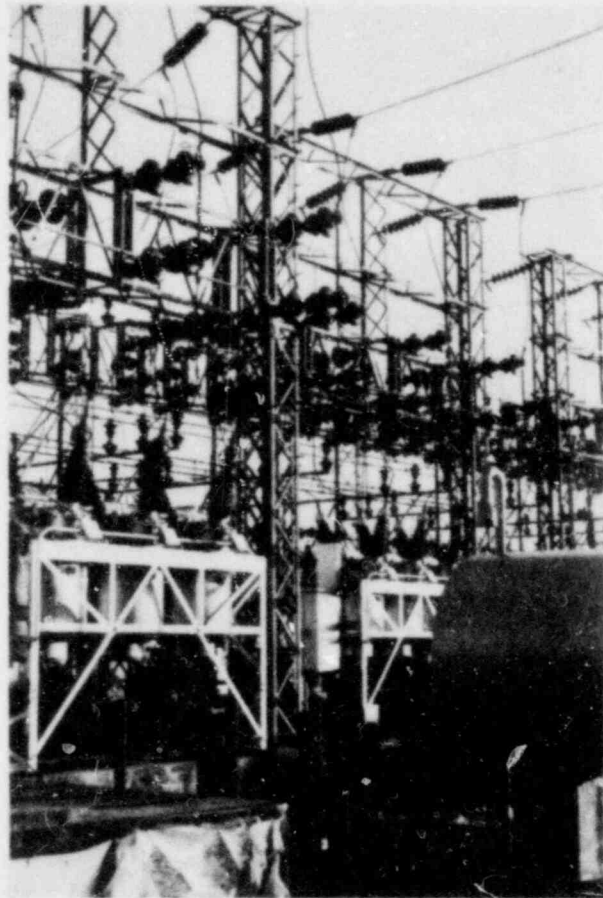
Figure 19: General View of Switchyard

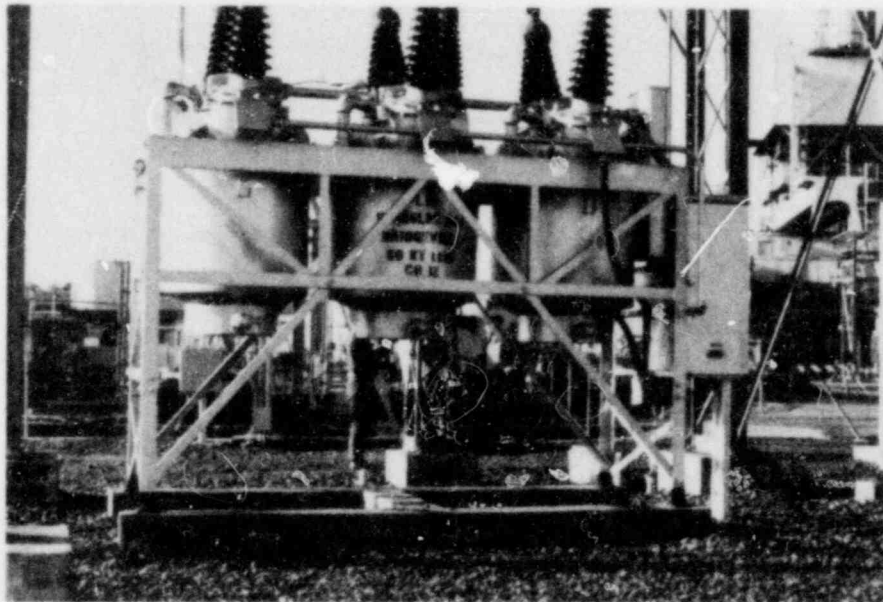
Figure 20: 60 kV Transformer

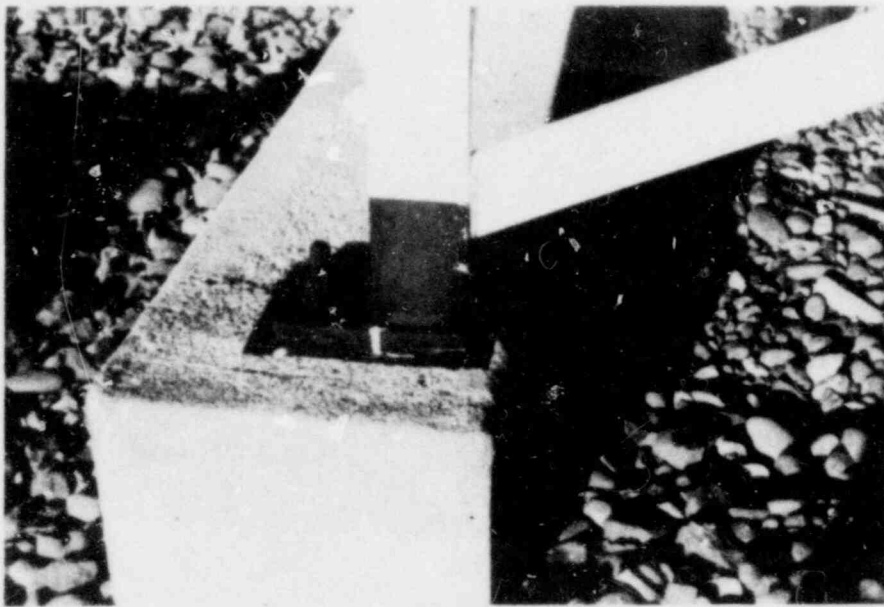
Figure 19 shows a general view of the switchyard; no damage was obvious. Figure 20 shows one of the eight 60 kV transformers. The direction of strongest motion was parallel to the long axis. Figure 21 shows a closeup of one of the bolted supports for the transformer (the long axis of transformer is parallel to the concrete footing). The cracking of the paint shown here was evident for about half of the transformers. No metal distress was obvious.

Figure 21: Cracked Paint at the Base of 60 kV Transformer Support

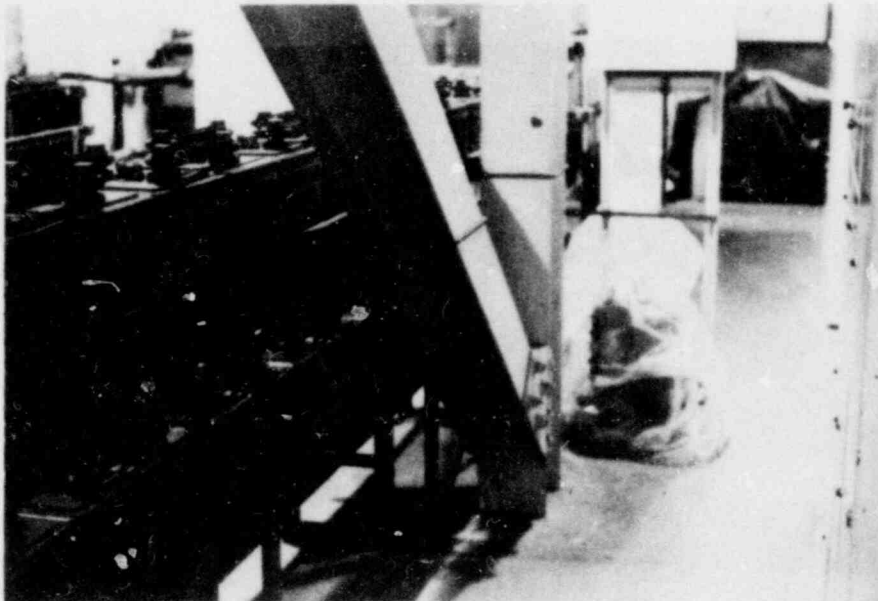
Figures 22 and 23 show a comparison of typical Units 1 and 2 batteries and racks and the Unit 3 batteries and racks. No effect on the batteries or racks was evident.

Figure 22: Typical Units 1 and 2 Batteries and Racks

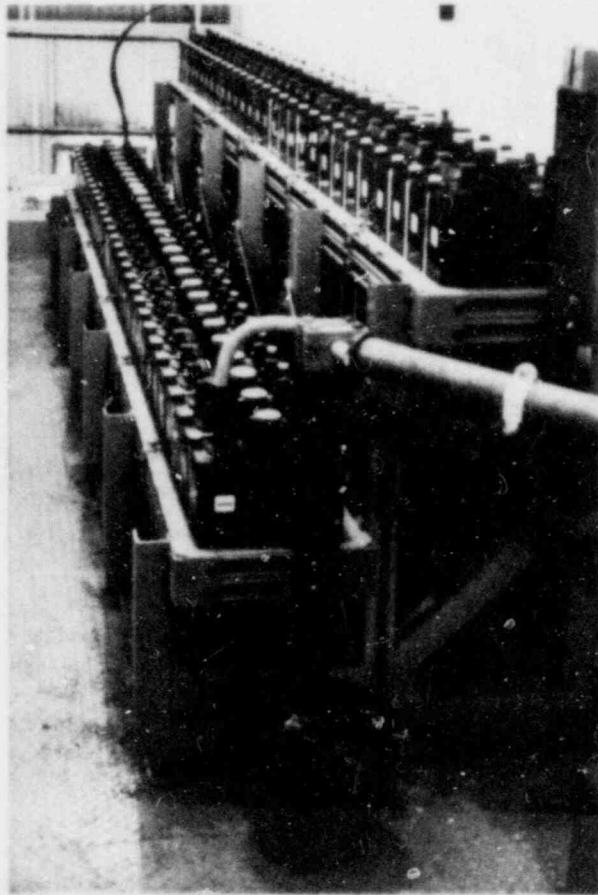
Figure 23: Unit 3 Batteries and Racks
